Canada-United States-Ontario-Michigan Border Transportation Partnership

Built Heritage Impact Assessment

Technically and Environmentally Preferred Alternative

December 2008

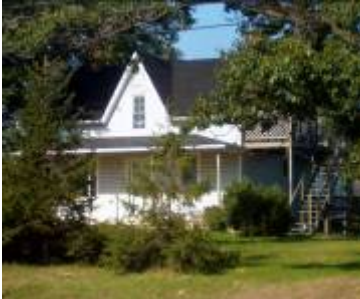
BHR No.	Address	Impact/ Mitigation	Rationale	
BHR 1	2746 Talbot Road, Windsor	Direct/ candidate for relocation	<ul style="list-style-type: none"> located in area of direct impact reflects early settlement and housing types associated with prominent early settlers' family that played a significant role in the ongoing history of Sandwich and Windsor size and construction of the building is suitable for relocation

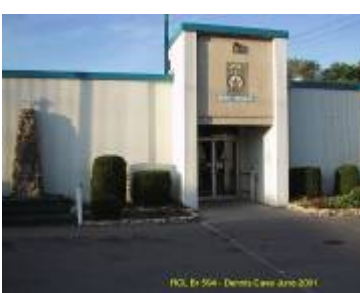
BHR 2	Legion Branch 594, 3920 Huron Church Line Road, La Salle	Direct/ document and salvage	<ul style="list-style-type: none"> located in area of direct impact building has local significance as a community focal point structure cannot be relocated

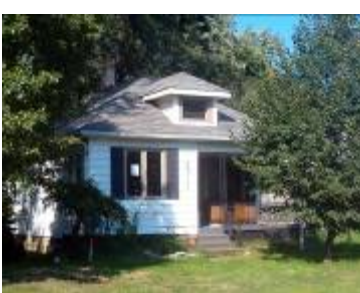
BHR 7	2310 Spring Garden Road, Windsor	Direct/ document and salvage Possible candidate for relocation as a group with BHR 8 and BHR 9	<ul style="list-style-type: none"> located in area of direct impact significance lies largely in its role as part of a small group with BHR 8 and BHR 9 possible case for relocating all three houses together

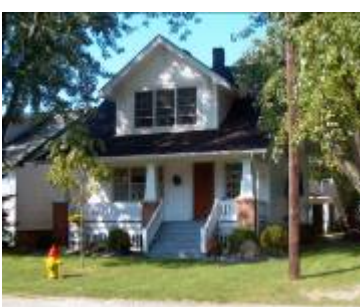
BHR 8	2290 Spring Garden Road, Windsor	Direct/candidate for relocation	<ul style="list-style-type: none"> located in area of direct impact good example of the 1930s bungalow with a high degree of design integrity size and structure are suitable for relocation part of a small group with BHR 7 and BHR 9, possible case for relocating all three houses together

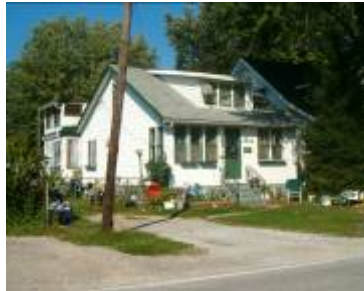
BHR No.	Address	Impact/ Mitigation	Rationale	
BHR 9	2284 Spring Garden Road, Windsor	Direct/document and salvage Possible candidate for relocation as a group with BHR 7 and BHR 8	<ul style="list-style-type: none"> located in area of direct impact significance lies largely in its role as part of a small group with BHR 7 and BHR 8 possible case for relocating all three houses together

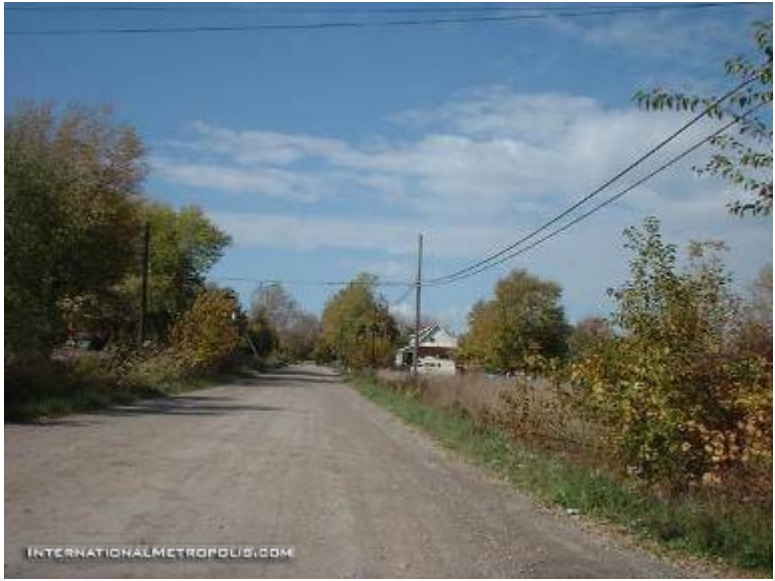
CULTURAL HERITAGE RESOURCE FORM: CULTURAL HERITAGE LANDSCAPES (CHL)	
Cultural Heritage Landscape No.: CHL 2

Lot: 55	
Concession: I	
Municipality: Sandwich West Township, Windsor	
County/R.M.: Essex	
Landscape Category: Former residential community	
Landscape Feature: n/a	
Current Use: Largely abandoned, 3 occupied houses	Brighton Beach Subdivision (photo courtesy Andrew Foot)
Integrity: Very low.	
Alterations: Several Streets now closed, vegetation cover has regenerated in many lots.	
Comments: At one time the Brighton Beach neighbourhood may have been of interest as a representative streetscape of a period in the history of Sandwich/Windsor, but too little is extant to express the character of the old subdivision.	
History: In 1913 a large steel plant was planned for Ojibway, south of Sandwich on the river, initiating a surge of residential development in the surrounding area. Brighton Beach was subdivided and the plan (no. 688) registered on 13 September 1913. The anticipated plant was not built until after the war, and then on a much smaller scale than originally proposed. Growth at Brighton Beach was slow, but it eventually became filled in during the 1920s and 1930s. Since expropriation, many of the houses and business have been destroyed by neglect or arson.

Association/Themes: The surviving features of Brighton Beach no longer express any themes or associations of significance.	
Landmark: While the story of Brighton Beach is generally known locally, there is insufficient fabric or identifiable form to qualify as a landmark.	
Associated BHR/CHL: none	
Statement of Significance: No designation is currently in effect. No further investigation is recommended regarding the Brighton Beach site, as its potential value as a CHL has been terminally compromised by loss of fabric and context.

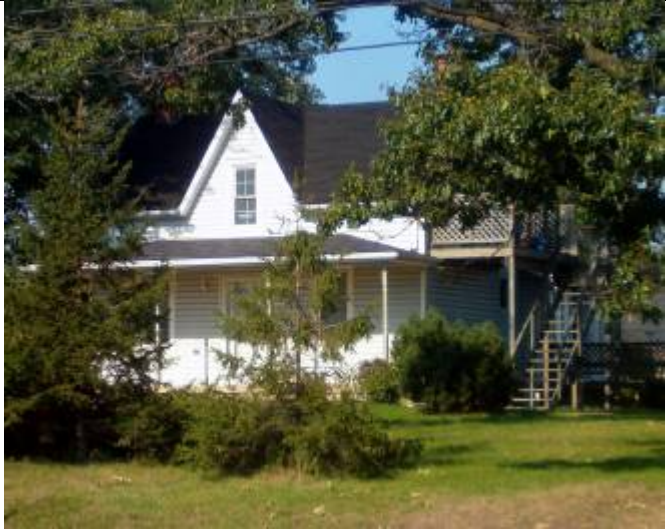
CULTURAL HERITAGE RESOURCE FORM: BUILT HERITAGE RESOURCE (BHR)	
Built Heritage Resource No.: BHR 1

Lot: 1	
Concession: IV	
Municipality: Sandwich West Township, Windsor	
County/R.M.: Essex	
Resource Category: building	
Resource Type: house	
Current Use: residential	
2746 Talbot Road, Windsor	
Architecture/Engineering: standard construction for the late 19 th century, with replacement windows & doors, new verandah and deck.	
Construction Period: ca1880	
Storeys: 1½	
Structural Material: frame on stone foundation; concrete block foundation under addition to the rear.	Cladding: vinyl.
Roof Type: side gable with centre front gable.	Roof Material: asphalt shingles.
Style/Design: vernacular Ontario farm house Notable Features: steeply pitched roof suggests design roots in gothic revival; the house retains much of its original character, although the removal of original details and the introduction of new materials has altered it somewhat.

Historical Associations: In 1848 this property was purchased by Jerome Reaume. Parts of the original homestead of 76 acres were severed and sold over the years, and the Reaume family owned several other parcels elsewhere in the township. The subject property was subdivided in 1928 by then-owners Annette, Arsène, Ernest & Ulysses Reaume, allowing the development of the residential neighbourhood in the new streets behind the house.	
Landmark: the house is prominently situated near the intersection of Talbot Road and Huron Church road.	
Group Value/CHL Association: n/a	
Statement of Significance: No designation is currently in effect. The building has a good degree of integrity, is prominently located and a good example of its type. It is also associated with a family that were considerable landowners in the mid-19 th century. Further investigation in documentary sources and with local historical resources is appropriate.

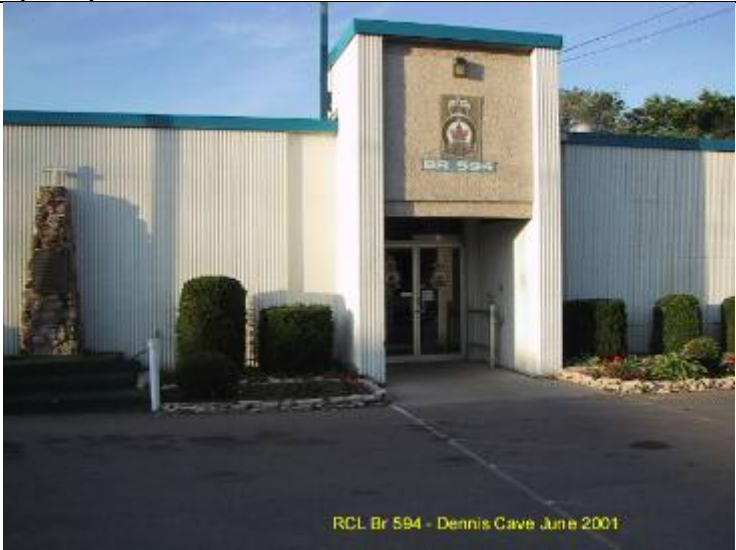
CULTURAL HERITAGE RESOURCE FORM: BUILT HERITAGE RESOURCE (BHR)	
Built Heritage Resource No.: BHR 2

<p style="text-align: right; color: yellow; font-size: small;">RCL Br 594 - Dennis Cave June 2001</p>
Lot: 1	
Concession: IV	
Municipality: Town of La Salle	
County/R.M.: Essex	
Resource Category: building	
Resource Type: institutional	
Current Use: Legion Hall	
<p>Legion Branch 594, 3920 Huron Church Line Road (photo: http://www.windsor.igs.net/~gladden/Br594RCL/INDEX.HTM)</p>	
<p>Architecture/Engineering: very straightforward structure of concrete, metal siding, etc, all typical for the period.</p>	
<p>Construction Period: 1961</p>	
<p>Storeys: 1</p>	
<p>Structural Material: concrete.</p>	<p>Cladding: textured siding, material unknown.</p>
<p>Roof Type: flat.</p>	<p>Roof Material: flat asphalt.</p>
<p>Style/Design: modern. Notable Features: very utilitarian design, with an imposing entrance that is the only remarkable feature.</p>

<p>Historical Association: Legion Branch 594 received its charter in 1961. It is actively involved in local affairs and the hall is used for a wide variety of occasions.</p>	
<p>Landmark: potential value due to its use & role in community affairs.</p>	
<p>Group Value/CHL Association: n/a.</p>	
<p>Statement of Significance: No designation is currently in effect. Further investigation is recommended due to the prominent function of the building in La Salle and its value as a social venue.</p>

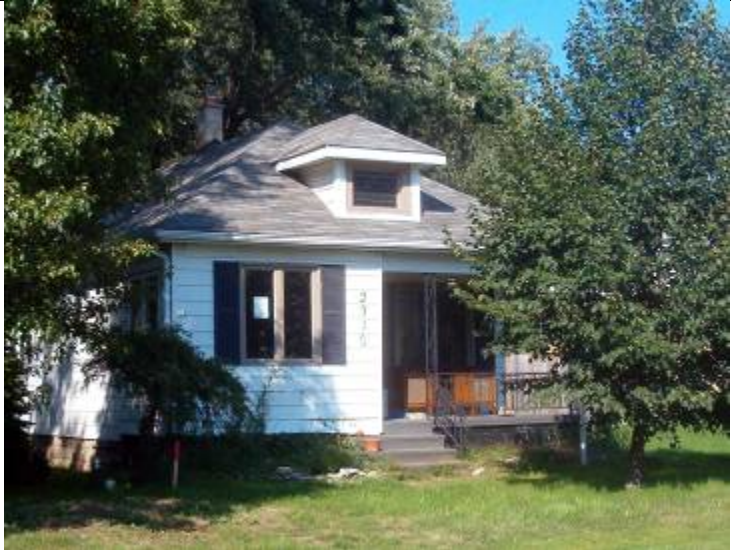
CULTURAL HERITAGE RESOURCE FORM: BUILT HERITAGE RESOURCE (BHR)	
Built Heritage Resource No.: BHR 7

Lot: 50	
Concession: II	
Municipality: Sandwich West Township, Windsor	
County/R.M.: Essex	
Resource Category: building	
Resource Type: house	
Current Use: residence	
2310 Spring Garden Road, Windsor	
Architecture/Engineering: typical plan and structure for small houses built between the wars.	
Construction Period: 1920s (subdivision plan was registered 20 October 1920).	
Storeys: 1½	
Structural Material: frame on textured concrete block foundation.	Cladding: asbestos shingles.
Roof Type: hipped with single front dormer.	Roof Material: asphalt shingles.
Style/Design: vernacular bungalow Notable Features: typical 1920s compact home which is a precursor to the post World War II veterans' housing.	
Historical Association: The house has no known association with any historical theme, person or event.	
Landmark: no value.

Group Value/CHL Association: This is one of three bungalows from approximately the same era that form a group reflecting the character, scale and style of residential housing between the wars; they have retained their design integrity and may have some merit as a CHL.	
Statement of Significance: No designation is currently in effect. Alone this house is not an exceptional example of its type, however because it survives in its original context it contributes to the character of the setting. Further investigation is recommended.

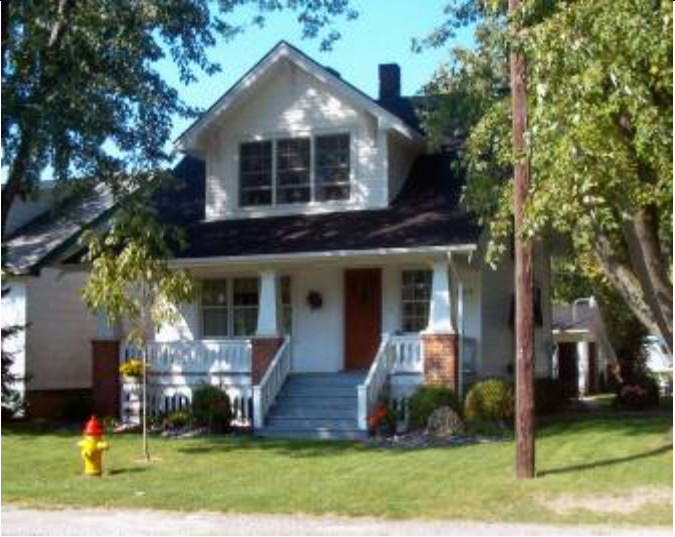
CULTURAL HERITAGE RESOURCE FORM: BUILT HERITAGE RESOURCE (BHR)	
Built Heritage Resource No.: BHR 8

Lot: 50	
Concession: II	
Municipality: Sandwich West Township, Windsor	
County/R.M.: Essex	
Resource Category: building	
Resource Type: house	
Current Use: residential	
2290 Spring Garden Road, Windsor	
Architecture/Engineering: possibly architect-designed, a good example of its type; structure and materials typical of its time, some introduction of new materials but integrity quite good.	
Construction Period: 1929	
Storeys: 1½	
Structural Material: frame on textured concrete block foundation, brick verandah posts.	Cladding: vinyl siding.
Roof Type: side gable with centre dormer; bell-cast slope may be a regional French derivation.	Roof Material: asphalt shingles.
Style/Design: Arts & Crafts Bungalow	
Notable Features: very good design with deep verandah under the main roof, stout square piers and Arts & Crafts detailing; the verandah has been rebuilt sympathetically and consistent with the original design.

Historical Association: The house has no known association with any historical theme, person or event.	
Landmark: unlikely.	
Group Value/CHL Association: This is one of three bungalows from approximately the same era that form a group on Spring Garden Road reflecting the character, scale and style of residential housing between the wars; they have retained their design integrity and may have some merit as a CHL.	
Statement of Significance: No designation is currently in effect. This is the best of the three houses in the row, and deserves to be evaluated on its own merit; it dominates the smaller houses on either side. Further investigation is recommended.

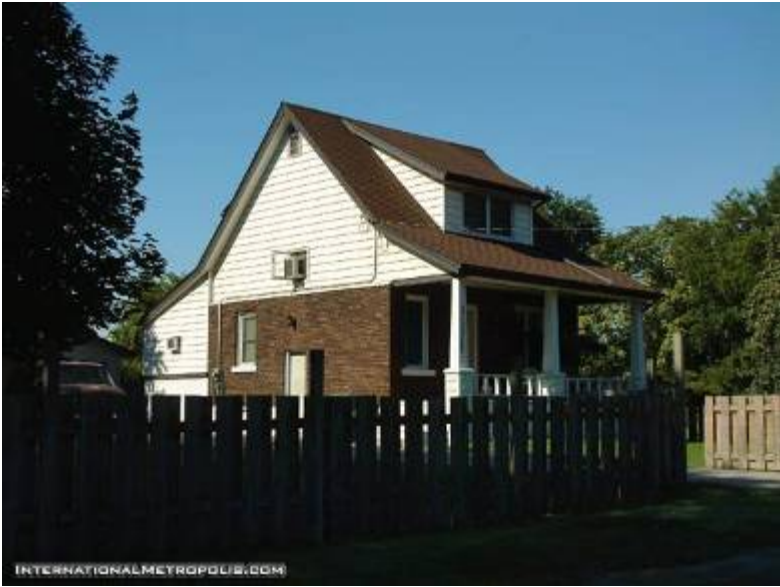
CULTURAL HERITAGE RESOURCE FORM: BUILT HERITAGE RESOURCE (BHR)	
Built Heritage Resource No.: BHR 15

Lot: 50	
Concession: I	
Municipality: Sandwich West Township, Windsor	
County/R.M.: Essex	
Resource Category: building	
Resource Type: house	
Current Use: residential	
325 Page Street, Windsor (photo courtesy Andrew Foot)	
Architecture/Engineering: A frame bungalow clad in brick veneer on the first floor, on a concrete block foundation; typical construction for the period.	
Construction Period: 1930s or 1940s	
Storeys: 1½	
Structural Material: probably frame with brick veneer, concrete block foundation, upper floor frame.	Cladding: brick veneer & shingles.
Roof Type: side gable with bell-cast, shed-roofed dormer.	Roof Material: asphalt shingles.
Style/Design: vernacular bungalow.	
Notable Features: a local variation of the bungalow with the changing slope of the roof, possibly of French derivation; not a particularly good example of the type.

Historical Association: the house has no known association with any historical theme, person or event.	
Landmark: no value.	
Group Value/CHL Association: one of three remaining houses in the Brighton Beach subdivision (see CLU 2); insufficient context survives to justify assigning any value.	
Statement of Significance: No designation is currently in effect. This building does not possess any noteworthy design quality, historical associations or significance as an element in a cultural landscape. No further action is recommended.

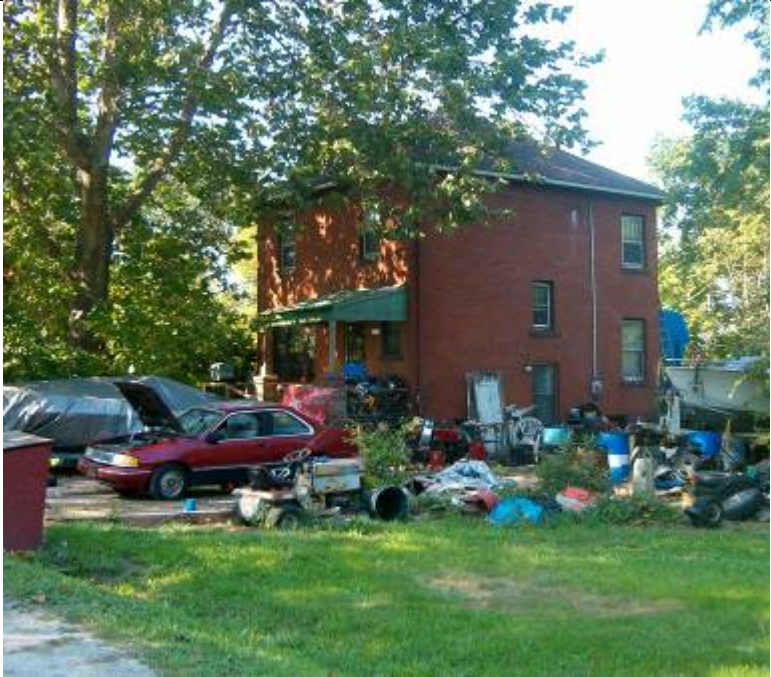
CULTURAL HERITAGE RESOURCE FORM: BUILT HERITAGE RESOURCE (BHR)	
Built Heritage Resource No.: BHR 16

Lot: 50	
Concession: I	
Municipality: Sandwich West Township, Windsor	
County/R.M.: Essex	
Resource Category: building	
Resource Type: house	
Current Use: residential	332 Healy Street, Windsor
Architecture/Engineering: Fair example of the early 20 th century 2-storey foursquare house. No notable architectural features.	
Construction Period: 1890-1915	
Storeys: 2	
Structural Material: probably frame structure with brick veneer, foundation unknown.	Cladding: brick
Roof Type: hipped with front dormer.	Roof Material: asphalt shingles.
Style/Design: vernacular foursquare.	
Notable Features: no notable design features.	
Historical Association: The house has no known association with any historical theme, person or event.	
Landmark: no value.	
Group Value/CHL Association: One of three remaining houses in the Brighton Beach subdivision (see CLU 2); insufficient context survives to justify assigning any value.

<p>Statement of Significance: No designation is currently in effect.</p> <p>This building does not possess any noteworthy design quality, historical associations or significance as an element in a cultural landscape.</p> <p>No further action is recommended.</p>

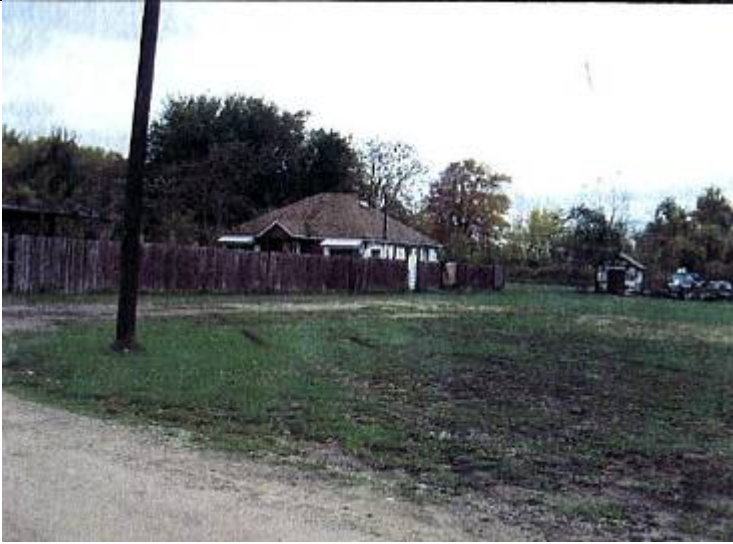
CULTURAL HERITAGE RESOURCE FORM: BUILT HERITAGE RESOURCE (BHR)	
Built Heritage Resource No.: BHR 17

Lot: 50	
Concession: I	
Municipality: Sandwich West Township, Windsor	
County/R.M.: Essex	
Resource Category: building	
Resource Type: house	
Current Use: unknown	<p>354 Healy Street, Windsor (<i>photo from: The Practical Alternative Evaluation Working Paper, Cultural Heritage [March 2008]</i>)</p>
<p>Architecture/Engineering: The building displays no architectural or structural features of note or quality. Much altered from original appearance.</p>	
<p>Construction Period: 1930s</p>	
<p>Storeys: 1</p>	
Structural Material: probably frame.	Cladding: vinyl siding.
Roof Type: hipped, front gable.	Roof Material: asphalt shingles.
<p>Style/Design: vernacular. Notable Features: none.</p>	
<p>Historical Associations: The house has no known association with any historical theme, person or event.</p>	
<p>Landmark: no value.</p>

<p>Group Value/CHL Association: One of three remaining houses in the Brighton Beach subdivision (see CLU 2); insufficient context survives to justify assigning any value.</p>	
<p>Statement of Significance: No designation is currently in effect.</p> <p>This building does not possess any noteworthy design quality, historical associations or significance as an element in a cultural landscape. It was previously listed because the central chimney suggested it might be of an earlier date than the 1930s, however subsequent research has uncovered no evidence to support this.</p> <p>No further action is recommended.</p>

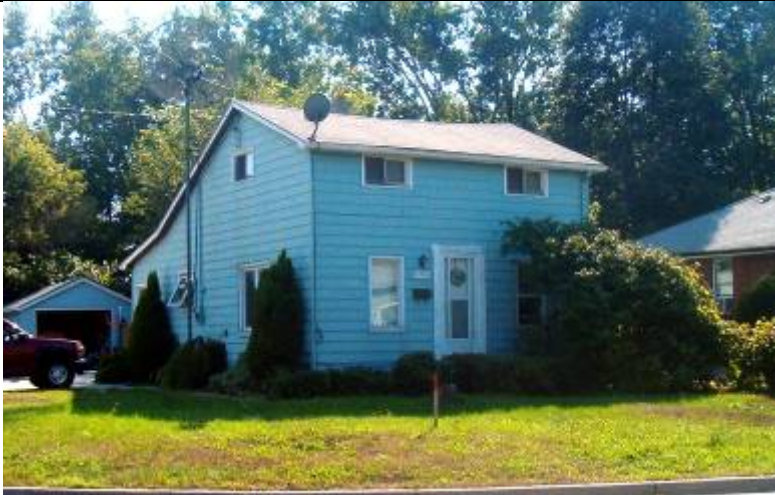
CULTURAL HERITAGE RESOURCE FORM: BUILT HERITAGE RESOURCE (BHR)	
Built Heritage Resource No.: BHR 19

Lot: 50	
Concession: II	
Municipality: Sandwich West Township, Windsor	
County/R.M.: Essex	
Resource Category: building	
Resource Type: house	
Current Use: residential	2369 Spring Garden Road, Windsor
Architecture/Engineering: local information suggests that this house is log construction, and may be of interest for that reason.	
Construction Period: possibly mid-19 th century.	
Storeys: 1½	
Structural Material: log (?) on stone foundation.	Cladding: aluminum siding.
Roof Type: side gable with salt box tail.	Roof Material: asphalt shingles.
Style/Design: vernacular cottage. Notable Features: proportions and fenestration suggest timber frame or log construction.	
Historical Association: early settlement period of Essex.	
Landmark: no.	
Group Value/CHL Association: no.	
Statement of Significance: No designation is currently in effect.

BHR 19	2369 Spring Garden Road, Windsor	Direct/candidate for relocation	<ul style="list-style-type: none"> located in area of direct impact in its present form, very unprepossessing, however the log structure within the shell (?) could be salvaged and reconstructed
