DRIC Detroit River Watercourses Reconnaissance Level Mussel Survey

Draft Memo

To: URS Canada Inc. and Ontario Ministry of Transportation
From: Christa L. Rigney, B.Sc., Invertebrate Biologist & Environmental Planner
Date: August 5, 2009
Re: DRIC Detroit River Watercourses Reconnaissance Level Mussel Survey

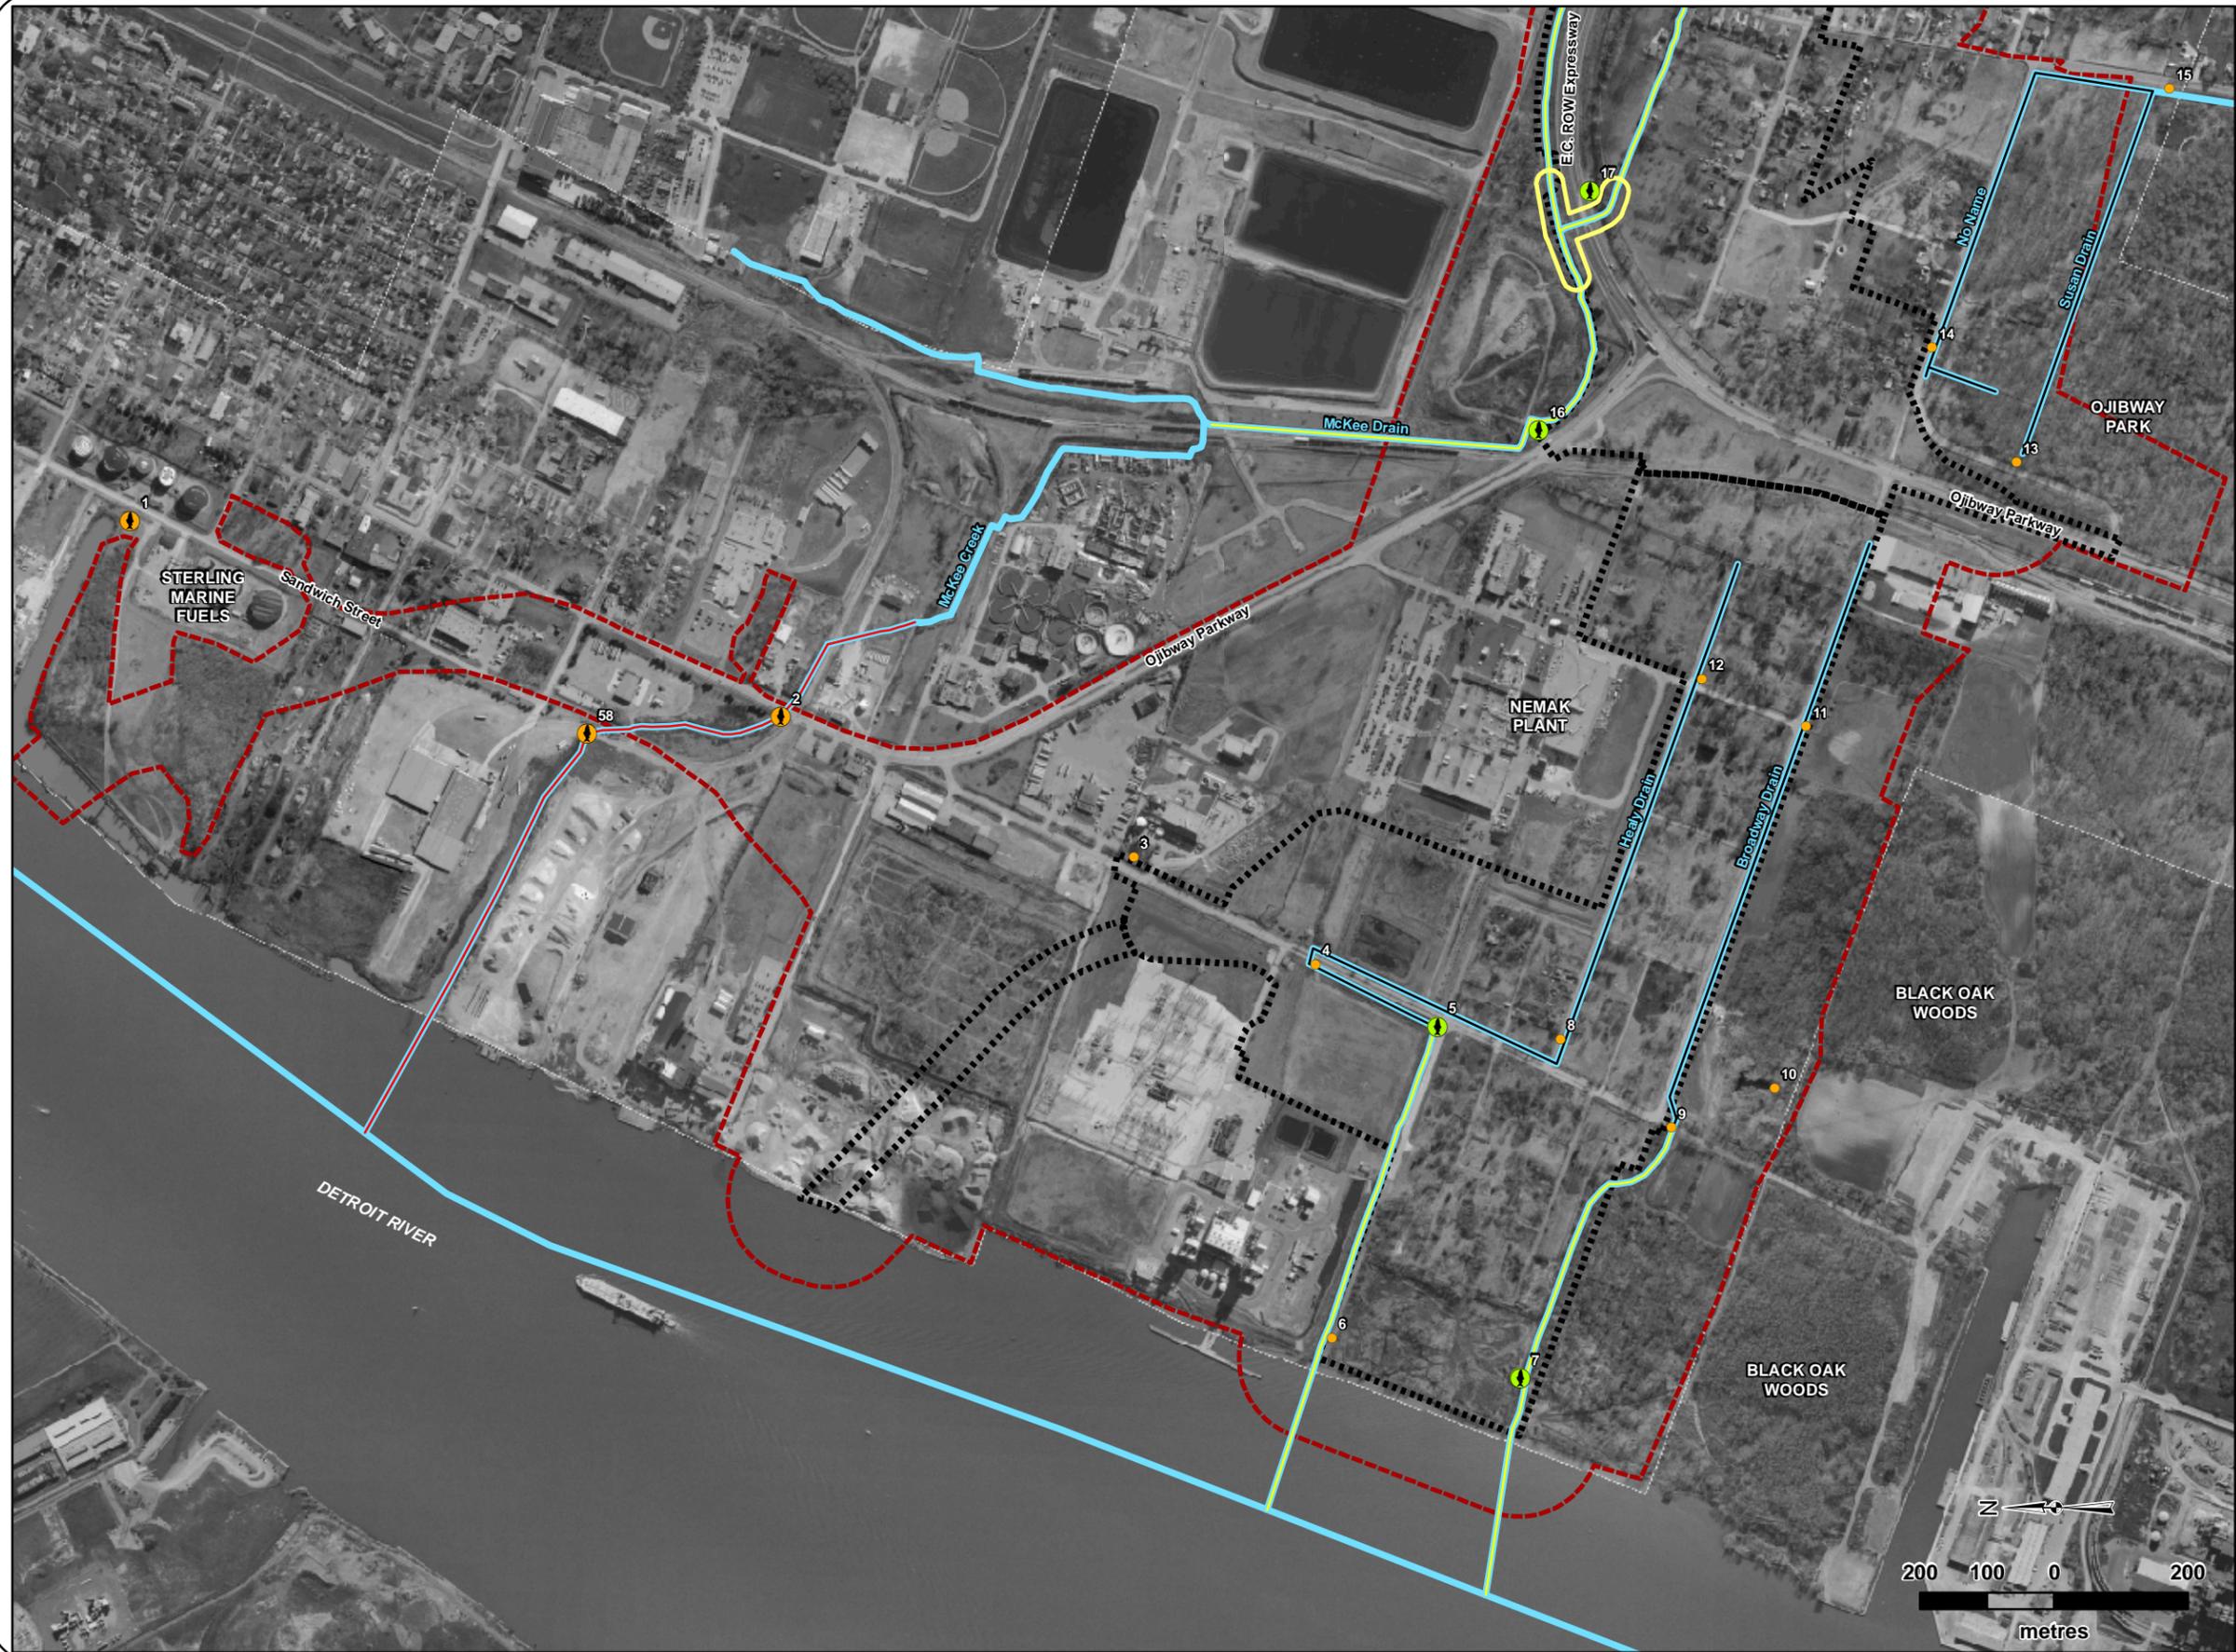
Figure 1. Watercourses and Fish Habitat Located in the Area of Investigation

WATERCOURSES AND FISH HABITAT LOCATED IN THE AREA OF INVESTIGATION

The watercourses sampled were selected based on the potential presence of permanent flow, fish habitat and/or presence of host fish species, as identified in the Draft Practical Alternatives Evaluation Working Paper – Natural Heritage (LGL 2008) and the Natural Heritage Impact Assessment – Recommended Plan (LGL 2008). The following watercourses were sampled: McKee Drain, Basin Drain, Youngstown Drain North Branch, Grand Marais Drain/Turkey Creek, Lennon Drain, Cahill Drain, Wolf Drain and Collins Drain. The location of these watercourses and sampling sites are presented in **Figure 1**.

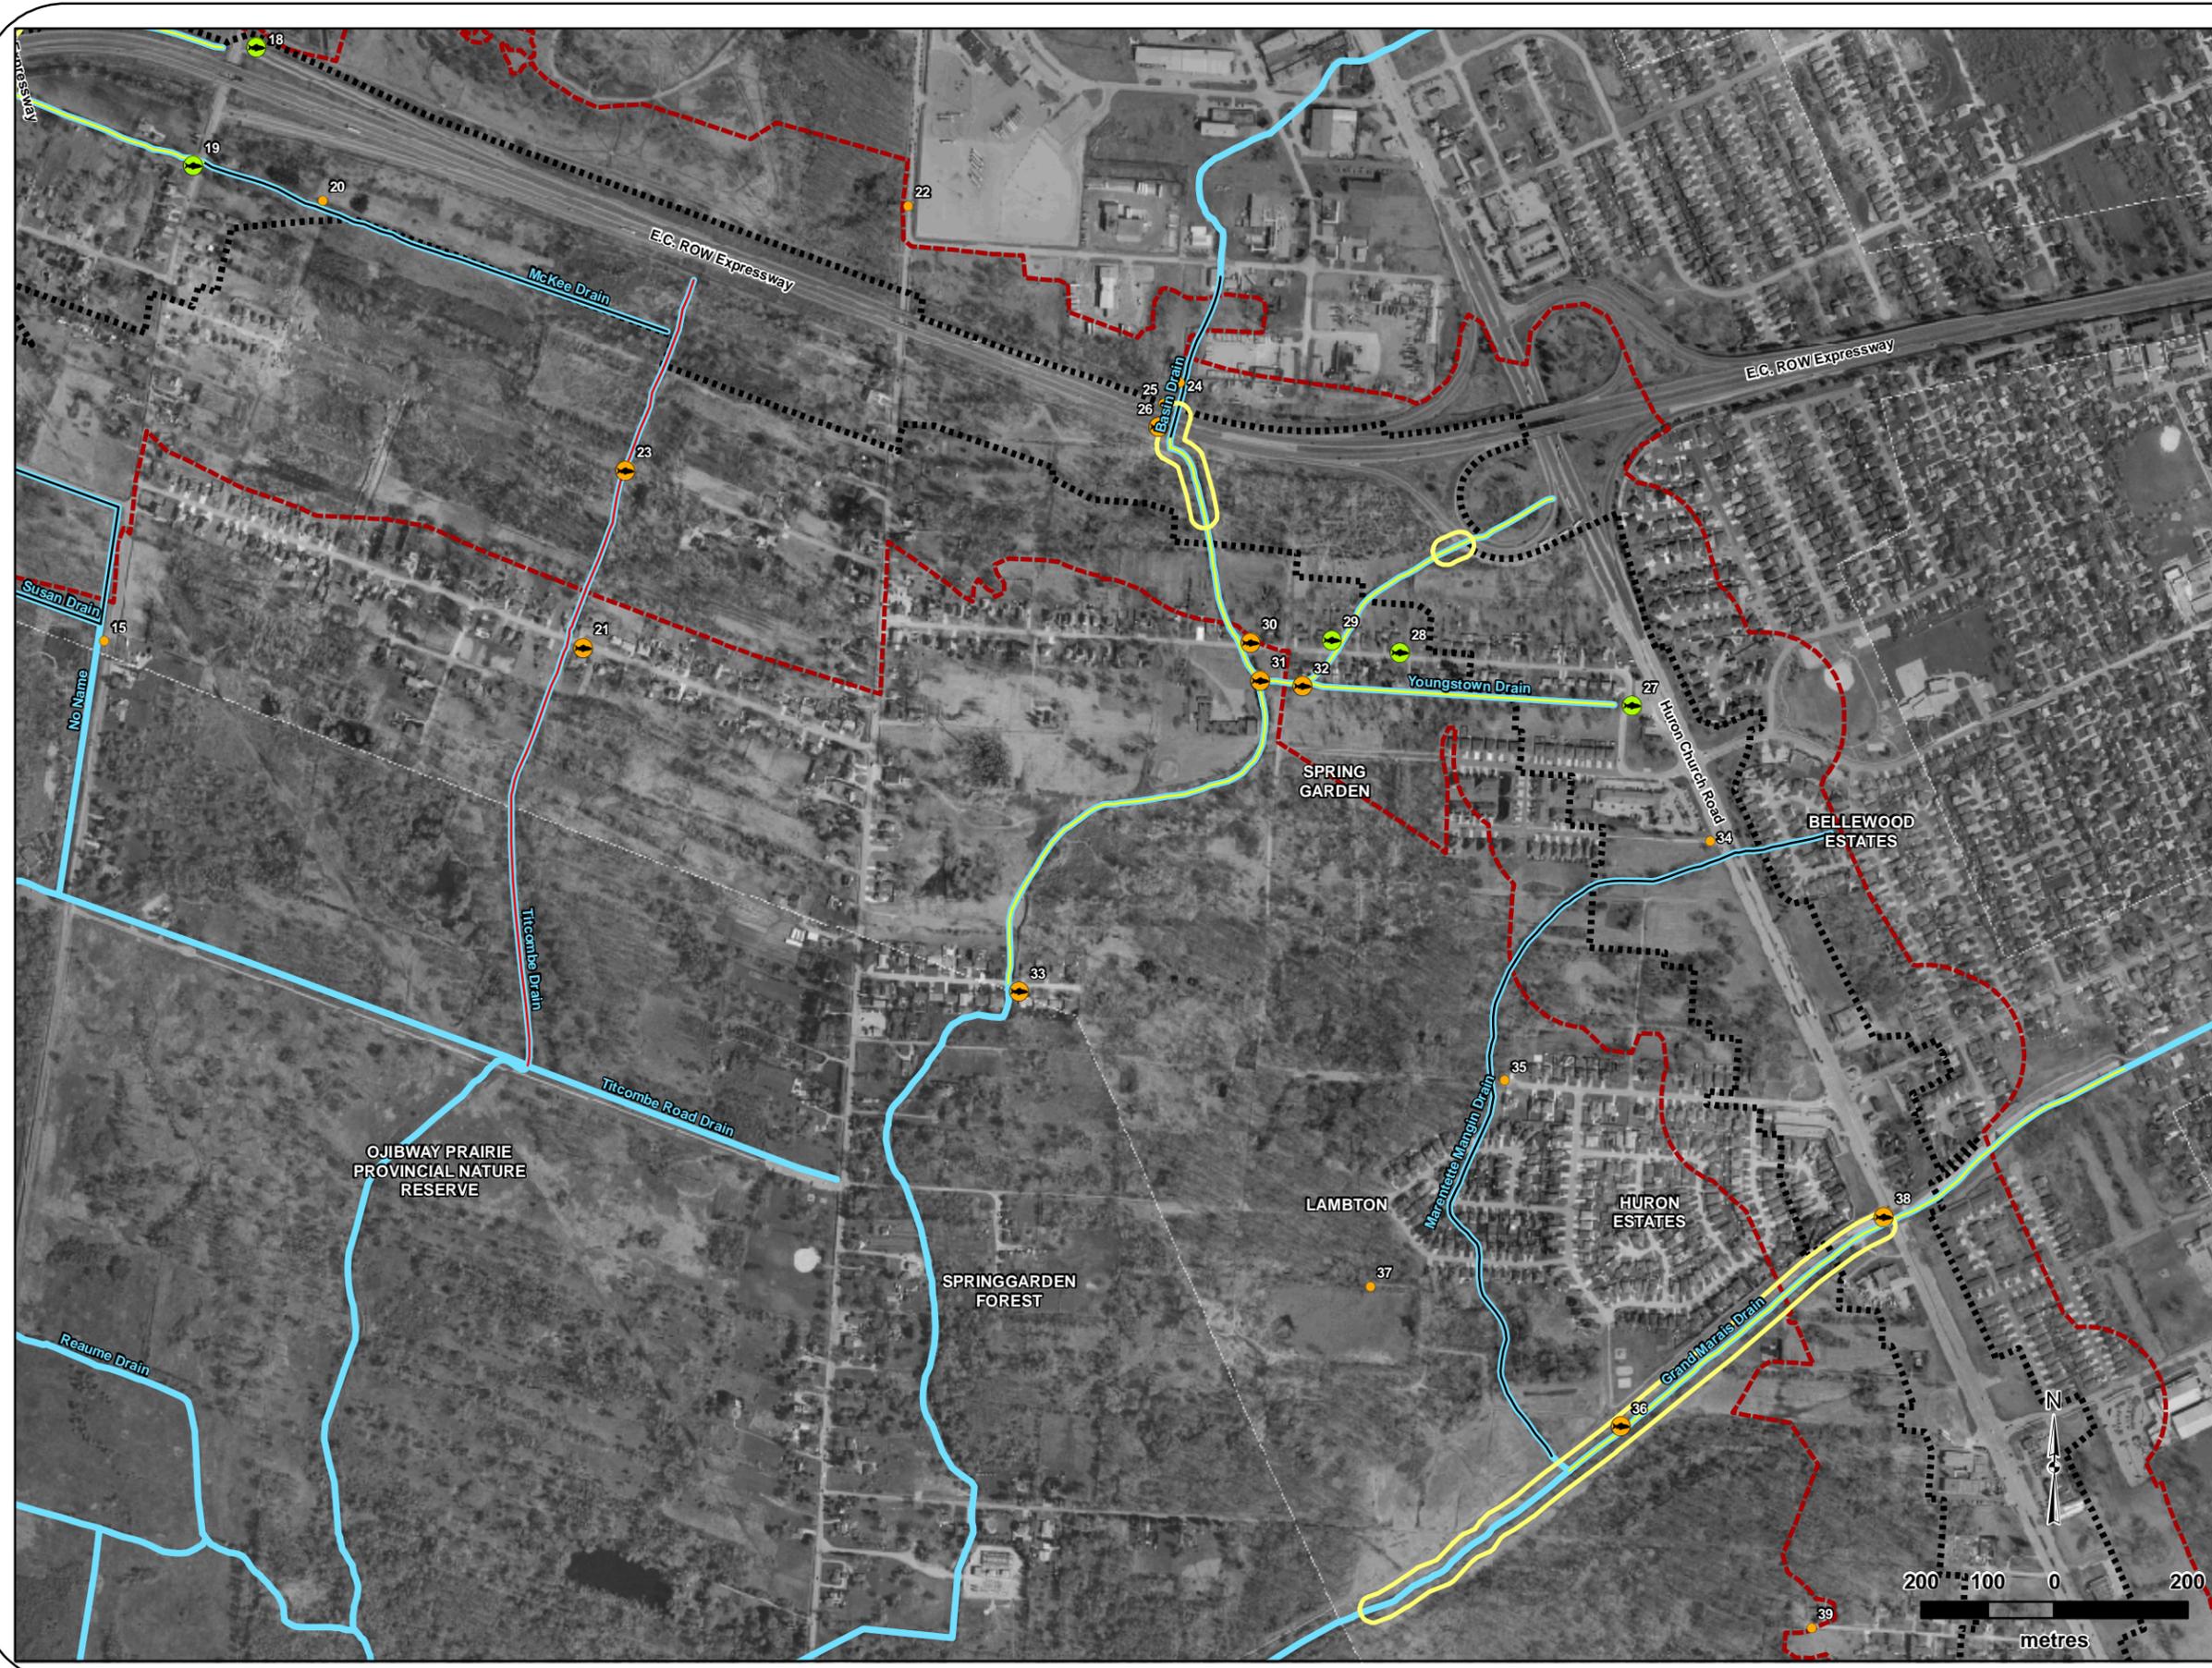
Project: TA4137	Figure: 1b
Date: July 2009	Prepared By: MWF
Scale: 1 : 10,000	Checked By: CLR

WATERCOURSES AND FISH HABITAT LOCATED IN THE AREA OF INVESTIGATION

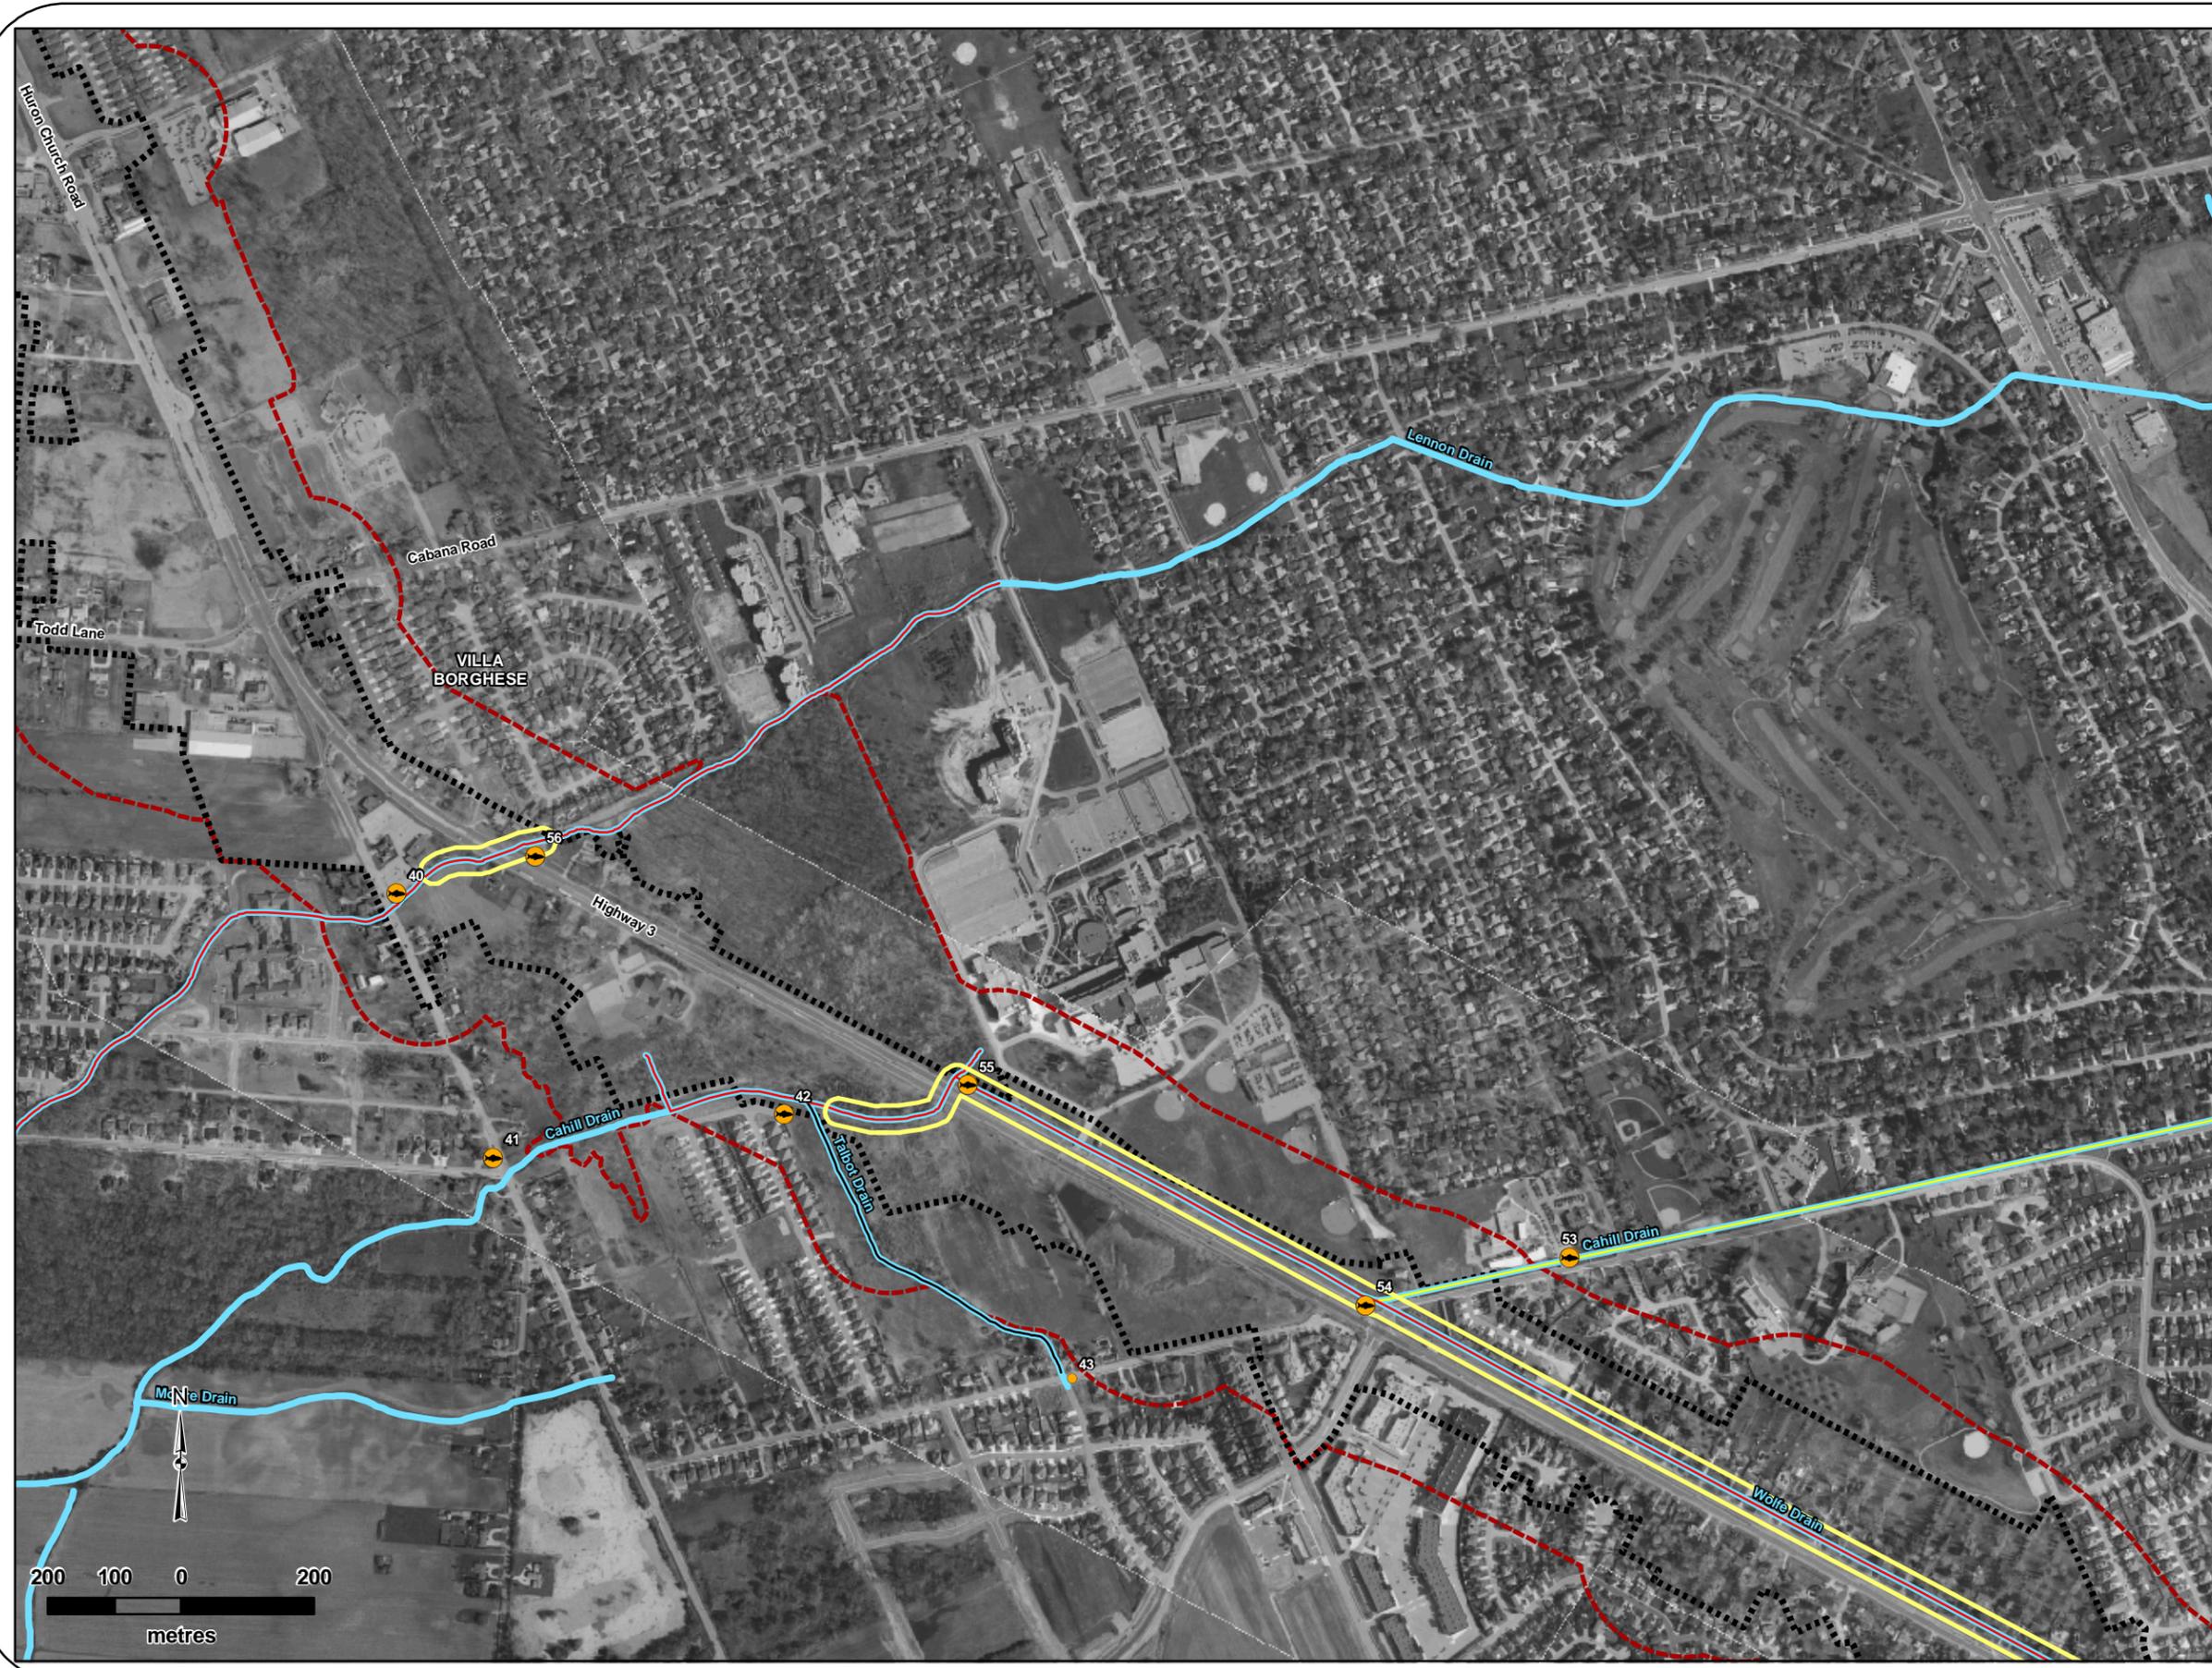
Project: TA4137	Figure: 1c
Date: July 2009	Prepared By: MWF
Scale: 1 : 10,000	Checked By: CLR

WATERCOURSES AND FISH HABITAT LOCATED IN THE AREA OF INVESTIGATION

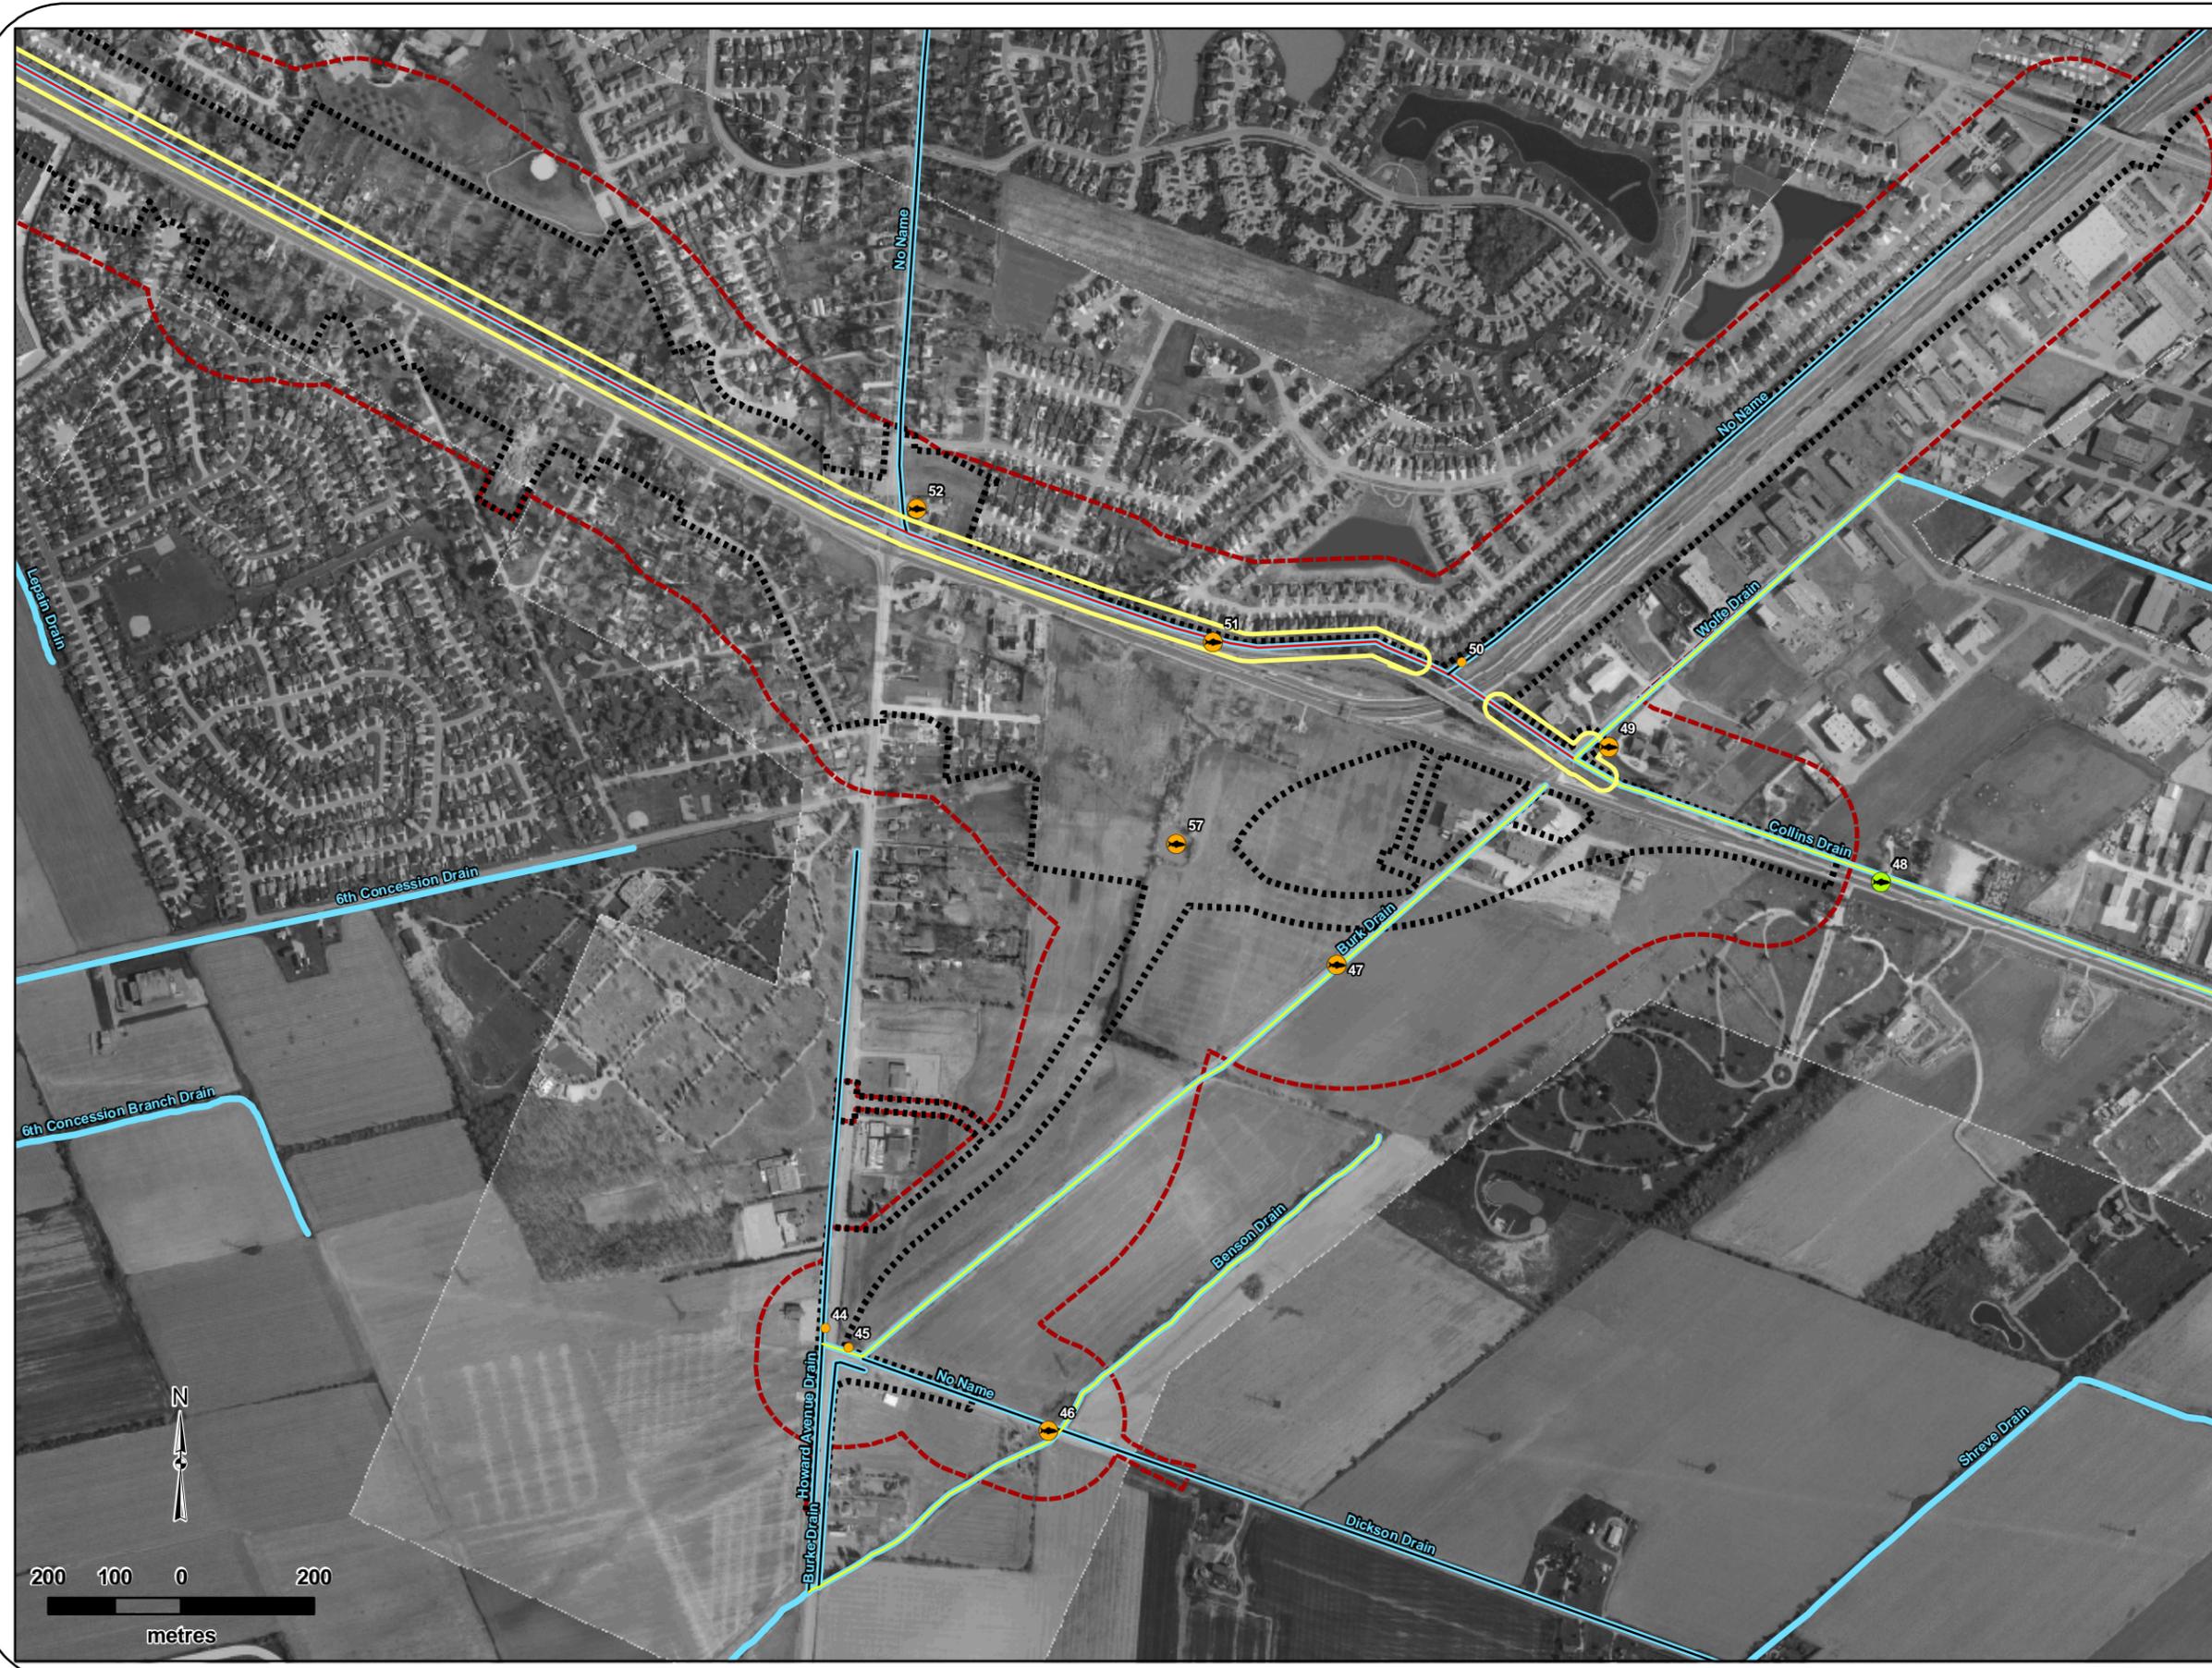
Project: TA4137	Figure: 1c
Date: July 2009	Prepared By: MWF
Scale: 1 : 10,000	Checked By: CLR

WATERCOURSES AND FISH HABITAT LOCATED IN THE AREA OF INVESTIGATION

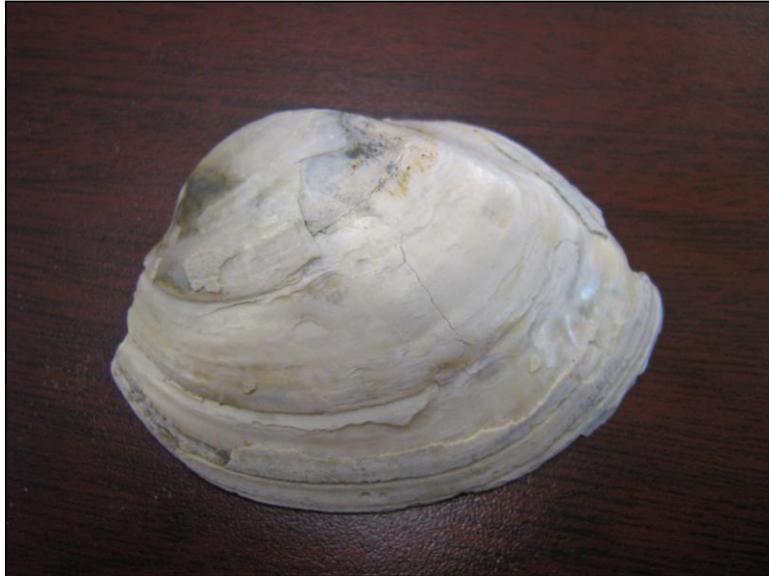
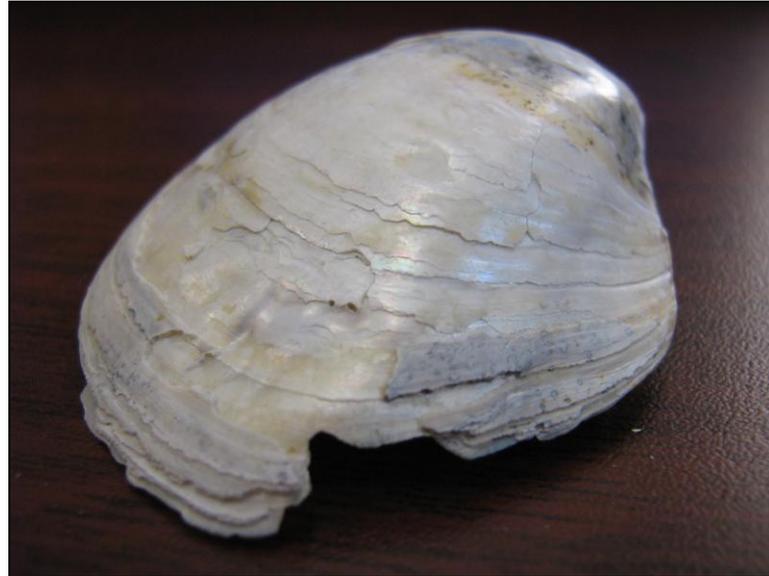
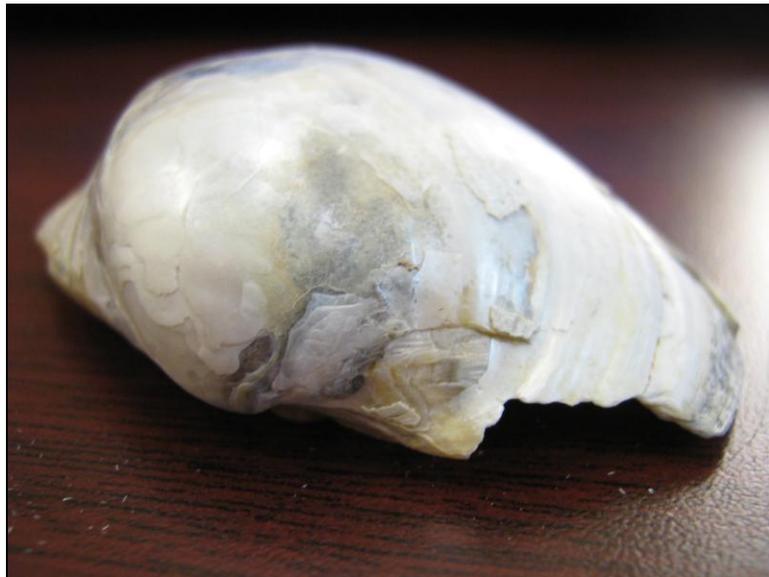
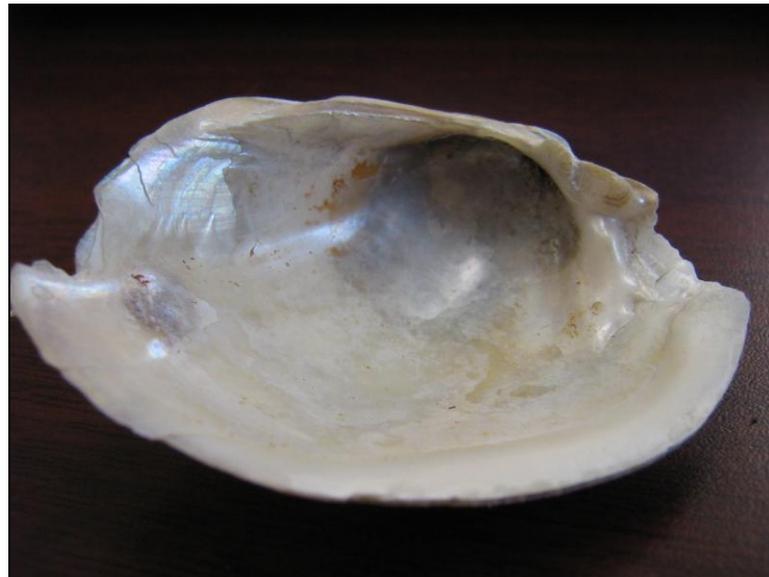
No live bivalves or shells were found within or in close proximity to any of the watercourses surveyed. One old shell was found beneath a guide rail on the roadbed of Talbot Road, just east of the terminus of Highway 401. The shell was approximately 15 m from Wolfe Drain and exhibited indication that the mussel has been dead for several years (bleaching, erosion of the shell exterior and 1/3 of the shell edges had broken off).

Identification of the mussel species is difficult due to the shell deterioration described above (see **Figure 2**). However, based on the features visible (posterior ridge, hinge teeth and shape), it is likely an Eastern Elliptio (*Elliptio complanata*). This species is among the most common and widespread in Ontario, and it is not considered a species-at-risk. Given the location where this shell was found, there is a high probability that it did not recently originate from the Wolfe Drain. Suitable habitat for Eastern Elliptio is likely not present in this watercourse, and the shell could have easily been transported to this location by wildlife, an incidental vehicle passing or as a constituent of the granular materials used for roadbed construction or maintenance.

Figure 2. Probable Eastern Elliptio shell found under a guide rail on Talbot Road, west of Highway 401.

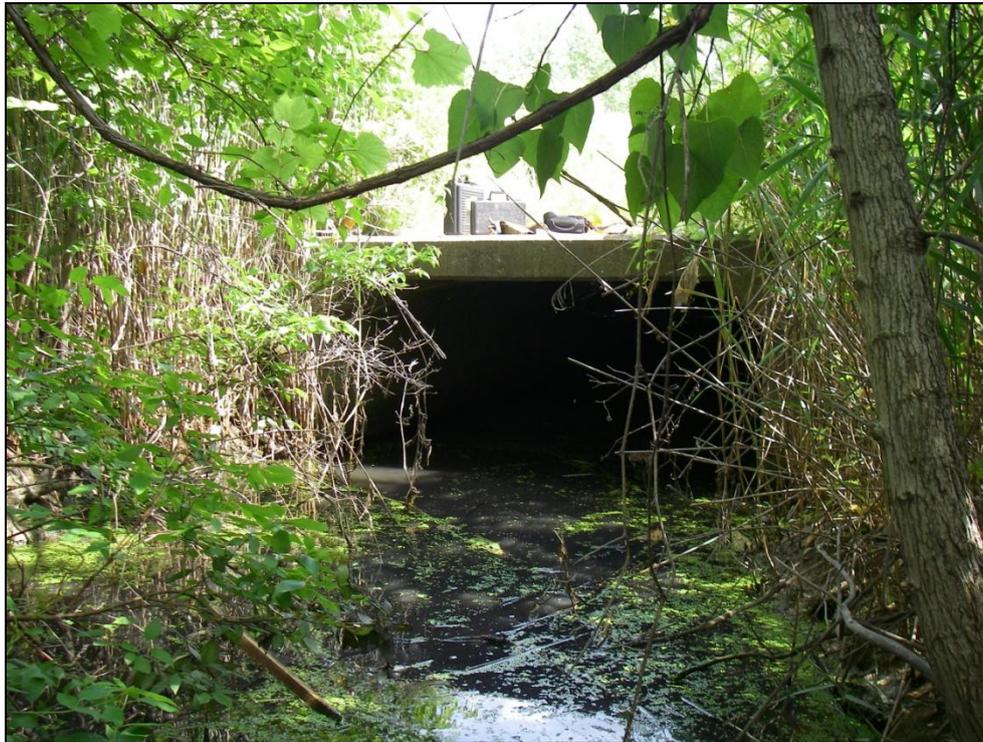
The McKee Drain crossing at the E.C. Row Expressway was investigated for a total of 2.0 person hours. The watercourse was not flowing at the time of the investigation and duckweed (*Lemna* sp.) was observed on the water surface. The channel was approximately 2.0 m wide and 0.25 m deep. The watercourse was searched for mussels approximately 10 m upstream and downstream of the crossing of E.C. Row Expressway. The substrates at this location were very soft and were approximately 10 cm to 30 cm thick. The substrates consisted of 40% muck, 35% detritus and 25% silt, and the morphology was 100% flats. The water temperature was 17.7°C, the pH 7.16, dissolved oxygen 11.0 mg/L, conductivity 1.657 µS/cm, turbidity 4.0 NTU and the total dissolved solids was 8.57 ppm. No mussels were observed. According to the fisheries field investigations (LGL 2008) there are no host fish species present at this crossing of this watercourse. Based on the lack of host fish present and the habitat conditions, it is highly unlikely that mussels occur at this location.

Photo 1: McKee Drain, looking southeast (upstream) towards the E.C. Row Expressway culvert crossing.

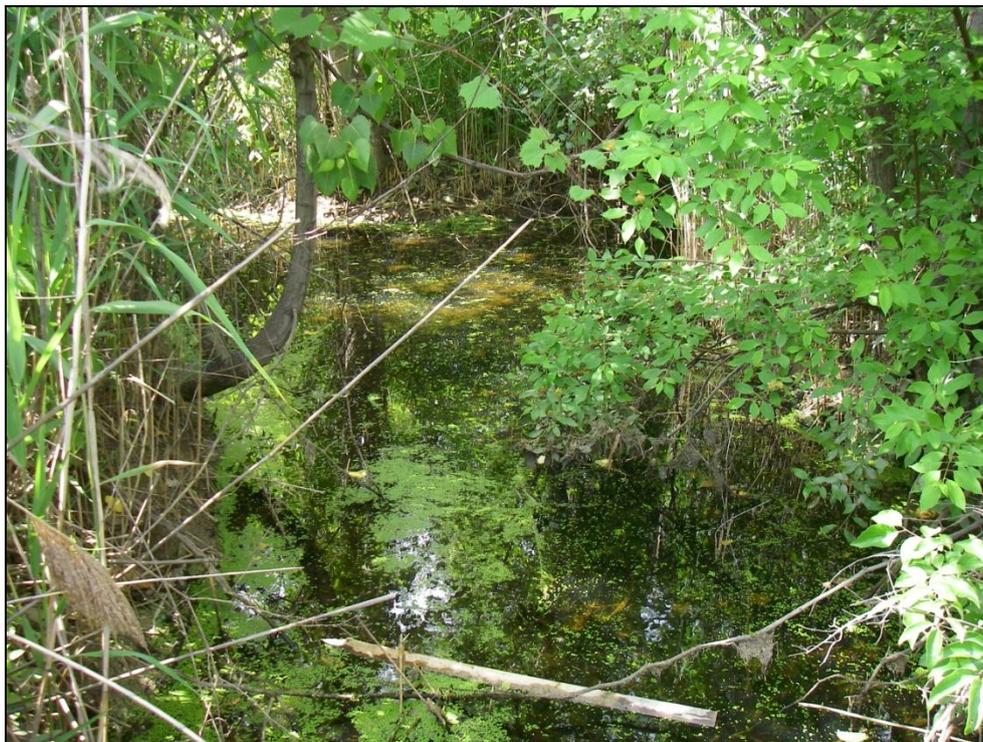
Photo 2: McKee Drain, looking northwest (downstream) from the E.C. Row Expressway culvert crossing.

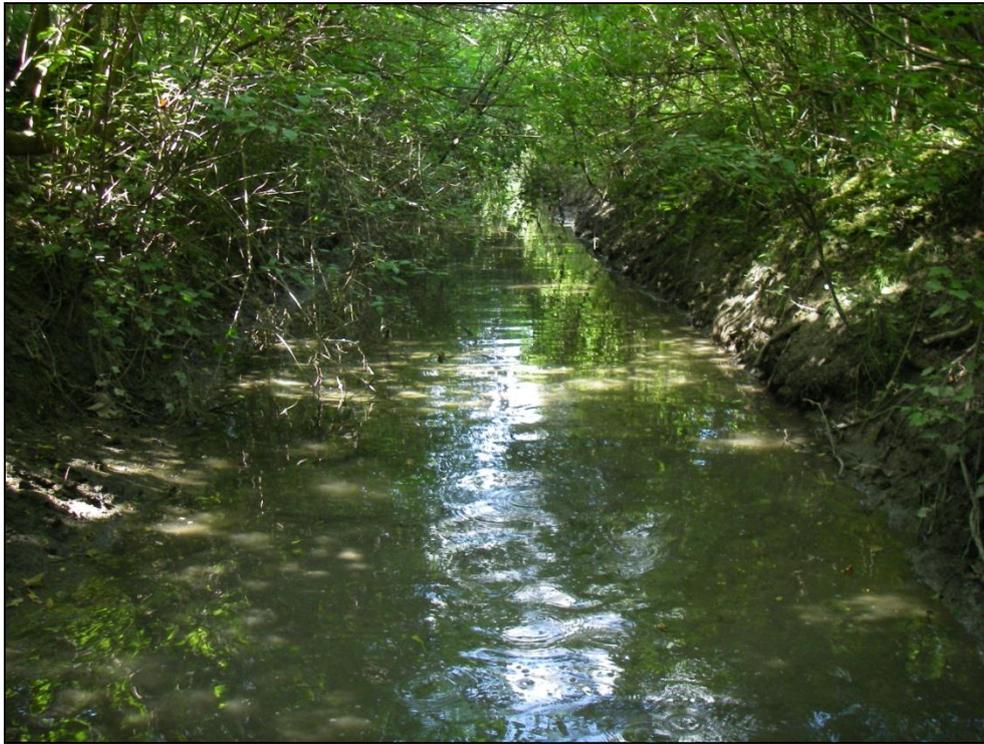
The Basin Drain crossing at the E.C. Row Expressway was investigated for a total of 3.3 person hours. Approximately 30 m of the watercourse was investigated. The watercourse had a low flow velocity at the time of field investigation. The channel was approximately 2.0 m wide and 0.25 m deep, and the morphology was 100% flats. The substrates were soft, and consisted of 40% silt, 40% muck and 20% detritus. The water temperature was 18.5°C, the pH 7.41, dissolved oxygen 6.9 mg/L, conductivity 1.35 µS/cm and the turbidity was 7.4 NTU. No mussels were observed. Host fish species may be present at this location, however the habitat present appears unsuitable for mussels.

Photo 3: Basin Drain, looking north (upstream) towards the E.C. Row Expressway crossing.

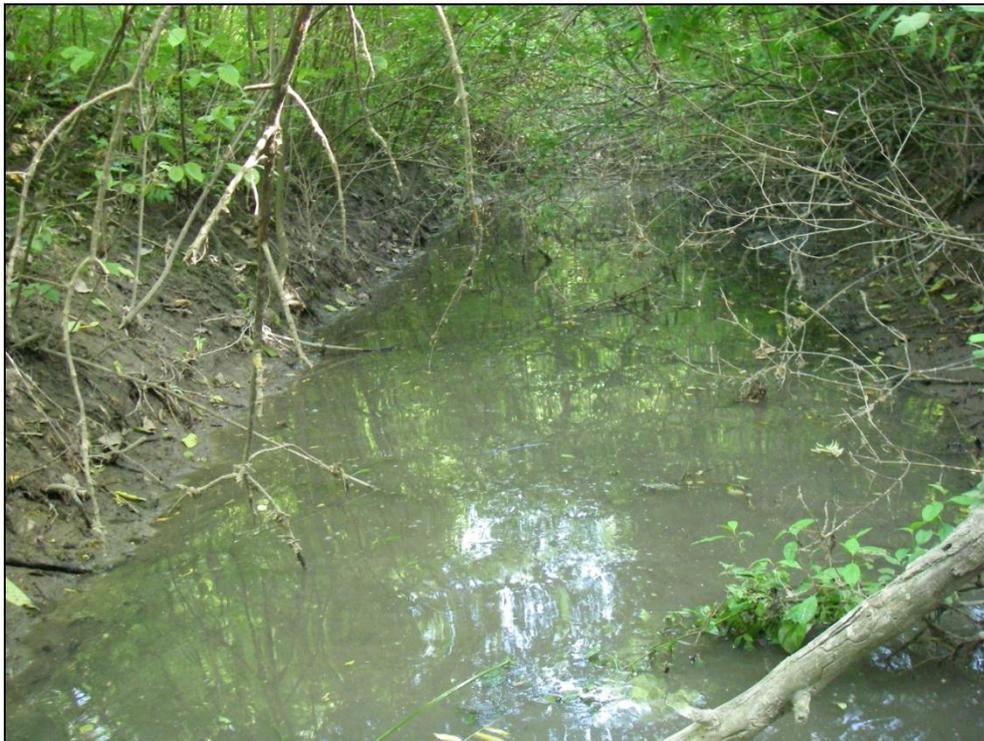
Photo 4: Basin Drain, looking south (downstream) from south of the E.C. Row Expressway crossing.

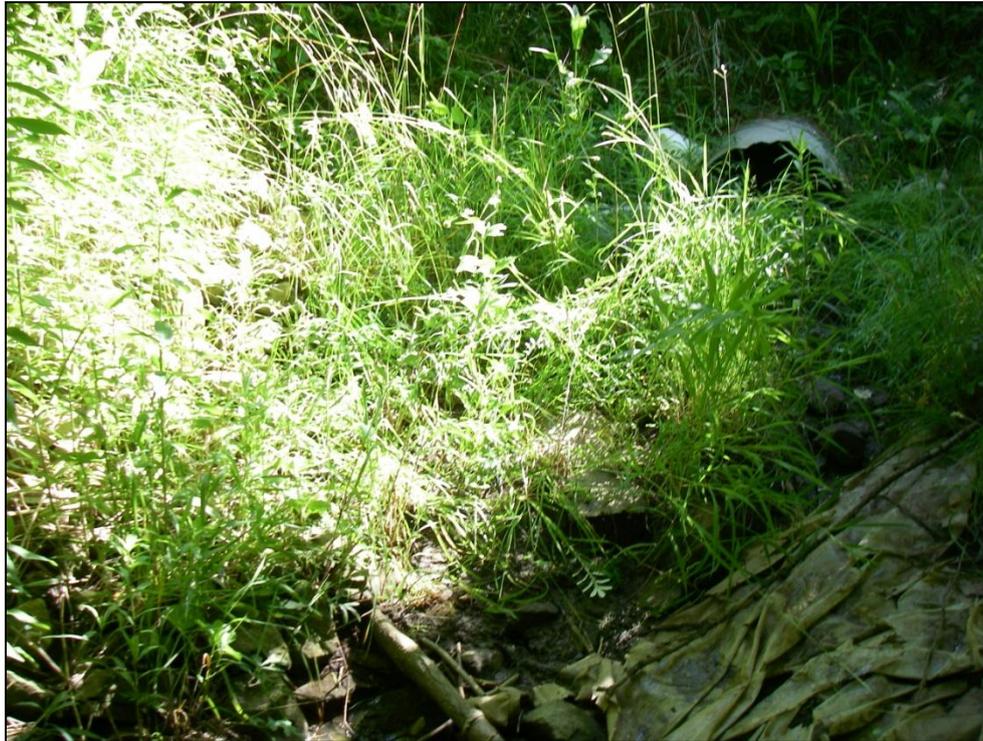
The north branch of Youngstown Drain was investigated for a total of 1.25 person hours. At the time of the investigation the watercourse was almost dry and had no flow. Water had gathered in several small pools however, there was no connectivity between these pools. There was an oily sheen on the water surface near the culvert under the E.C. Row Expressway/Huron Church Road interchange. The habitat at this location was insufficient to support mussels and no mussels were observed.

Photo 5: Youngstown Drain, looking northeast (upstream) towards E.C. Row to Huron Church Road eastbound to southbound off ramp culvert.

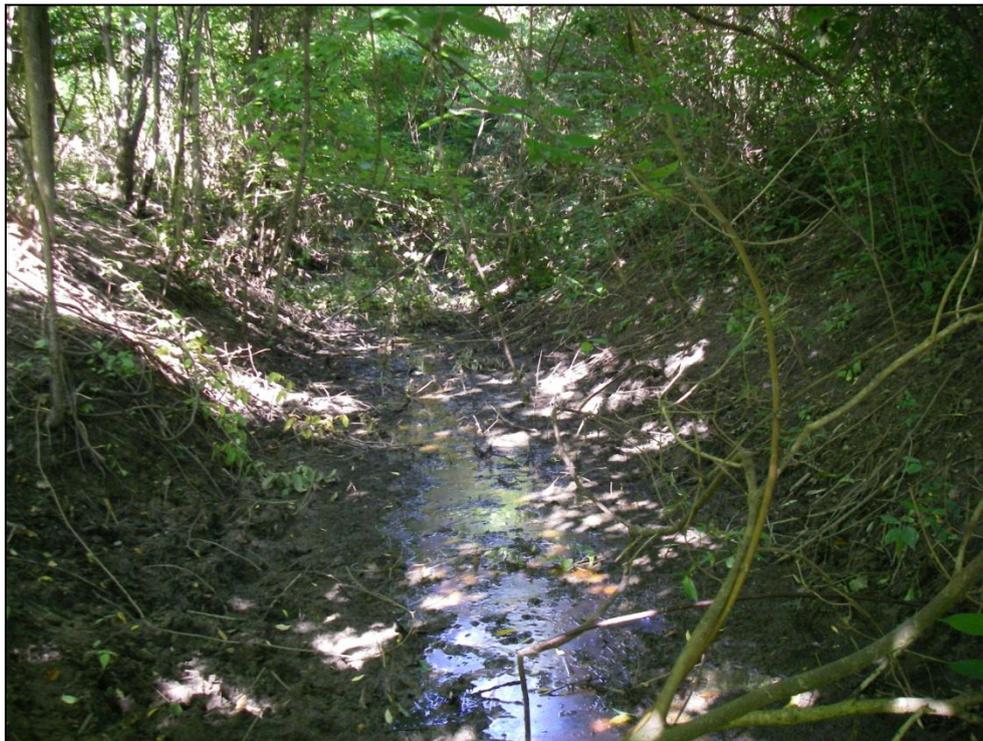
Photo 6: Youngstown Drain, looking southwest (downstream) from the E.C. Row Expressway to Huron Church Road eastbound to southbound off ramp culvert. Note the oily sheen on the surface.
