DRIC Detroit River Watercourses Reconnaissance Level Mussel Survey

Draft Memo

To: URS Canada Inc. and Ontario Ministry of Transportation
From: Christa L. Rigney, B.Sc., Invertebrate Biologist & Environmental Planner
Date: August 5, 2009
Re: DRIC Detroit River Watercourses Reconnaissance Level Mussel Survey

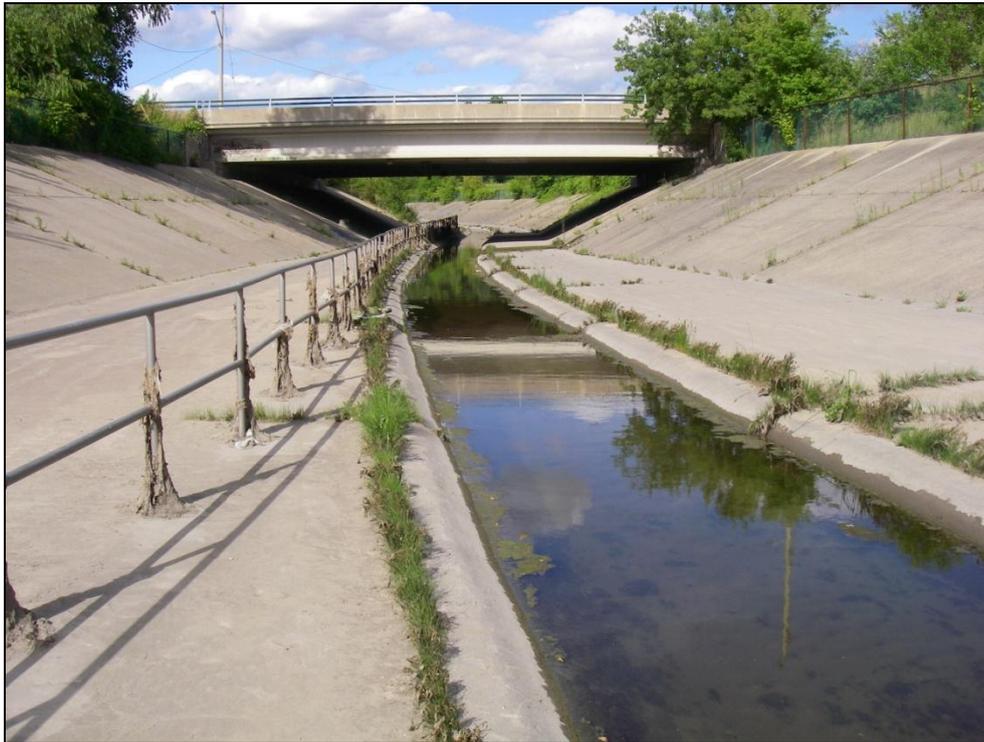
Grand Marais Drain/Turkey Creek from the Huron Church Road crossing to the end of the concrete channel (1,000 m downstream) was investigated, plus approximately 15 m of the “natural” channel area downstream of the concrete channel. A total of 4.3 person hours were devoted to investigating this site. Within the concrete lined portion of the watercourse, the channel is approximately 2 m wide and 0.3 m deep. The bottom of the channel is a poured concrete floor (90% substrate), with some gravel and sand in areas where cracks in the concrete have created small current breaks (remaining 10% of substrate). The watercourse velocity was low at the time of investigations. At the end of the concrete channel the watercourse banks and substrate became naturalized. Here the channel was approximately 18 m wide and the depth ranged from 0.05 m at the immediate outlet to 0.65 m further downstream. Here the channel morphology was 100 % flats and the

Photo 7: Turkey Creek, looking northeast (upstream) towards Huron Church Road.

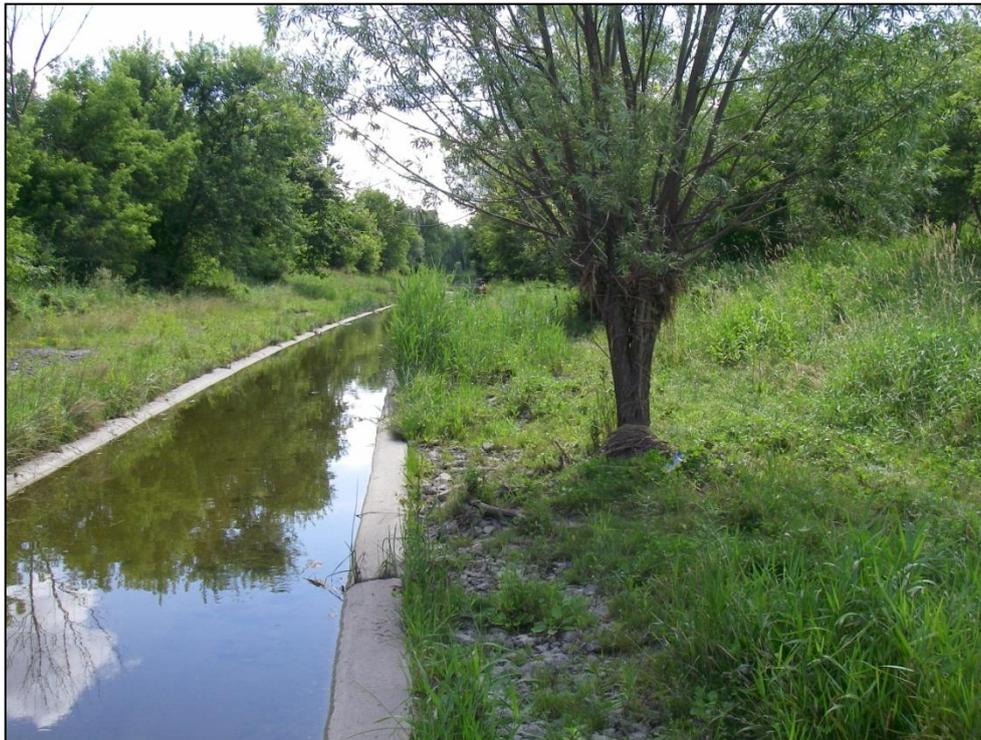
Photo 8: Turkey Creek, looking southwest (downstream) from south of Huron Church Road.

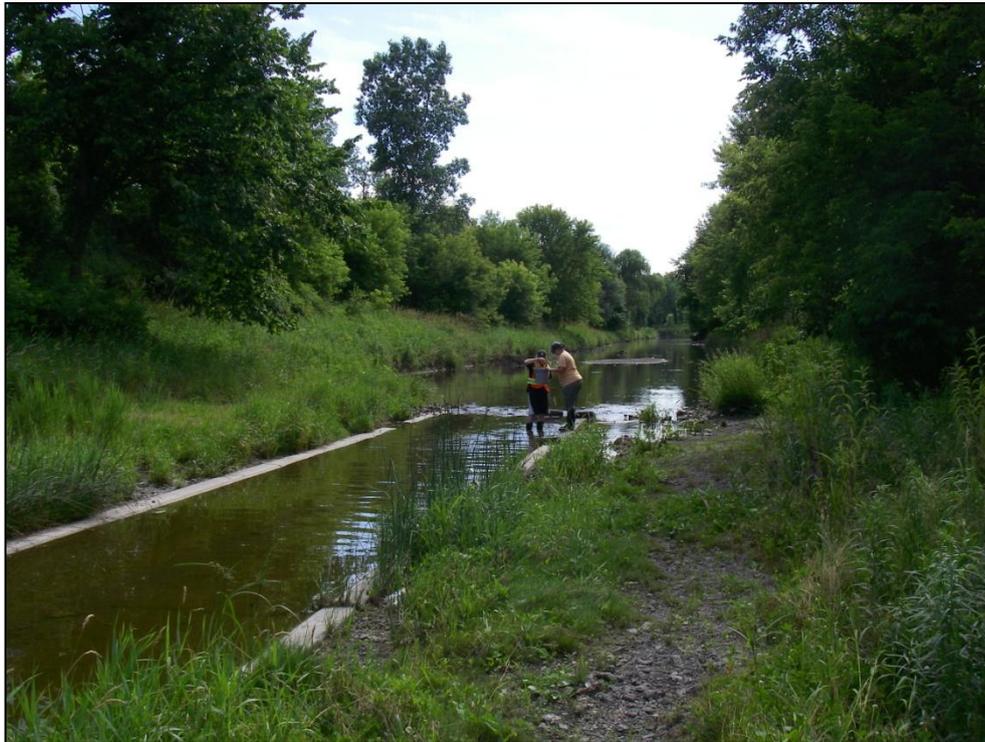
substrate was 70% gravel, 15% sand and 15% silt. The water temperature was 27.5°C, the pH 9.7, dissolved oxygen 14.8 mg/L, conductivity 1172 µS/cm, turbidity 2.6 NTU and the total dissolved solids was 513 ppm. No mussels were observed despite a thorough check of the concrete lined channel and concrete expansion joints (cracks), and the area immediately downstream of the concrete channel. Some mussel host fish species are present at this location; however the habitat conditions within the concrete lined channel are highly unsuitable for mussels. Downstream of the concrete channel the habitat conditions improve; however they are still marginal, and this area is not located in the footprint of The Windsor-Essex Parkway.

Photo 9: Turkey Creek, looking southwest (downstream) towards the end of the concrete section of stream.

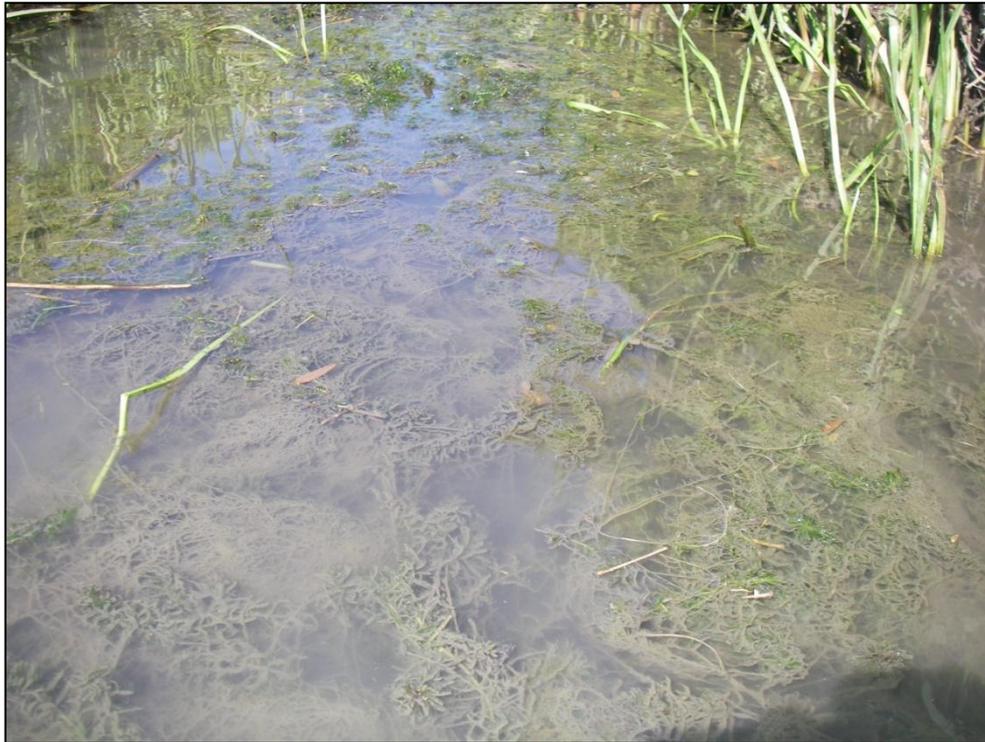
Lennon Drain at the crossing of Talbot Road was investigated for a total of 2.0 person hours. Approximately 50 m upstream of the culvert and 20 m downstream were thoroughly searched for mussels. Upstream of the culvert the channel is approximately 1.75 m wide, 0.10 m deep and lined with mesh netting (likely the remnants of a geotextile) to stabilize the bottom of the channel. Downstream of the culvert the channel is 1.25 m wide, 0.15 m deep, lined with riprap and the entire water column is densely filled with submerged macrophytes. The flow was very low and the morphology was 80% flats and 20% runs. The substrate was 73% riprap, 15% silt, 5% detritus and 2% gravel. The water temperature was 17.4°C, the pH 7.72, dissolved oxygen 8.5 mg/L, conductivity 5.86 µS/cm, turbidity 7.4 NTU and the total dissolved solids was 3.09 ppm. No mussels were observed. Some of the fish species present are known to be hosts for mussels. The habitat upstream of the culvert also appears initially to be potentially suitable for mussels, however a closer investigation of the overall habitat conditions of the reach suggests that it is insufficient to support mussel species. Given the absence of mussels observed and the marginal habitat present, it is unlikely that mussel species occur at this location.

Photo 11: Lennon Drain looking southwest (downstream) from Talbot Road.

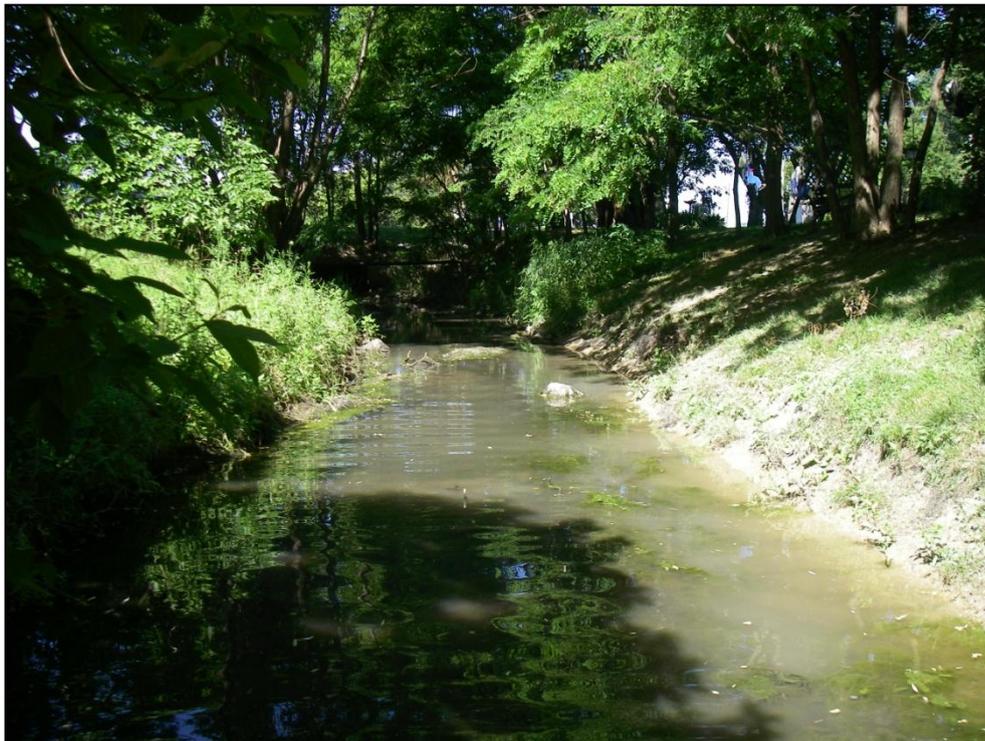
Photo 12: Lennon Drain looking southwest (downstream) towards Talbot Road.

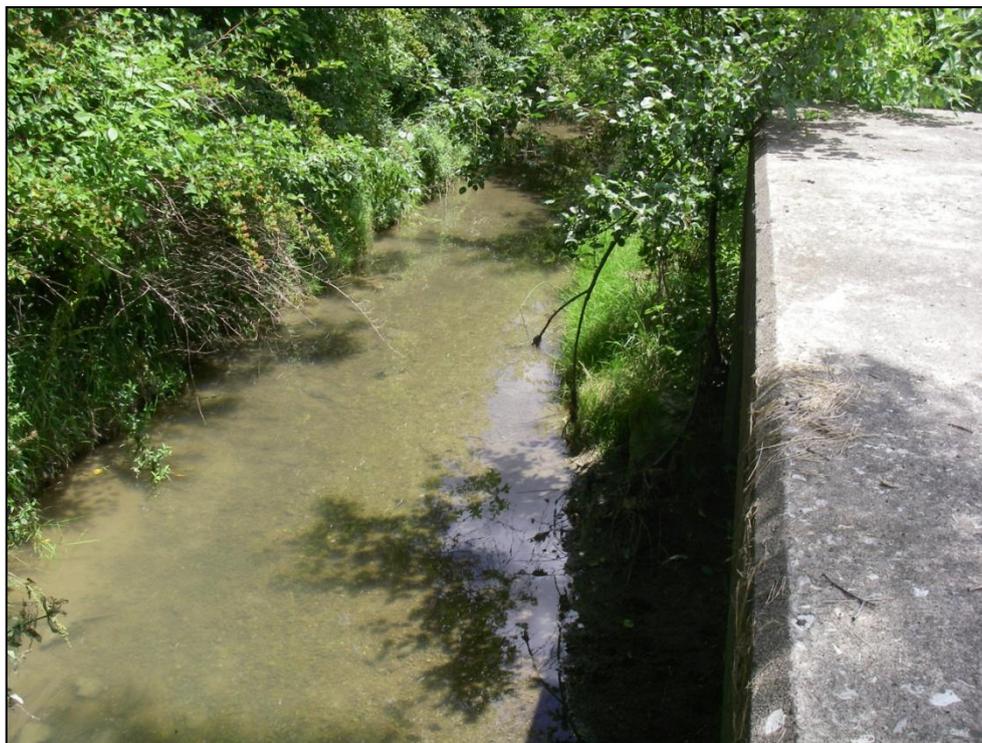
Cahill Drain from immediately downstream of Talbot Road to the Talbot Road/Cousineau Road intersection was investigated in two segments: at the Talbot Road crossing, and from upstream of the Talbot Road crossing to the Talbot Road/Cousineau Road intersection. The Talbot Road crossing was searched for mussels for a total of 3.0 person hours. At the crossing of Talbot Road the reach is approximately 1.0 m wide and 0.1 m deep. The flow is low and the morphology is 35% runs, 35% riffles and 30% pools. The substrate is 45% gravel, 25% sand, 25% silt and 5% cobble, and much of the channel is littered with debris. The water temperature is 18.0°C, the pH 7.9, dissolved oxygen 7.5 mg/L, conductivity 1.2 µS/cm, turbidity 8.2 NTU and the total dissolved solids are 606 ppm.

Photo 13: Cahill Drain looking southeast (upstream) from the Talbot Road crossing.

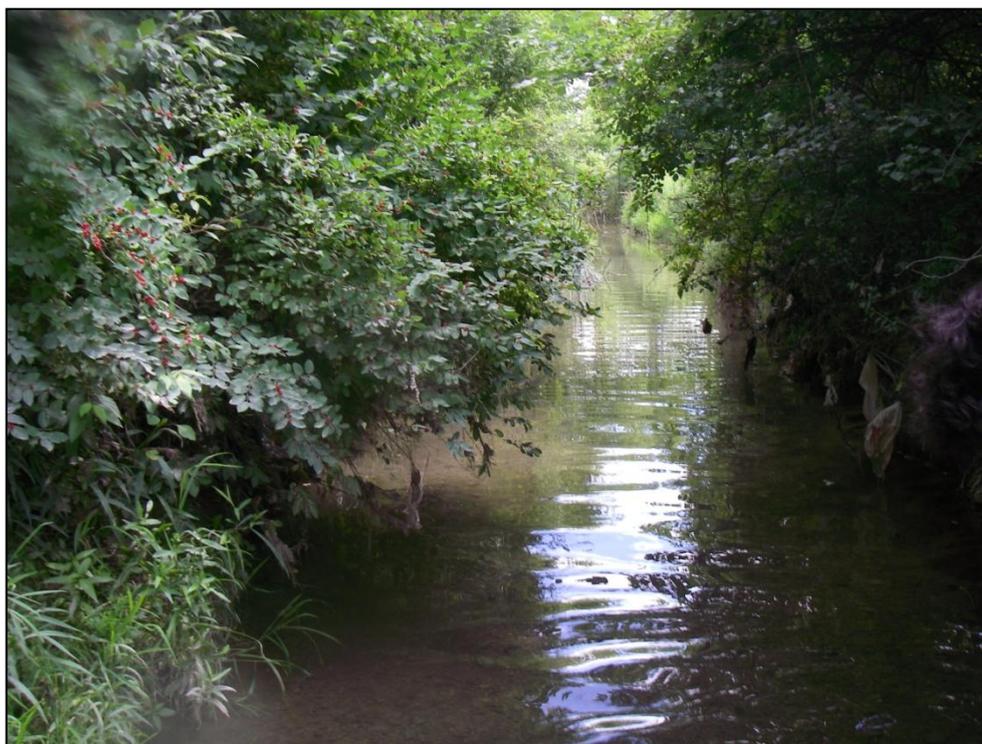
The 815 m reach where Cahill Drain parallels Talbot Road was investigated for a total of 3.5 person hours. From Talbot Road to Cousineau Road the watercourse is approximately 2.0 m wide and ranges from 0.1 m to 0.4 m deep. The flow remained low and the morphology was 45% runs, 45% flats and 10% riffles. The substrate was 60% gravel, 25% sand, 10% silt and 5% detritus and again much of the channel was littered with debris. The water temperature was 19.27°C, the pH 7.67, dissolved oxygen 4.7 mg/L, conductivity 899 µS/cm, turbidity 35 NTU and the total dissolved solids was 453 ppm. While walking upstream the water became noticeably turbid downstream of Cousineau Road. No apparent source for this turbidity was evident.

Photo 14: Cahill Drain looking southeast (upstream) facing towards the Cousineau Road crossing.

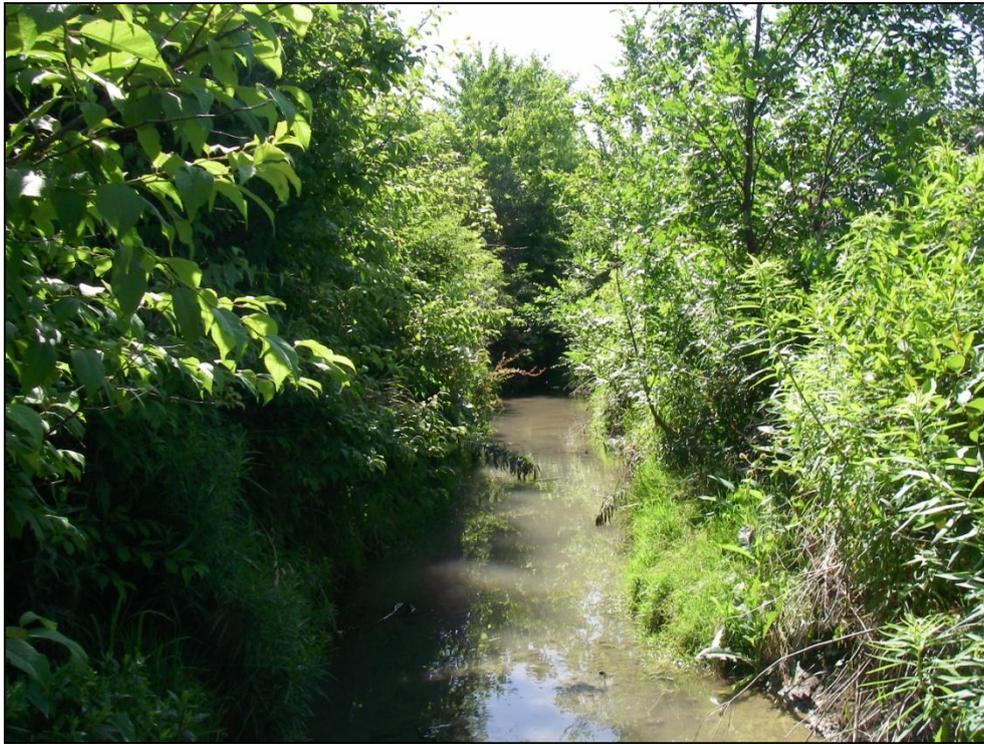
The 1,560 m of Wolfe Drain from Cousineau Road to Howard Avenue was investigated for a total of 4.24 person hours. The width of the channel here ranged from 0.5 m to 2.0 m and the depth from 0.1 m to 0.4 m. The flow was low with a morphology of 80% runs and 20% riffles. The substrate was 30% gravel, 30% sand, 20% silt, 5% cobble and 5% clay. The water was again turbid, and appeared to be from where the turbidity at Cahill Drain originated. The water temperature was 17.96°C, the pH 7.74, dissolved oxygen 3.63 mg/L, conductivity 1.12 µS/cm, turbidity 7.0 NTU and the total dissolved solids was 560 ppm. No apparent source for the turbidity was observed, although there was a significant amount of debris and yard waste within the watercourse throughout this reach, and the watercourse is relatively close to Talbot Road.

Photo 15: Wolfe Drain looking southeast (upstream) from Cousineau Road.

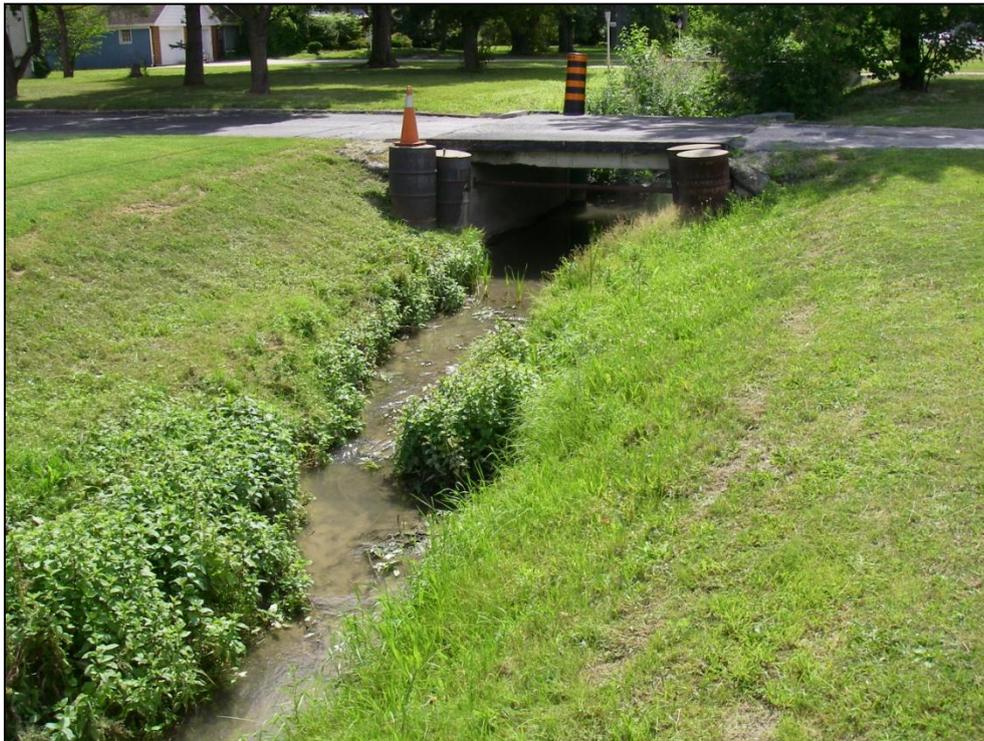
Photo 16: Wolfe Drain looking southeast (upstream) towards a driveway between Cousineau Road and Howard Avenue.

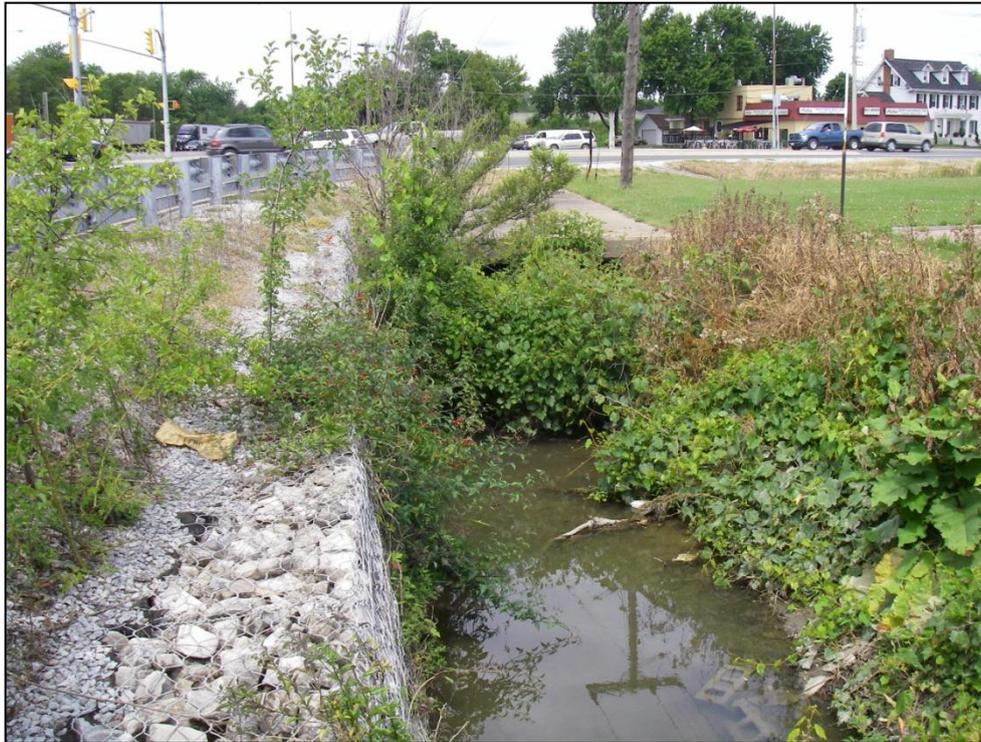
The 780 m of Wolfe Drain from Howard Avenue to the terminus of Highway 401 was investigated for a total of 1.25 person hours. The width of the channel here ranged from 0.5 m to 2.0 m and the depth from 0.1 m to 0.4 m. The flow was also low here, though the water clarity was improved. The morphology was 70% runs, 20% flats and 10% riffles. The substrate was 80% silt, 15% gravel and 5% sand. No water chemistry readings were taken given the proximity of other readings upstream and downstream.

Photo 17: Wolfe Drain looking northwest (downstream) towards Howard Avenue.

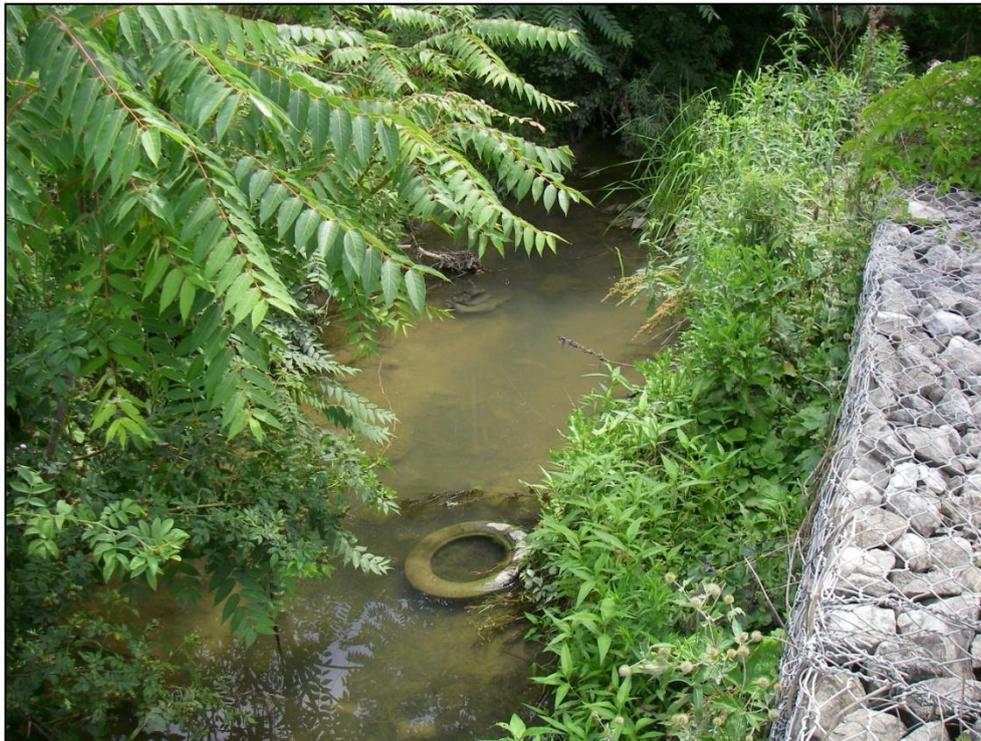
Photo 18: Wolfe Drain looking southeast (upstream) from Howard Avenue.

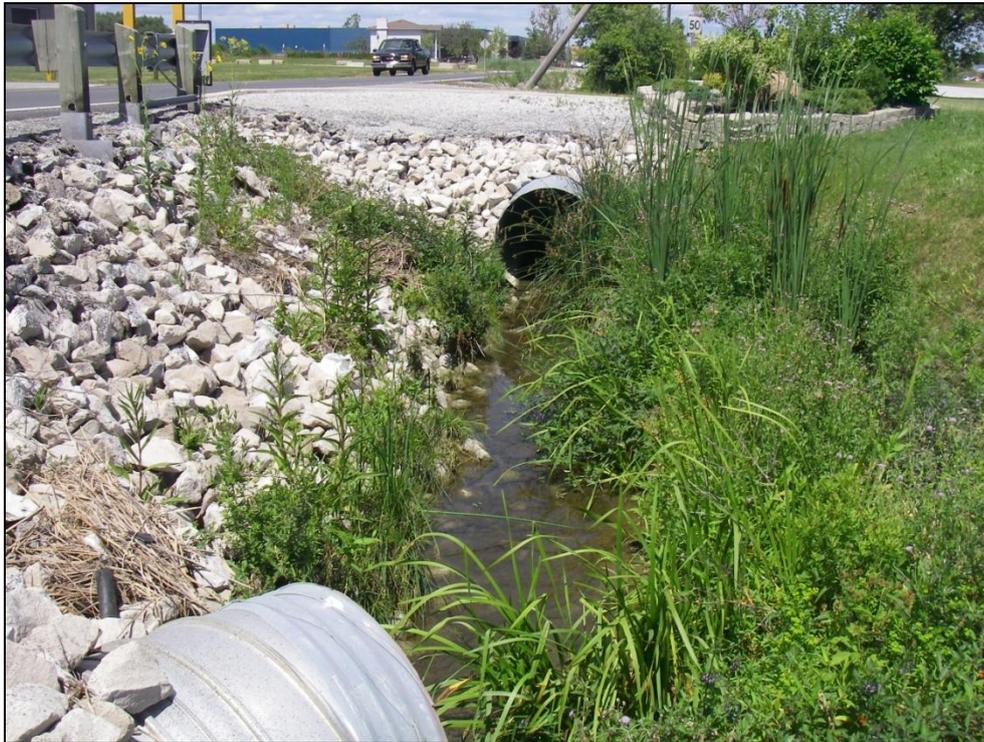
Upstream of the Talbot Road/Outer Driver intersection Wolfe Drain turns northward and is a riprap lined channel filled with cattails (*Typha* sp.). The watercourse had minimal flow and sampling was not conducted as the habitat appears unsuitable for mussels. No mussels were recorded in the reaches located downstream of this section.

Photo 19: Wolfe Drain looking east (upstream) from the Talbot Road/Outer Road intersection.

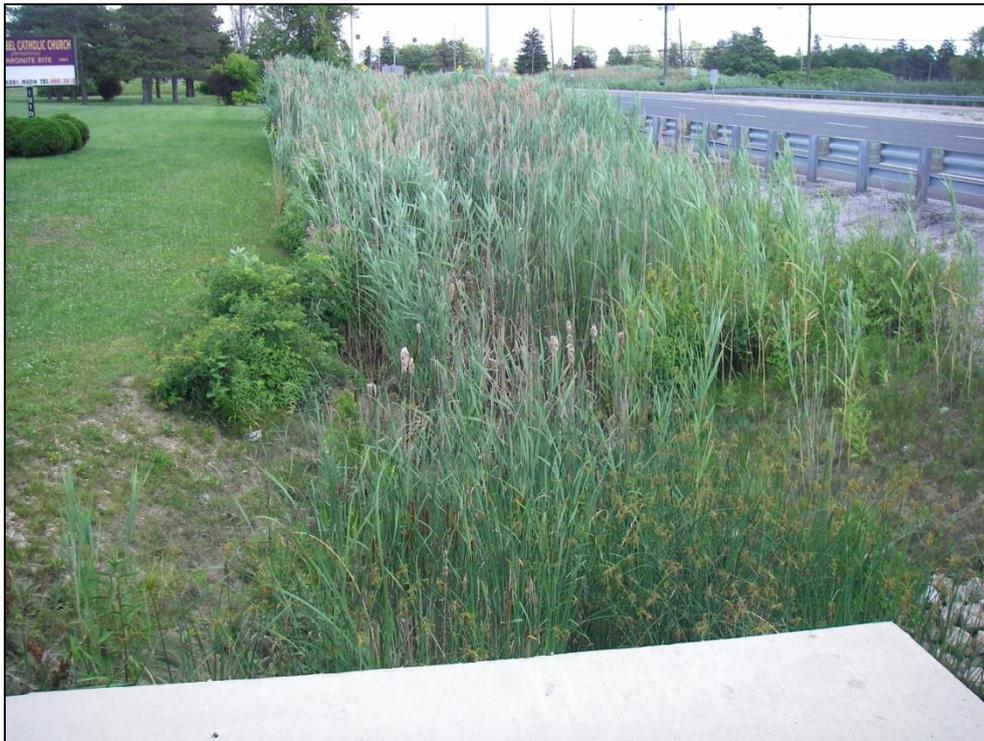
Collins Drain upstream of the junction with Wolfe Drain (at the Talbot Road/Outer Drive) intersection was investigated briefly, however no mussel review was conducted. The watercourse had virtually no flow, the channel was lined with riprap and full of cattails and, as a result, suitable mussel habitat was not present. In addition, no mussels were recorded in the reaches of Wolfe Drain located downstream of Collins Drain.

Photo 20: Collins Drain looking south (upstream) from the Talbot Road/Outer Road intersection.
