**Canada-United States-Ontario-Michigan
Border Transportation Partnership**

**Practical Alternatives Evaluation
Working Paper
Archaeology**

**March 2008
(Revised April 2008)**

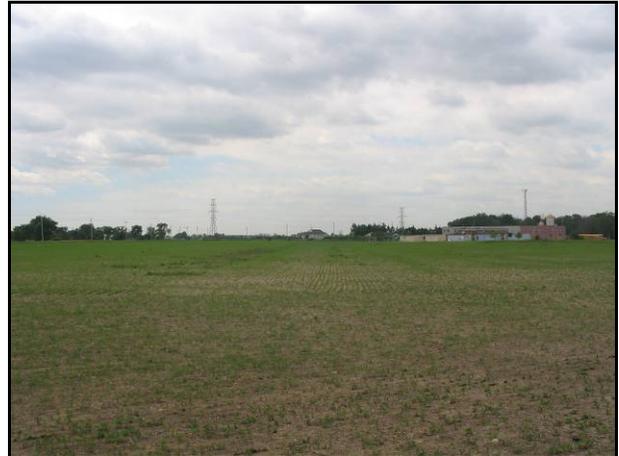
Plate 1: Unit 1 - view to northeast, good visibility in soybean field.

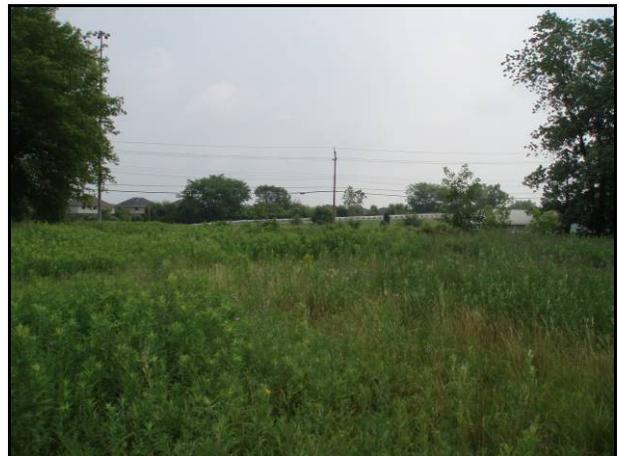
Plate 5: Unit 5 – view to southwest, test pitting in abandoned field.

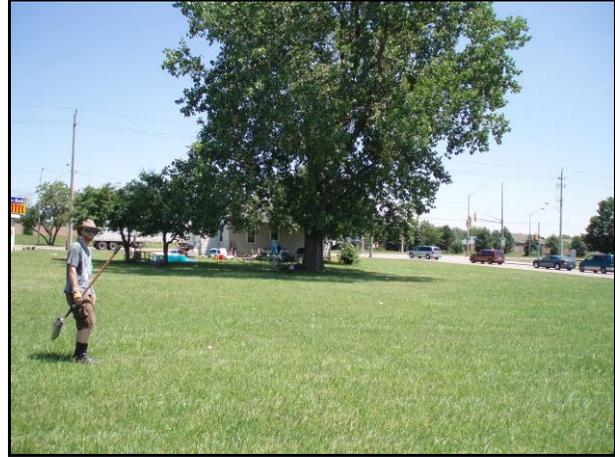
Plate 1: Unit 1 - view to north, test pit assessment of lawn along Spring Garden Road.

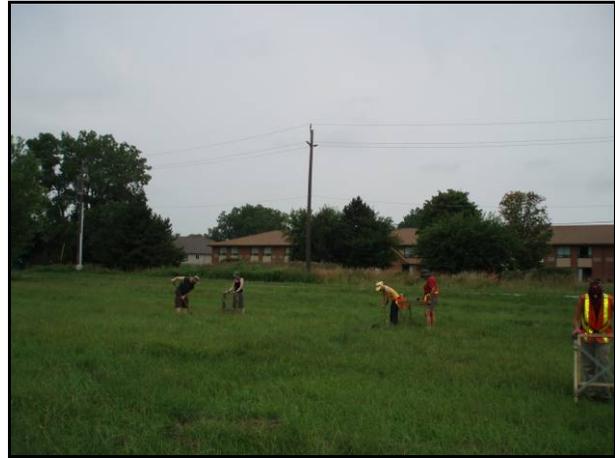
Plate 1: Unit 1 – view to north, largely disturbed by grading, landscaping & utilities.

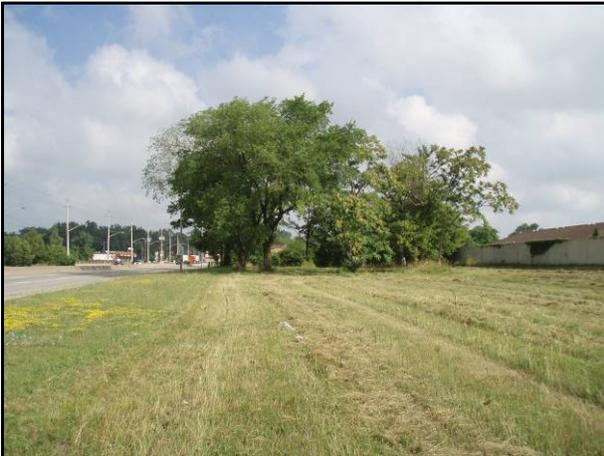
Plate 2: Unit 1 – view to west, disturbed conditions along Turkey Creek.

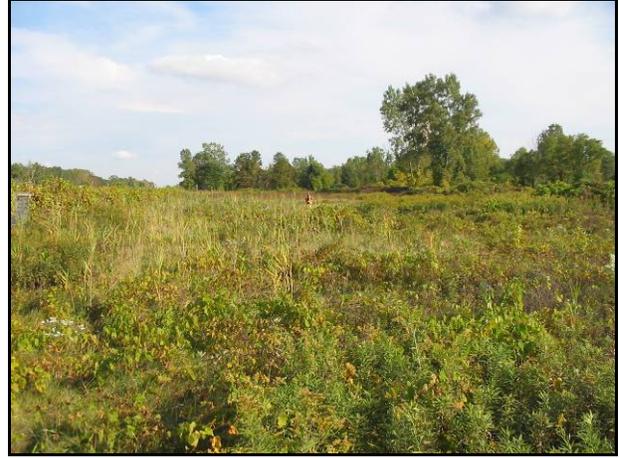
Plate 1: Unit 1 - view to southeast, judgmental testing determined disturbance near road.

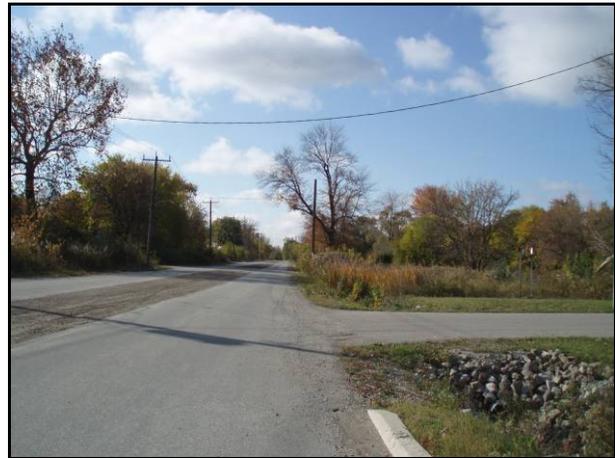
Plate 3: Unit 6 - view to southwest, judgmental testing determined 40-100% disturbance. Undisturbed areas test pitted.

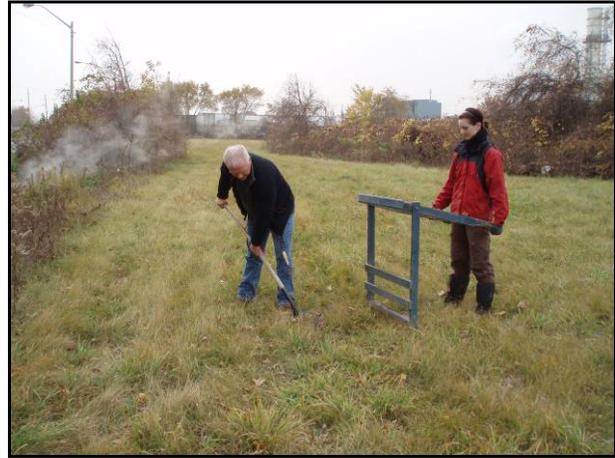
Plate 1: Unit 1 – Looking NW at pedestrian survey.
