**Canada-United States-Ontario-Michigan
Border Transportation Partnership**

**Practical Alternatives Evaluation
Working Paper**

Cultural Heritage

**March 2007
(Revised April 2008)**

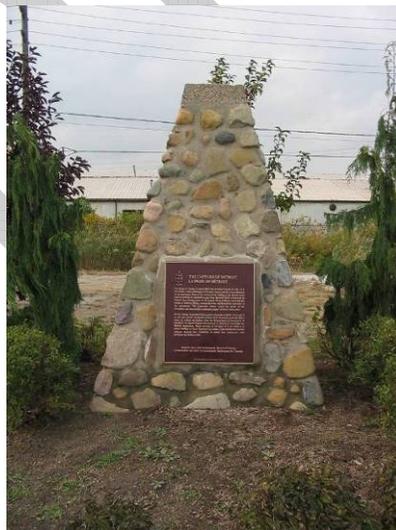
Plate 5: Historic Sites and Monuments Board of Canada monument (BHF 12) at Ojibway Parkway / Sandwich St. and Prospect Ave

Within the industrial-use area north of Brighton Beach and south of the old town of Sandwich, a cairn has been erected at the junction of Prospect Avenue and Sandwich Street / Ojibway Parkway by the Historic Sites and Monuments Board of Canada to commemorate a National Historic Event (BHF 12, Plate 5). The plaque on this cairn presents the following text:

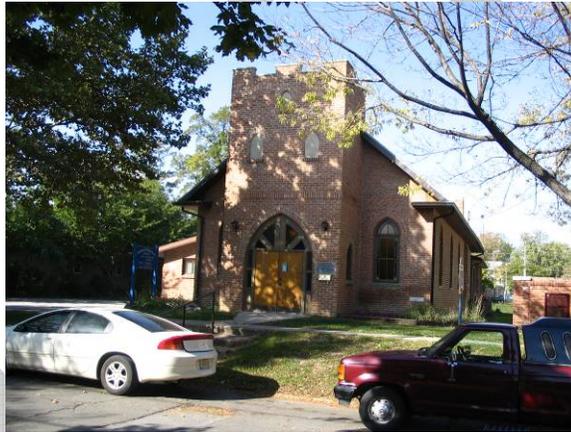
Plate 6: Sandwich First Baptist Church

Adjacent to the ACA is the core of the old town of Sandwich (CLU 3) including the Sandwich First Baptist Church, a National Historic Site, at 3652 Peter Street, between Watkins Street and Prince Street (Plate 6). Two plaques have been placed at this site, one placed by the Historic Sites and Monuments Board of Canada and the other by the Ontario Heritage Foundation. The former Lido Venice Tavern at 3885 Sandwich Street (Plate 7) was destroyed by fire in the summer of 2006.

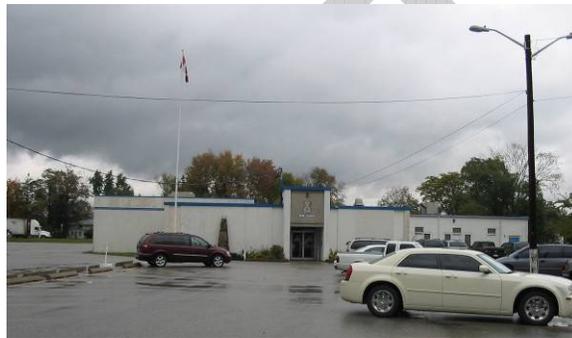
Plate 8: Royal Canadian Legion Branch 594

Built Heritage Feature: BHF 2
Address: 3920 Huron Church Line
Feature Type: Royal Canadian Legion Branch 594
Construction Period: 1961
Construction Material: Concrete walling on unknown foundation
Description: One storey structure with a flat roof
Architecture Type: Typical Legion design
Integrity: Very good
Historical Associations: Post-war Military history
Other Comments: There is a small museum within the Legion, including a display case and historic photographs.

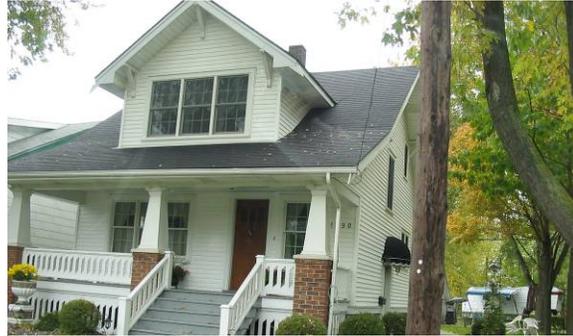
Plate 10: Spring Garden Road house (BHF 8) circa 1929

The land south of E.C. Row Expressway and west of Huron Church Road is predominantly open space, although residential development is evident on Spring Garden Road (Plate 10), Malden Road and Armanda Street. Two of the Malden Road properties are dated to the nineteenth century settlement of the area (BHF 10 and BHF 11) and one of them is on the Windsor Heritage Inventory (Plate 11).

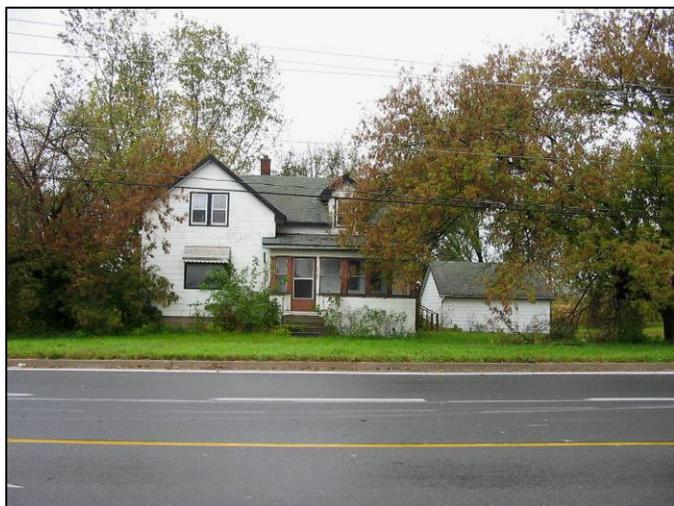
Built Heritage Feature: BHF 3
Address: 3905 Huron Church Line

Construction Material: Unknown walling on textured concrete foundation

Other Comments: This abandoned farmhouse has an associated shed as well as an outbuilding to the rear. It is bordered to the south and west by productive agricultural land.

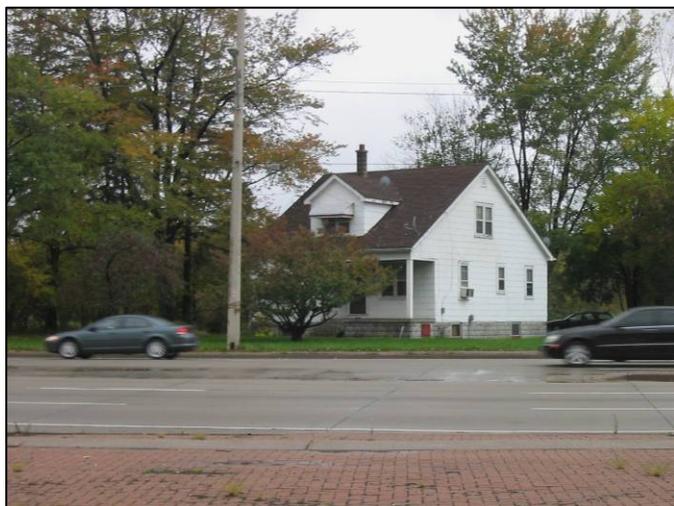
Built Heritage Feature: BHF 4
Address: 3495 Huron Church Road

Construction Material: Unknown walling on textured concrete foundation

Other Comments: The house is angled sideways reflecting the former seigniorial pattern.

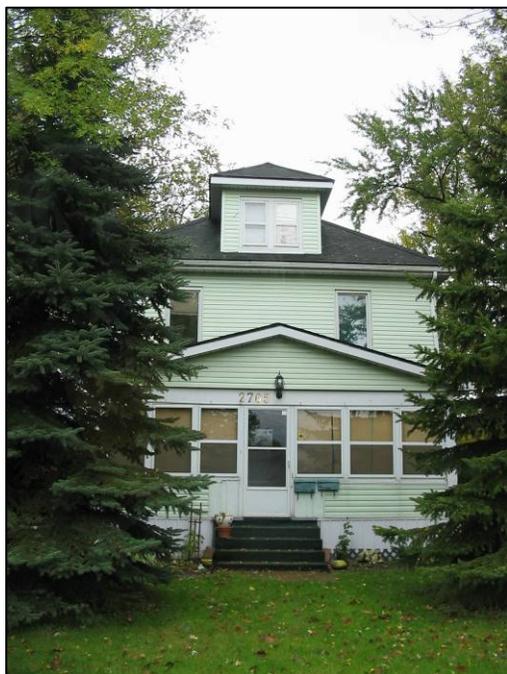
Built Heritage Feature:	BHF 5
Address:	2765 Reddock Avenue
Feature Type:	House
Construction Period:	1901-39
Construction Material:	Unknown walling on textured concrete foundation
Description:	Two storey structure with an asphalt hipped roof and a center dormer on the second floor. The house is clad in synthetic siding. This sizeable early twentieth century house has an enclosed porch and a rear outbuilding. There are some newer windows.
Architecture Type:	Vernacular; Four-square
Integrity:	Fair
Historical Associations:	Township settlement
Other Comments:	Mature trees dot the property. During an archaeological assessment conducted to the rear of the house, a stone faced crossed was recovered. The association of this artifact to the property is unknown.

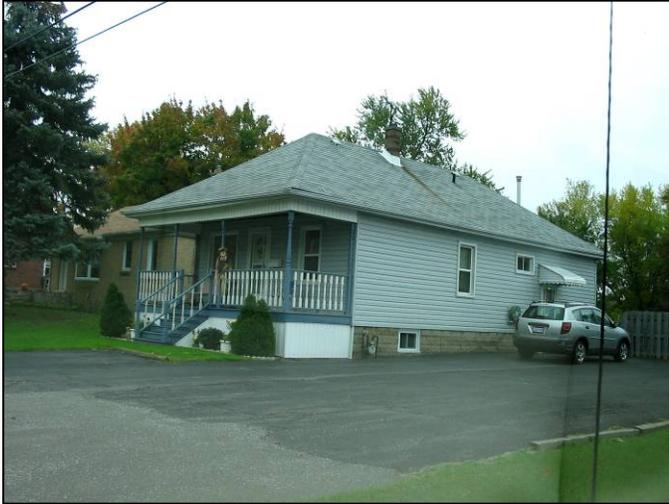
Built Heritage Feature: BHF 6
Address: 2261 Spring Garden Road
Feature Type: House
Construction Period: 1901-39
Construction Material: Unknown walling on textured concrete foundation
Description: One storey bungalow with an asphalt hipped roof and synthetic siding. It has a full length front porch, a central chimney stack and newer windows.
Architecture Type: Vernacular
Integrity: Good
Historical Associations: Early residential housing
Other Comments:

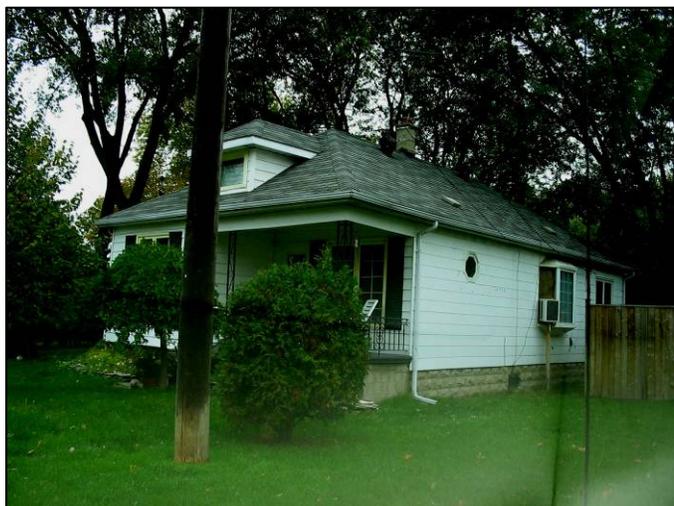
Built Heritage Feature:	BHF 7
Address:	2310 Spring Garden Road
Feature Type:	House
Construction Period:	1901-39
Construction Material:	Asbestos covered frame walling with a textured concrete foundation
Description:	One storey bungalow with an asphalt hipped roof with a centre dormer. The front has large windows with shutters and there are newer aluminum windows to the rear. There is also a newer concrete porch.
Architecture Type:	Vernacular
Integrity:	Good
Historical Associations:	Early residential housing
Other Comments:	There is a garage/shed in the rear. An oral history provided at a Public Information Centre indicates that this house and 2290 Spring Garden Road (BHF 8) were originally built by two brothers.

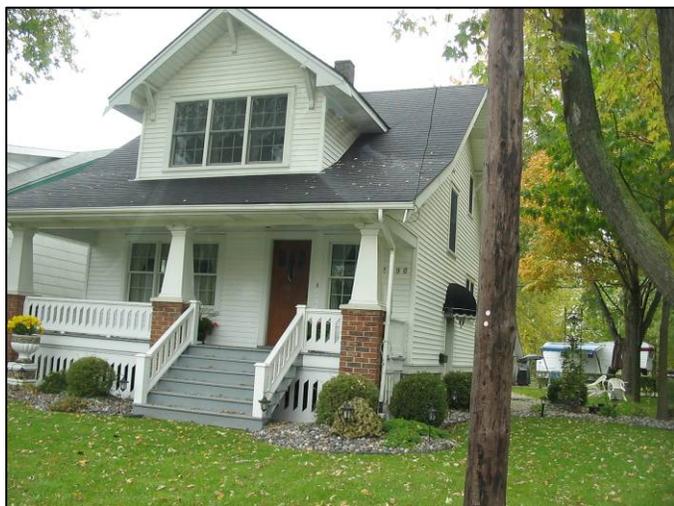
Built Heritage Feature:	BHF 8
Address:	2290 Spring Garden Road
Feature Type:	House
Construction Period:	1929
Construction Material:	Frame on textured concrete foundation
Description:	One and one-half storey house with a sloping asphalt side gable roof held up by three pillars. A large dormer provides a significant extension on the upper floor. The house is clad in synthetic siding and has newer windows. The front porch has been rebuilt.
Architecture Type:	Vernacular Arts and Crafts
Integrity:	Very good
Historical Associations:	Early residential housing
Other Comments:	The property is treed.
	An oral history provided at a Public Information Centre indicates that this house and 2310 Spring Garden Road (BHF 7) were originally built by two brothers.

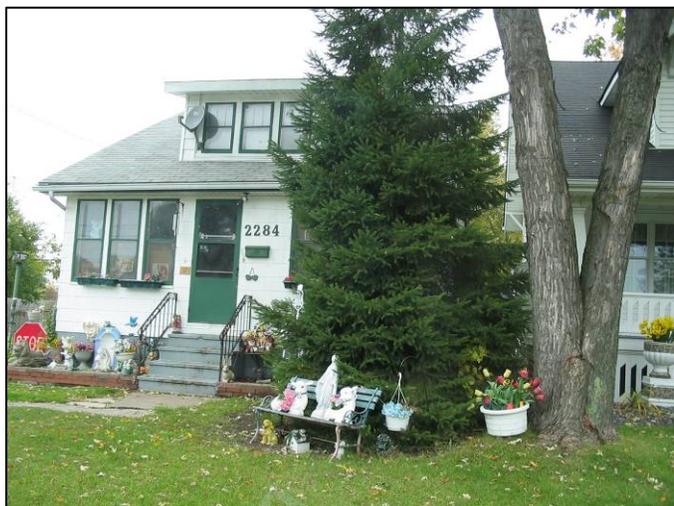
Built Heritage Feature: BHF 9
Address: 2284 Spring Garden Road

Construction Material: Frame walling on textured concrete foundation

Other Comments: The house is located on larger lot.

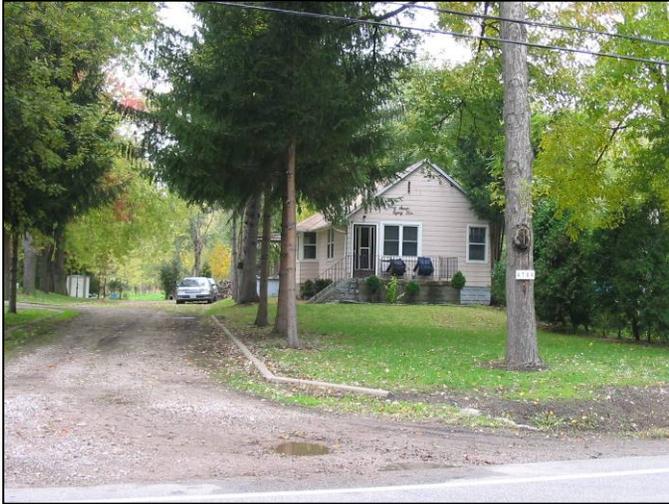
Built Heritage Feature: BHF 10
Address: 4784 Malden Road

Construction Material: Frame walling on textured concrete foundation

Other Comments: The house is set back from the road on a treed property. An oral history provided at a Public Information Centre indicates that this house is the original Matchette homestead.

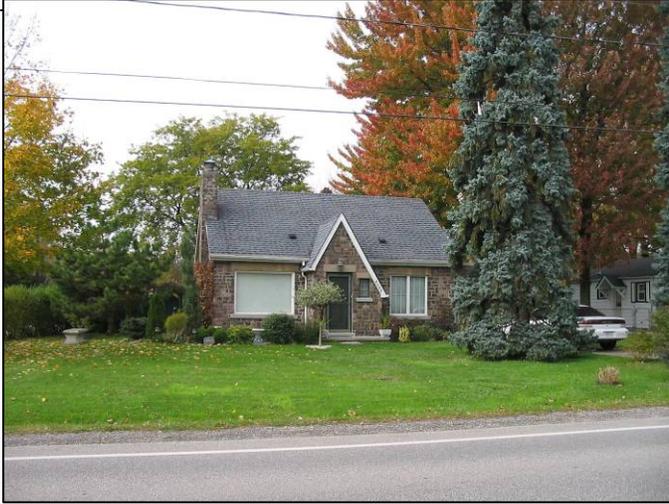
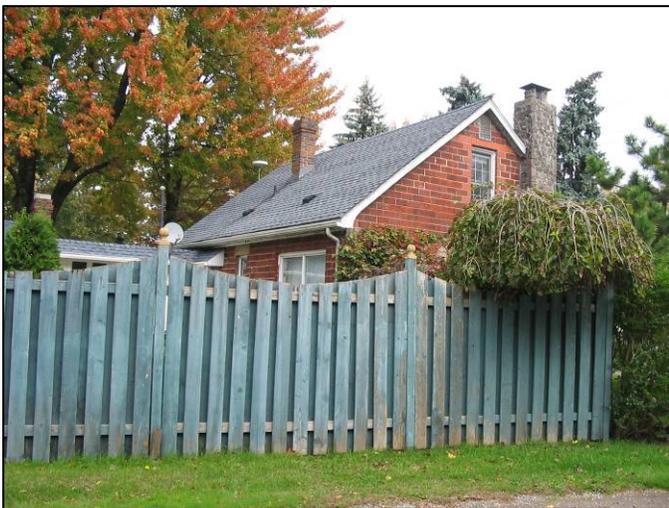
BHF 11

Mixed stone and brick walling on unknown foundation

There is a rear outbuilding and stone gates.

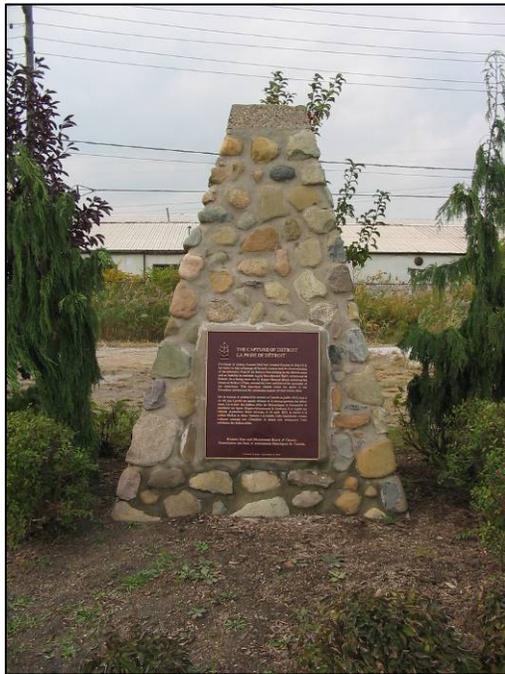
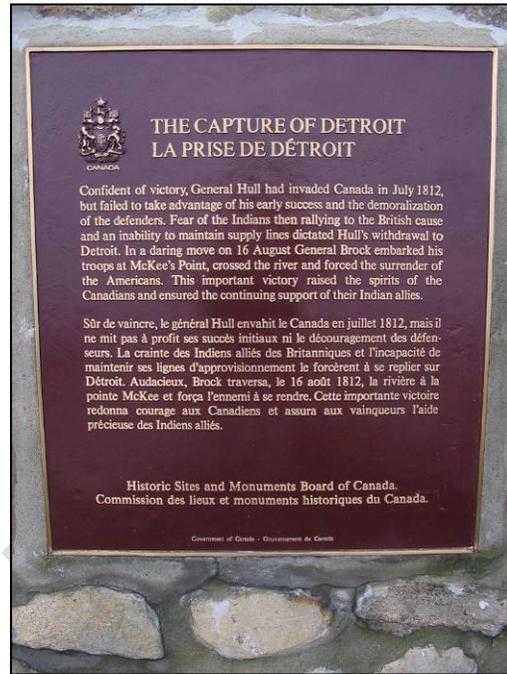
BHF 12

Built Heritage Feature:

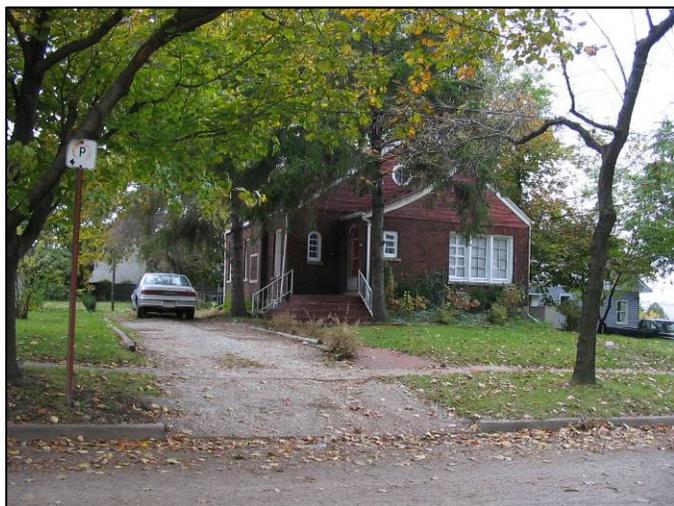
Built Heritage Feature:	BHF 13
Address:	261 Hill Street
Feature Type:	House
Construction Period:	1901-39
Construction Material:	Brick walling on textured concrete foundation
Description:	One storey structure with an asphalt side gable roof. This arts and crafts influenced house has wood windows of atypical shapes and wood frames with brick sills. The facing is comprised of irregular wood shingles. The front portion of the house has a sloped roof.
Architecture Type:	Vernacular
Integrity:	Very good
Historical Associations:	Early residential housing
Other Comments:	Very decorative.

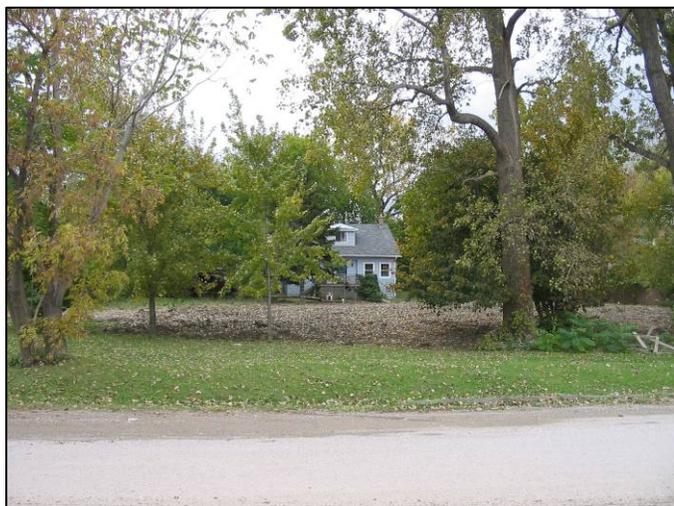
Built Heritage Feature:	BHF 14
Address:	3769 Russell Street
Feature Type:	House
Construction Period:	Pre-1900
Construction Material:	Wood frame on cinderblock foundation
Description:	One and one-half storey structure with an asphalt side gable roof. A dormer window projects from the upper floor. The house is clad with synthetic siding. It is entirely altered with new windows, a new roof, and aluminum siding.
Architecture Type:	Vernacular
Integrity:	Fair. Much altered
Historical Associations:	Township settlement
Other Comments:	This much altered nineteenth century house sits on a rise above Russell Street. The property has mature trees. Remnants of an older fence are visible. The current owner attended the Public Information Centre and indicated that his family had owned the house for quite some time.

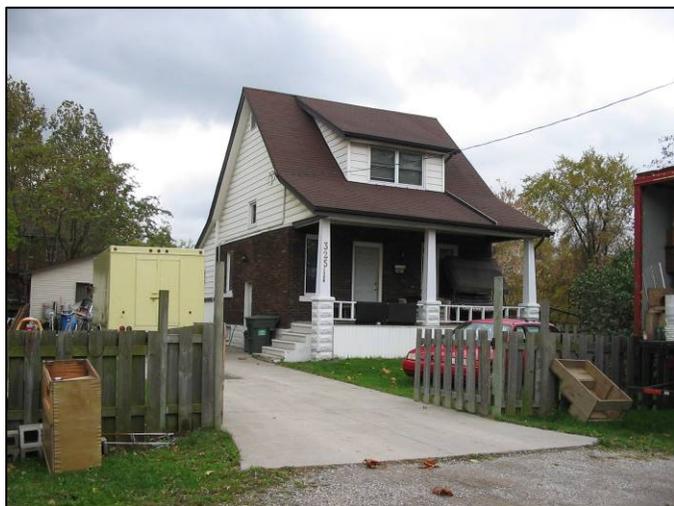
Built Heritage Feature: BHF 15
Address: 325 Page Street (Brighton Beach)
Feature Type: House
Construction Period: 1901-39
Construction Material: Brick walling on textured concrete foundation
Description: One and one-storey house with an asphalt roof
Architecture Type: Vernacular
Integrity: Fair
Historical Associations: Early residential housing; Brighton Beach
Other Comments: This residence is one of three occupied houses in the Brighton Beach area. There are mature trees on the property.

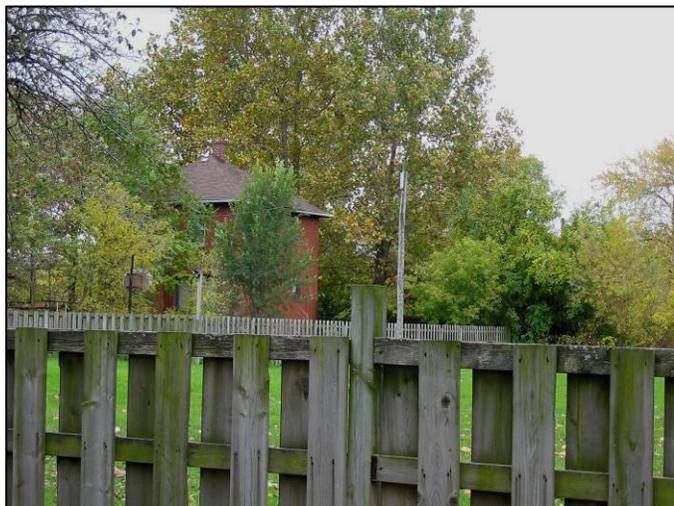
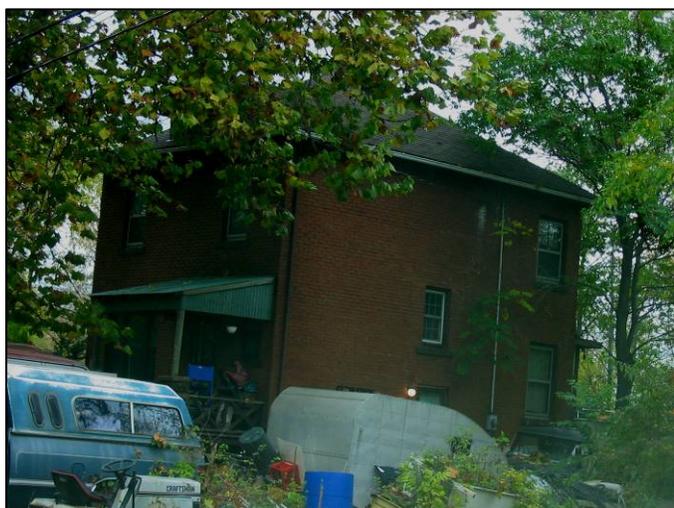
Built Heritage Feature: BHF 16
Address: 332 Healy Street (Brighton Beach)
Feature Type: House
Construction Period: 1901-39
Construction Material: Brick walling on unknown foundation
Description: Two storey structure with an asphalt hipped roof. A dormer projects from the upper floor.
Architecture Type: Vernacular; Foursquare
Integrity: Fair
Historical Associations: Early residential housing; Brighton Beach
Other Comments: There are mature trees on the property.

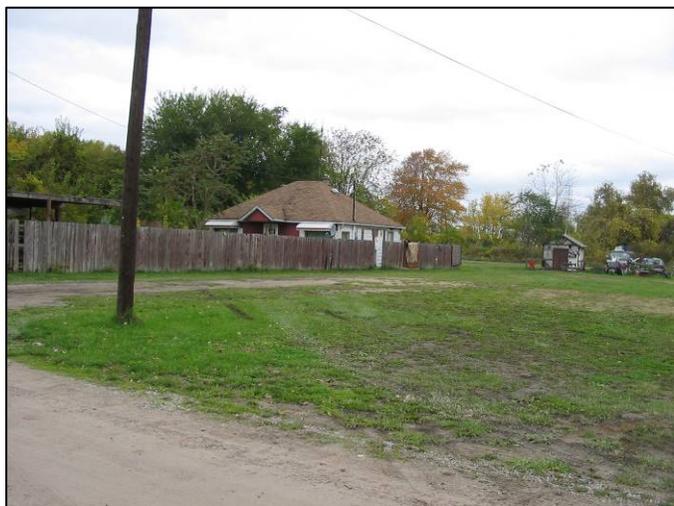
Built Heritage Feature: BHF 17
Address: 354 Healy Street
Feature Type: House
Construction Period: Pre-1900
Construction Material: Unknown walling on unknown foundation
Description: One storey structure with an asphalt hipped roof and synthetic siding. The centre chimney stack indicates an earlier date.
Architecture Type: Vernacular; Ontario cottage
Integrity: Poor. Much altered
Historical Associations: Township settlement
Other Comments: The property is used to store scrap metal.

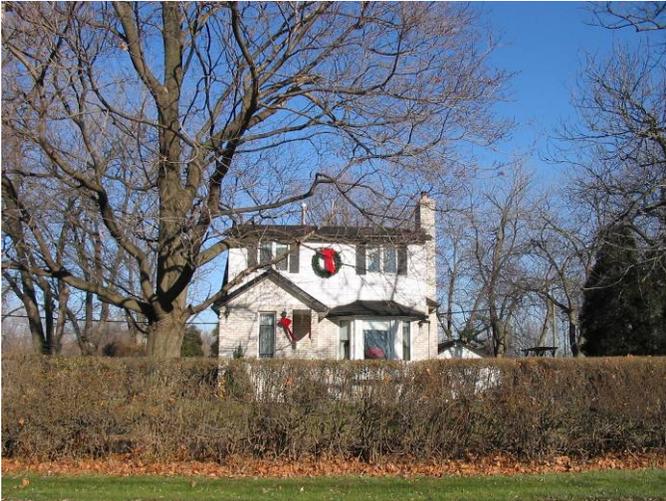
Built Heritage Feature: BHF 18
Address: 2090 Spring Garden Road (moved from Sandwich West)

Feature Type: House

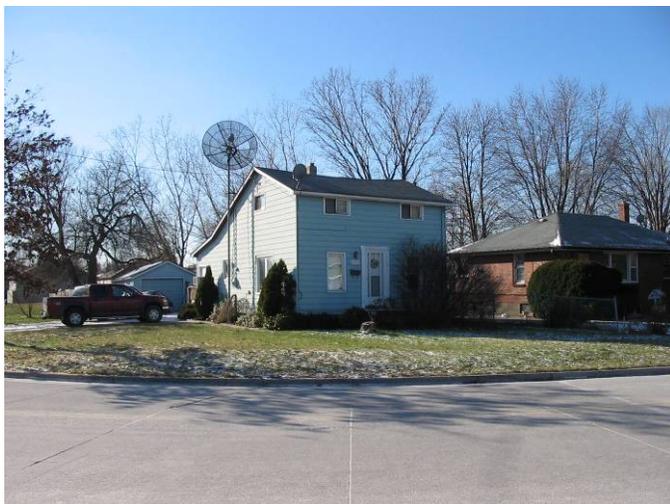
Built Heritage Feature: BHF 19
Address: 2369 Spring Garden Road
Feature Type: House
Construction Period: Pre-1900
Construction Material: Likely frame, potentially log on an unknown foundation.
Description: One storey structure with a shallow pitched asphalt roof. This potentially early structure has been much altered. It has a three-bay design with newer aluminum windows and synthetic siding. A rear addition slopes in a salt-box design.
Architecture Type: Vernacular
Integrity: Poor. Much altered
Historical Associations: Township settlement
Other Comments: A neighbour who attended a Public Information Centre suggested that this house may have an early log structure at its core and the design supports this idea. It has been added to the inventory based on this report.

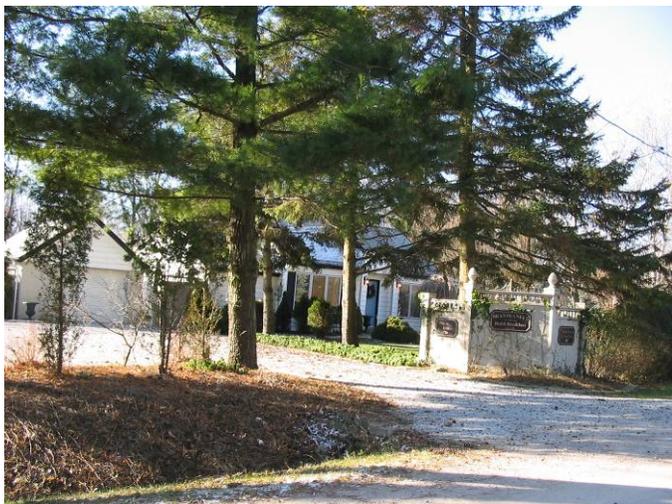
Built Heritage Feature: BHF 20
Address: 1649 Chappus Road

Construction Material: Unknown walling on unknown foundation

Other Comments: A neighbour who attended a Public Information Centre suggested that this house may have an early structure at its core. It has been added to the inventory based on this report.

Mature trees on a landscaped property.

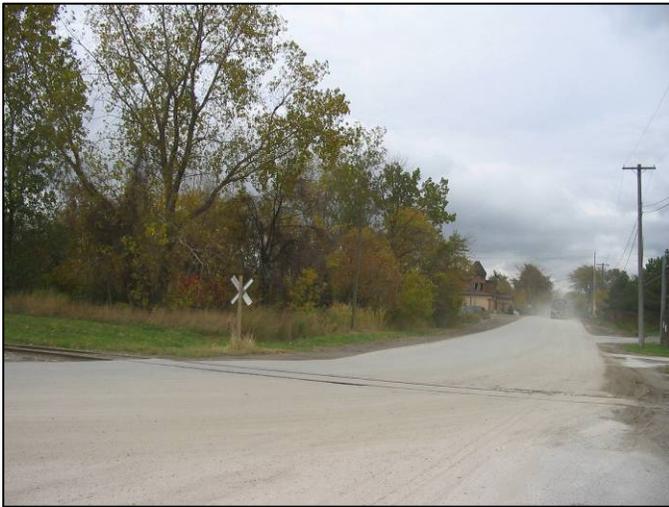
Cultural Landscape Unit: CLU 1
Address: Chappell Street and Russell Street

Landscape Feature Type: Tunnel

Description: Local history/lore suggests that a tunnel runs under this woodlot to an area behind the now burned and demolished Lido Venice tavern at the corner of Chapell and Sandwich streets. This tunnel system associated with the Underground Railroad and/or prohibition remains unsubstantiated by existing primary and secondary sources.

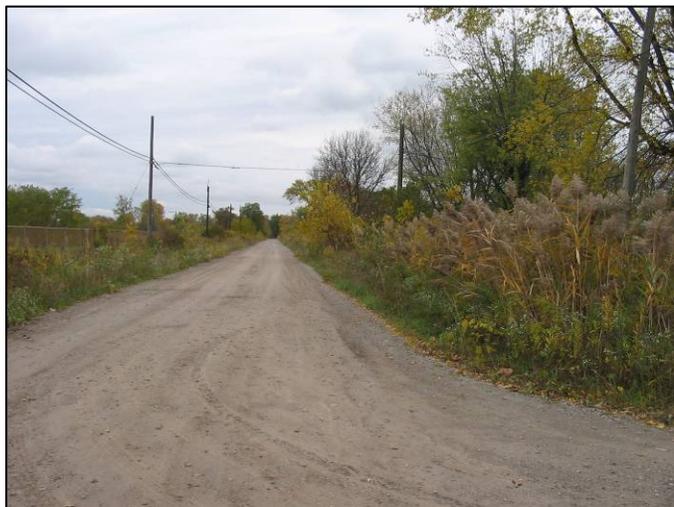
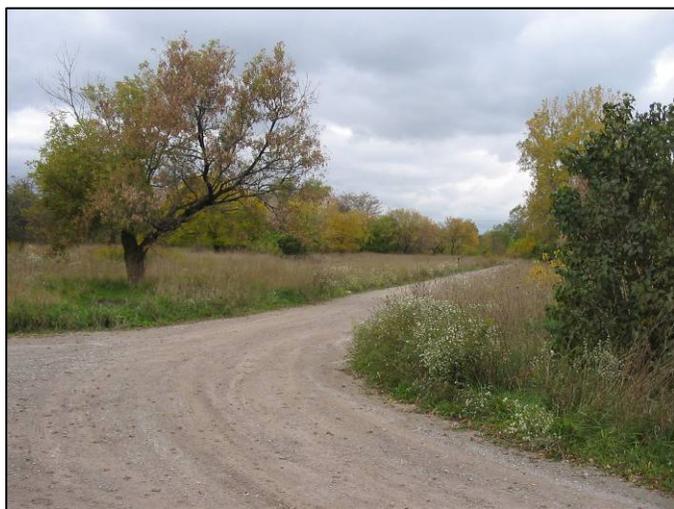
Cultural Landscape Unit: CLU 2
Address: Area bordered by Water Street to the west, Chappus to the north, Scotten to the east and Broadway/Wright to the south
Landscape Feature Type: Brighton Beach subdivision
Description: This planned subdivision was laid out in the early twentieth century and a community resided there until the area was cleared in the 1970s. Roads and driveways are evident in the landscapes. There are mature trees in the area.

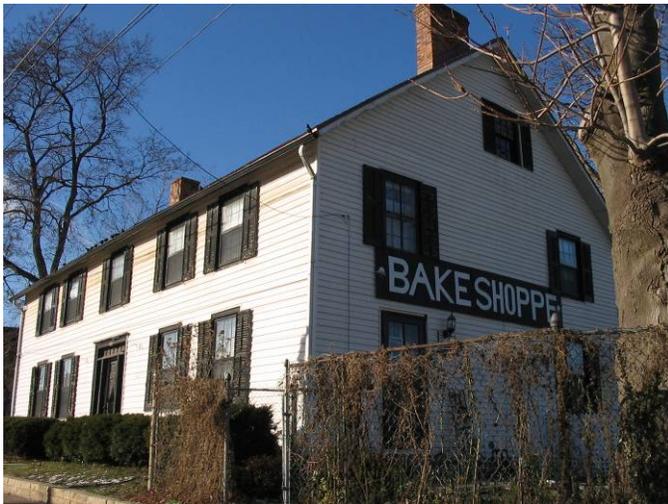
Cultural Landscape Unit: CLU 3
Address: Sandwich (old town)

Landscape Feature Type: Historic settlement
