Canada-United States-Ontario-Michigan Border Transportation Partnership

Archaeology Assessment

Technically and Environmentally Preferred Alternative

December 2008

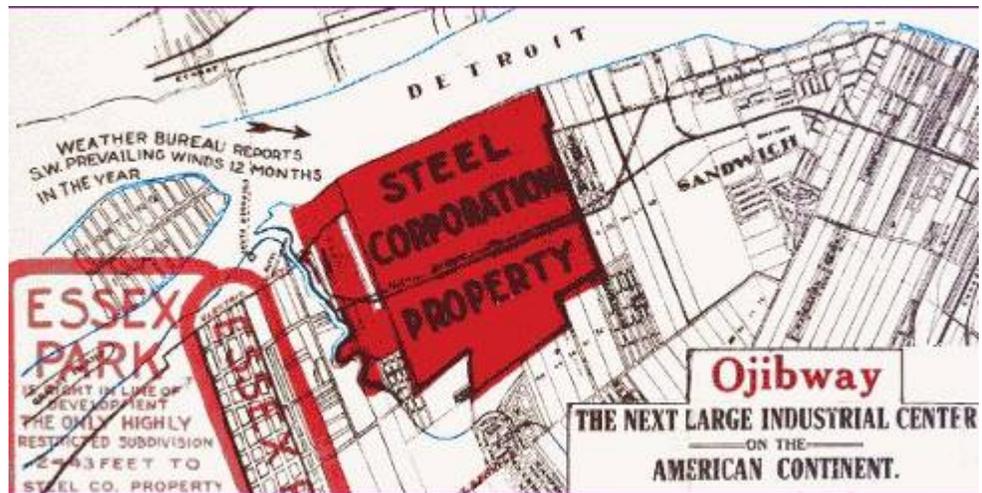
Figure 2: Ojibway Development Plan

Note: Map is showing the proposed industrial and residential development adjacent to the Area of Continued Analysis (<http://www.ojibway.ca/history.htm>)

In step with the growth of Windsor and environs, development pressure came to bear on land flanking major roads, and near commercial or industrial focal points. An early example is the Brighton Beach residential community. When a large new steel plant was proposed for land along the river in Ojibway, developers were quick to subdivide land for residential use nearby (refer to Figure 2). Plan 688, subdividing Lot 55, Concession I was registered in 1913. A plan to subdivide Lot 50, Concession II along Huron Church Road was registered in 1920 (Plan 1020, Sandwich West Township), creating Spring Garden Road. In 1928, Lot 1 Concession IV, at the intersection of Talbot and Huron Church Line Roads, was subdivided into residential lots (Plans 1299, 1437 Sandwich West Township). Parts of all three surveys fall within the TEPA.
