Appendix E – Baseline Vibration Monitoring Results (2006)

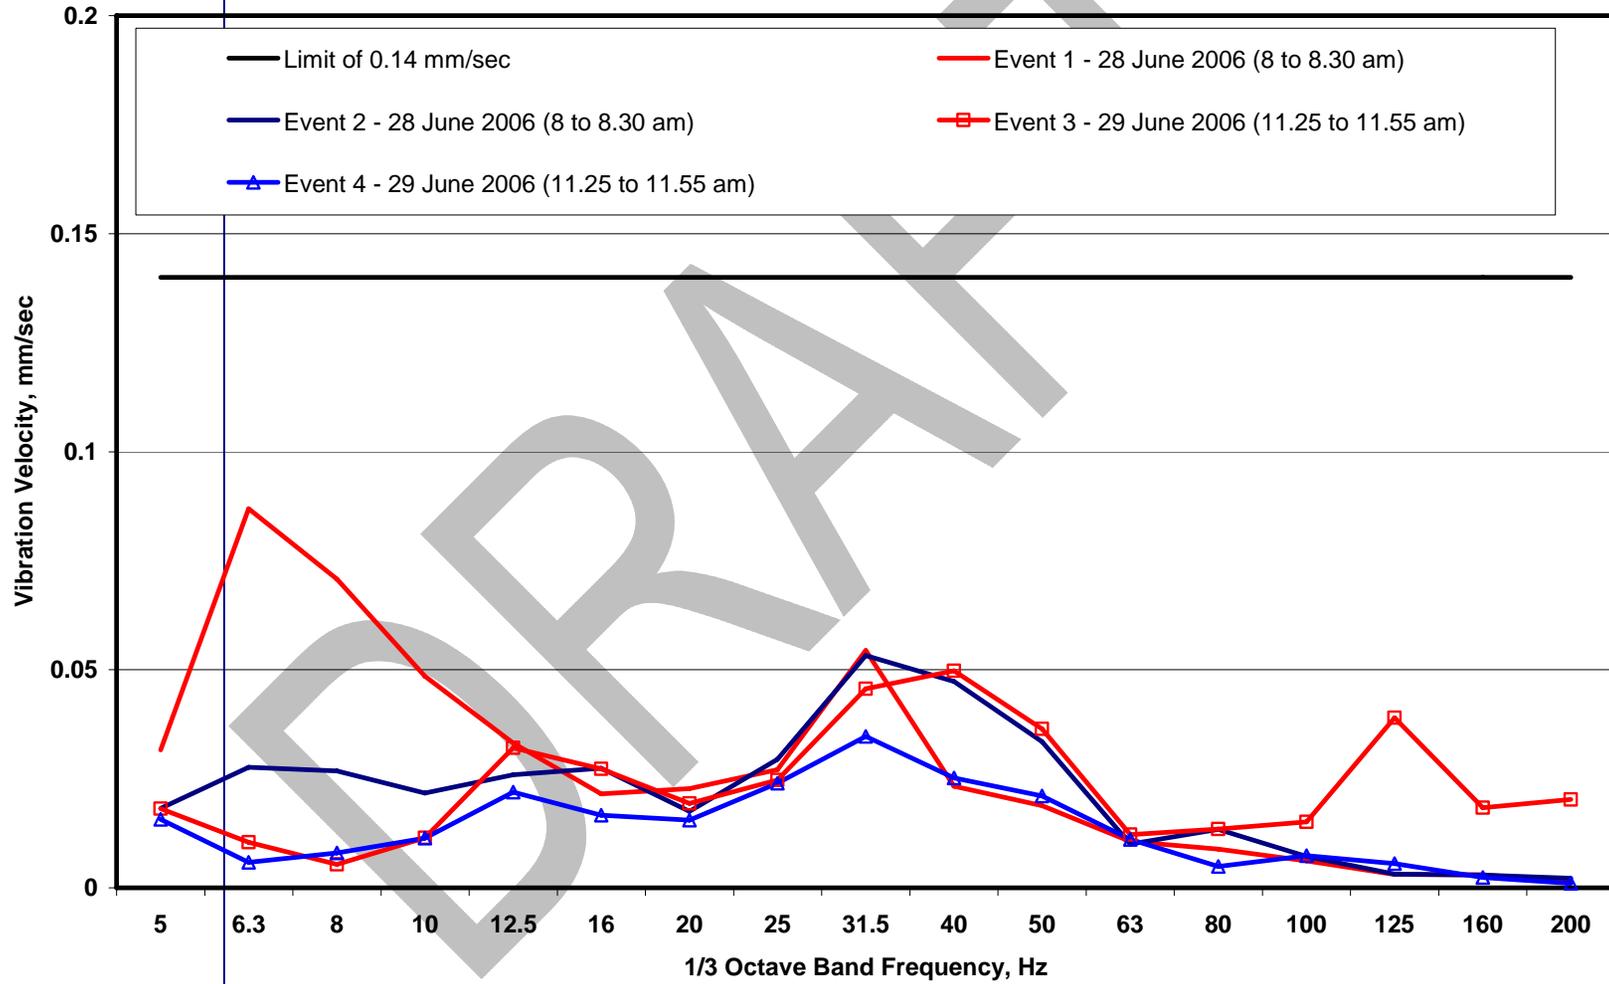
Figure 1. Vibration Levels from Road Traffic Pass-Bys
House Between 1140 and 1202 Talbot Street

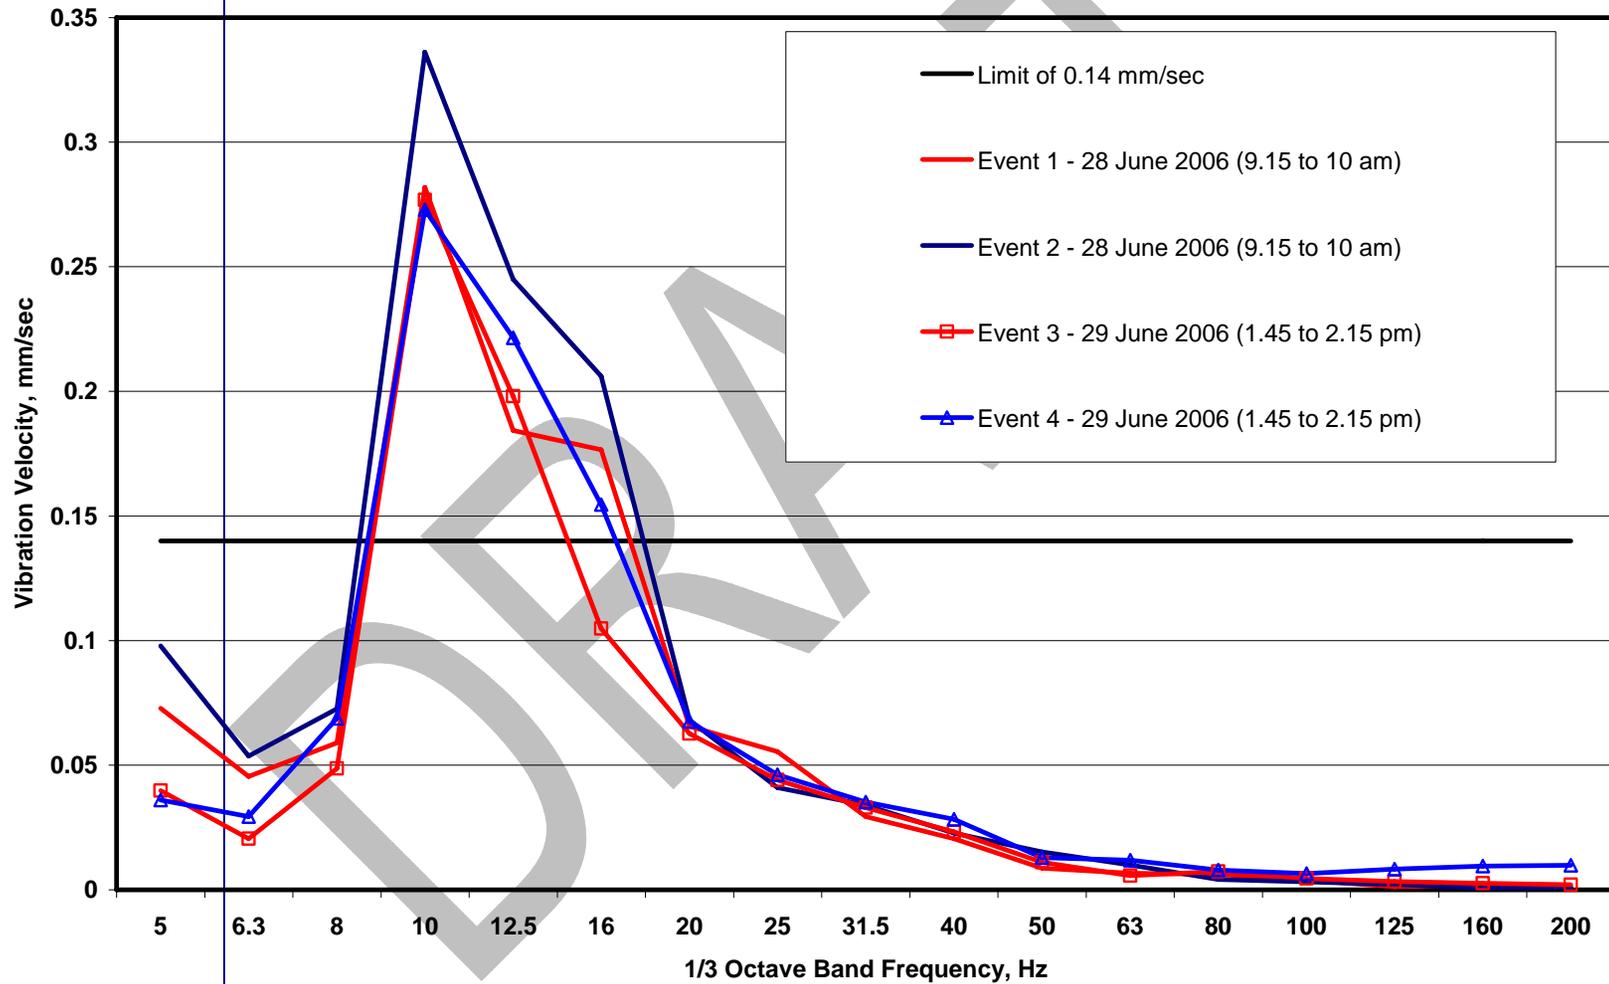
Figure 2. Vibration Levels from Road Traffic Pass-Bys
Sidewalk near the 5th Block South of Riverside Avenue

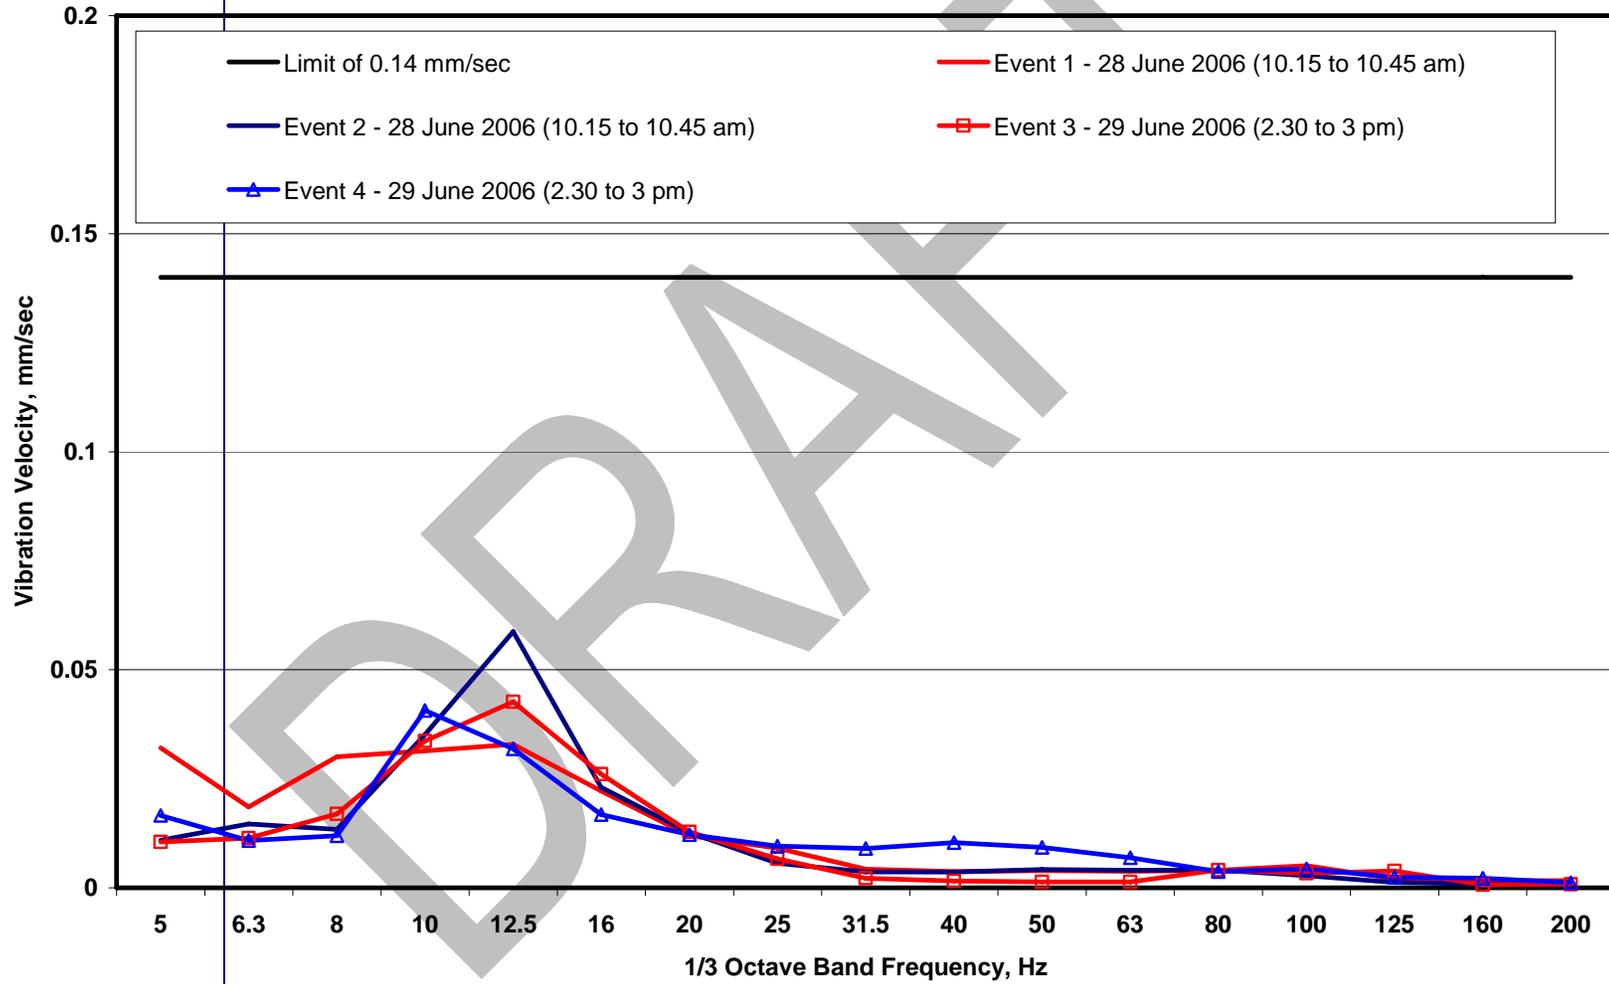
**Figure 3. Vibration Levels from Road Traffic Pass-Bys
End of Mill Road**

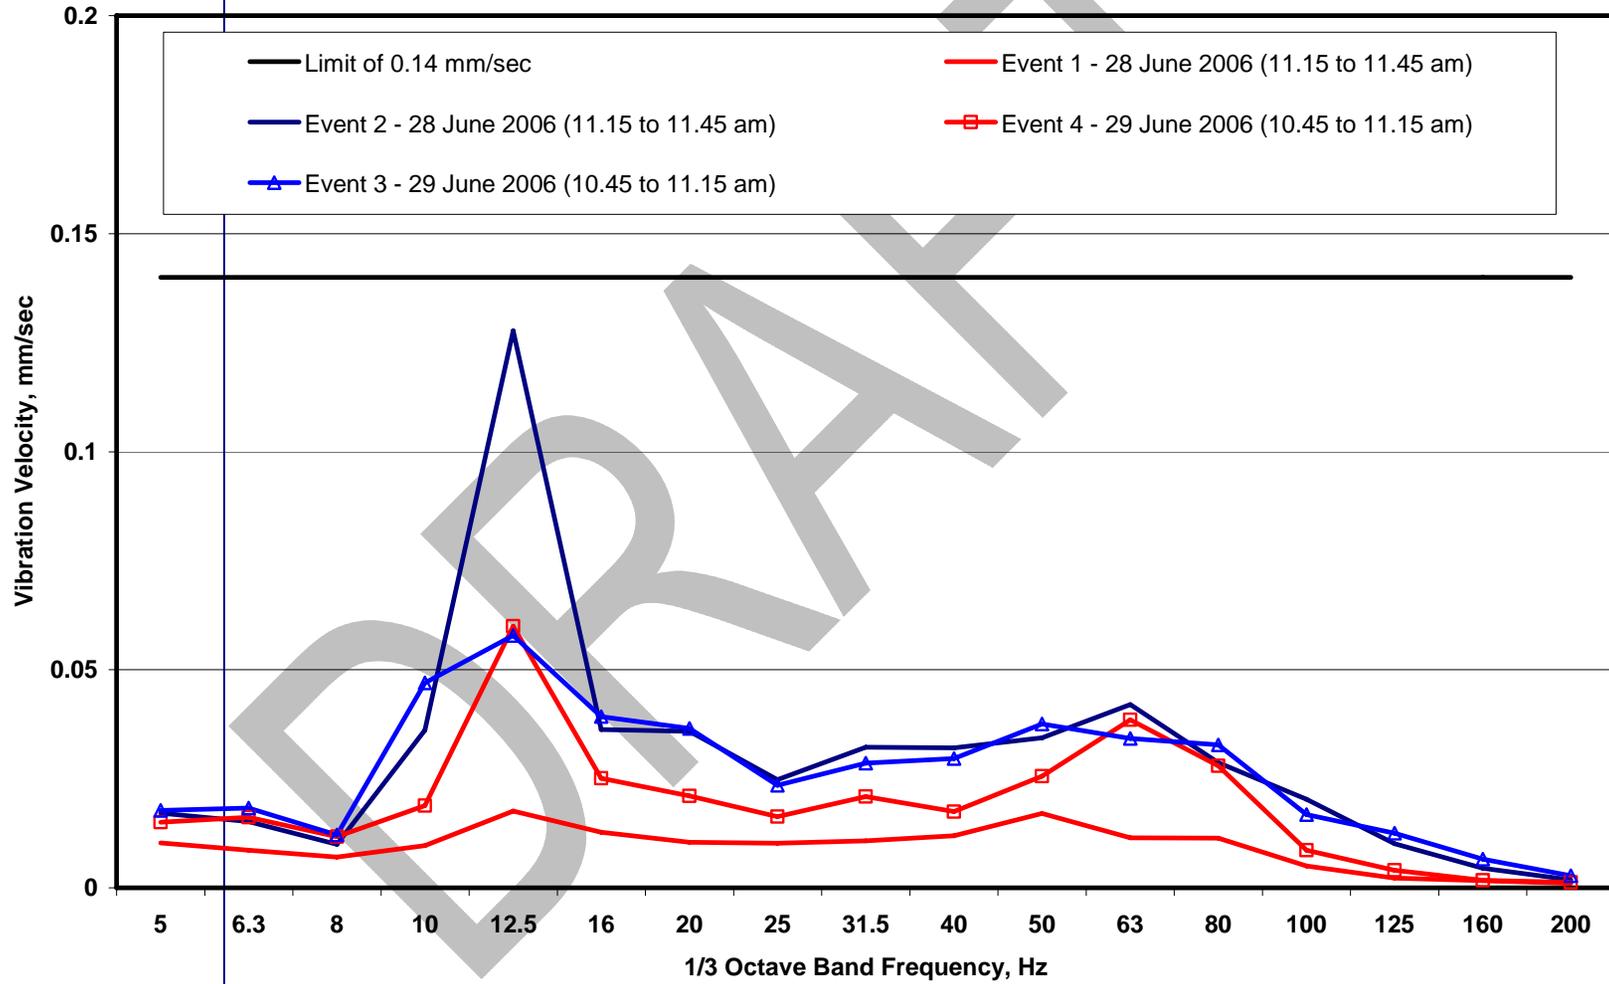
**Figure 4. Vibration Levels from Road Traffic Pass-Bys
Heritage Park Alliance Church**

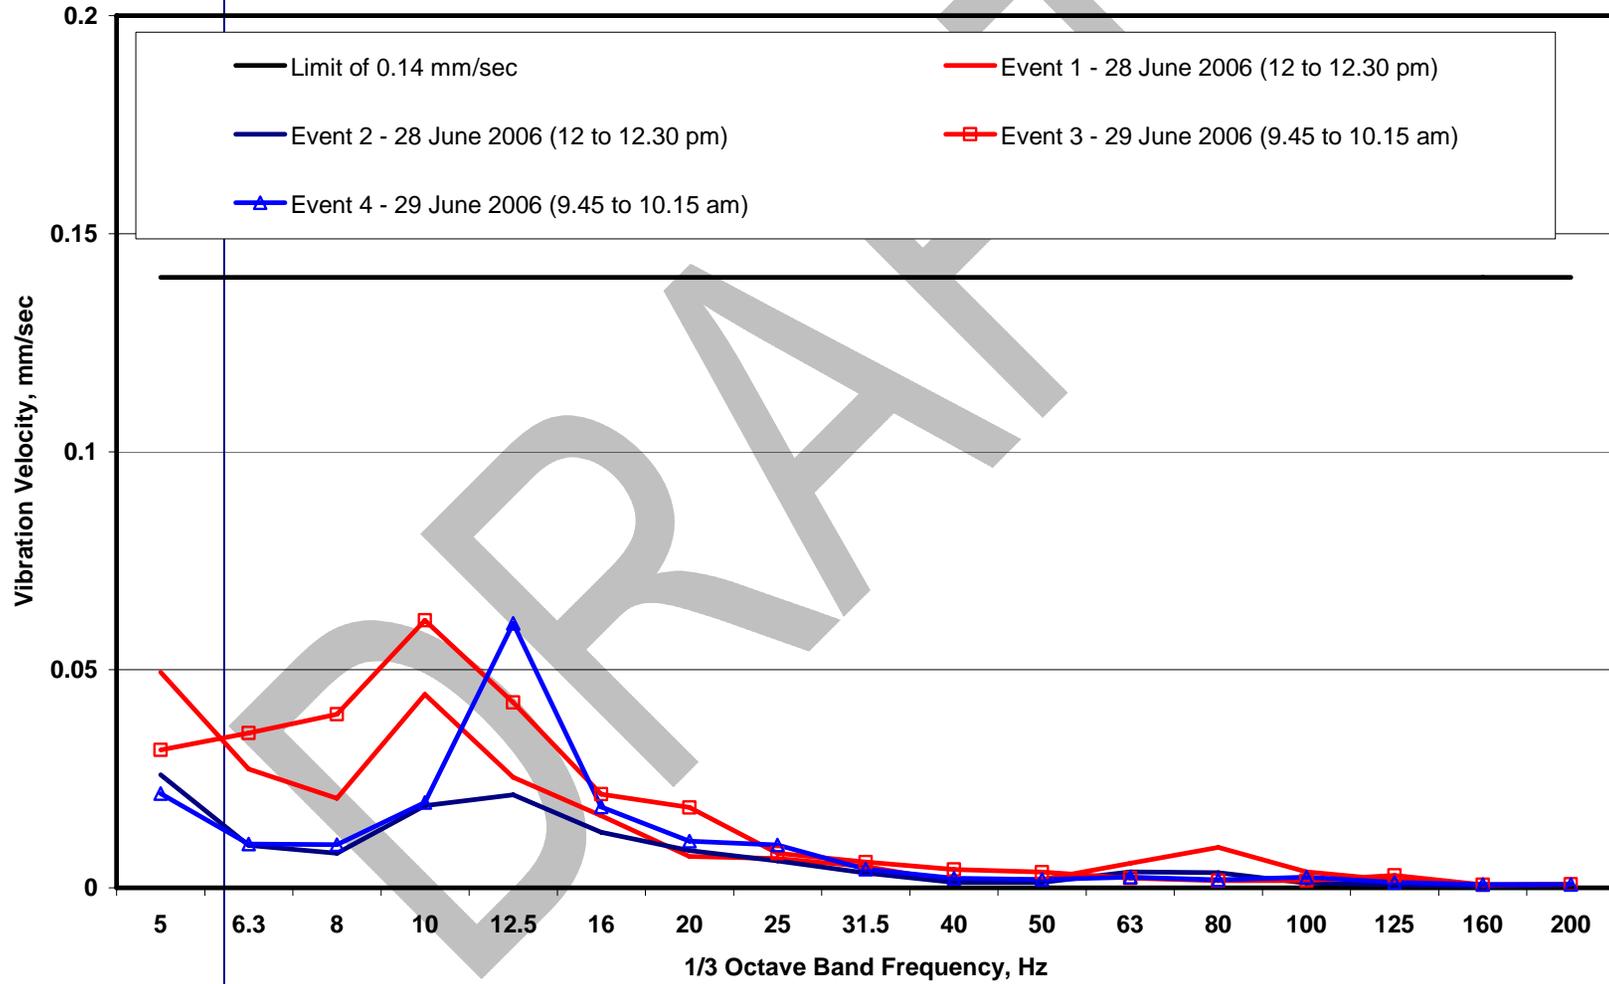
Figure 5. Vibration Levels from Road Traffic Pass-Bys
Park near 2370 Northway

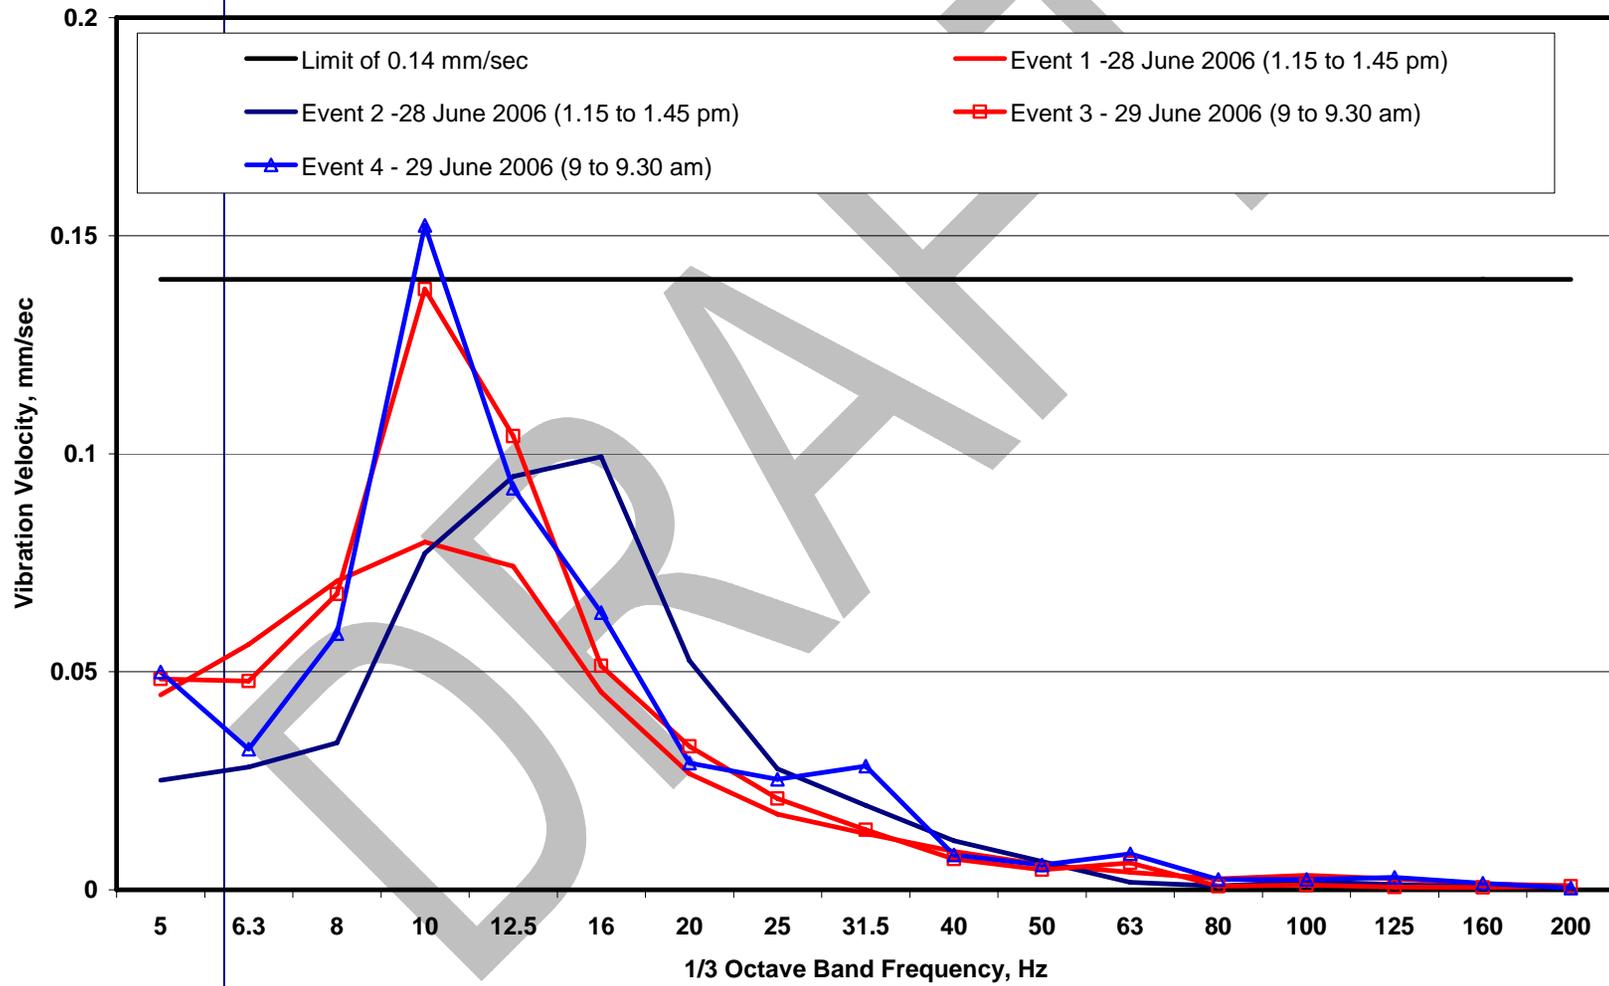
Figure 6. Vibration Levels from Road Traffic Pass-Bys
Dainty Rice (Ojibway and Broadway)

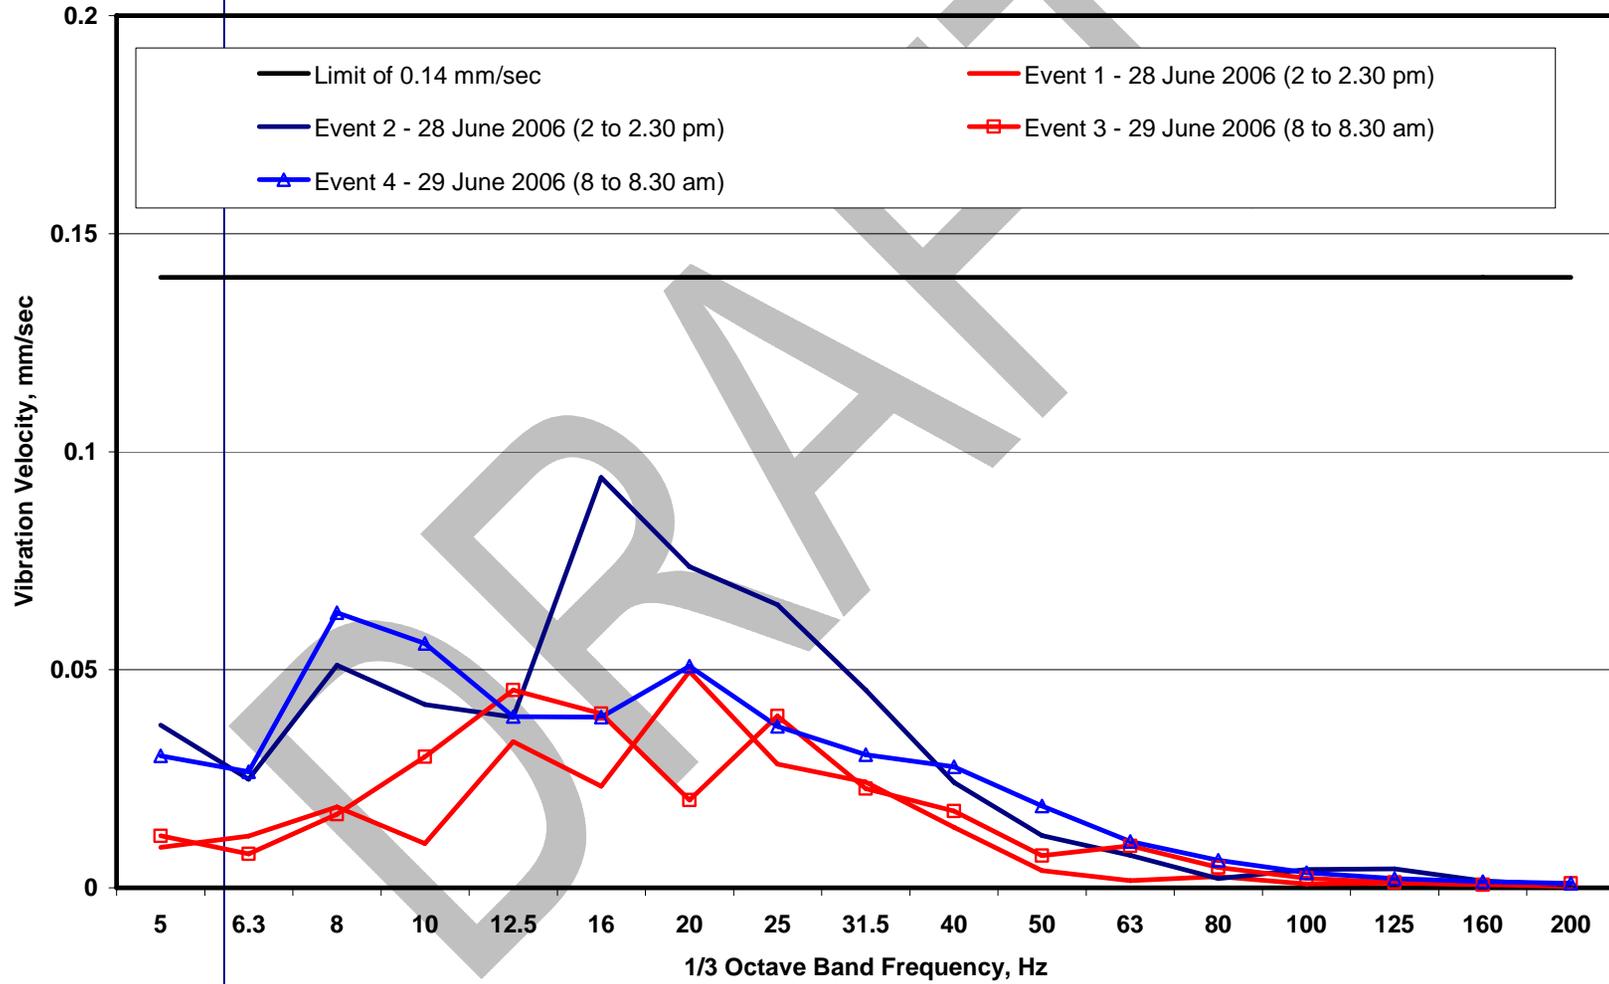
Figure 7. Vibration Levels from Road Traffic Pass-Bys
Near 4340 Malden

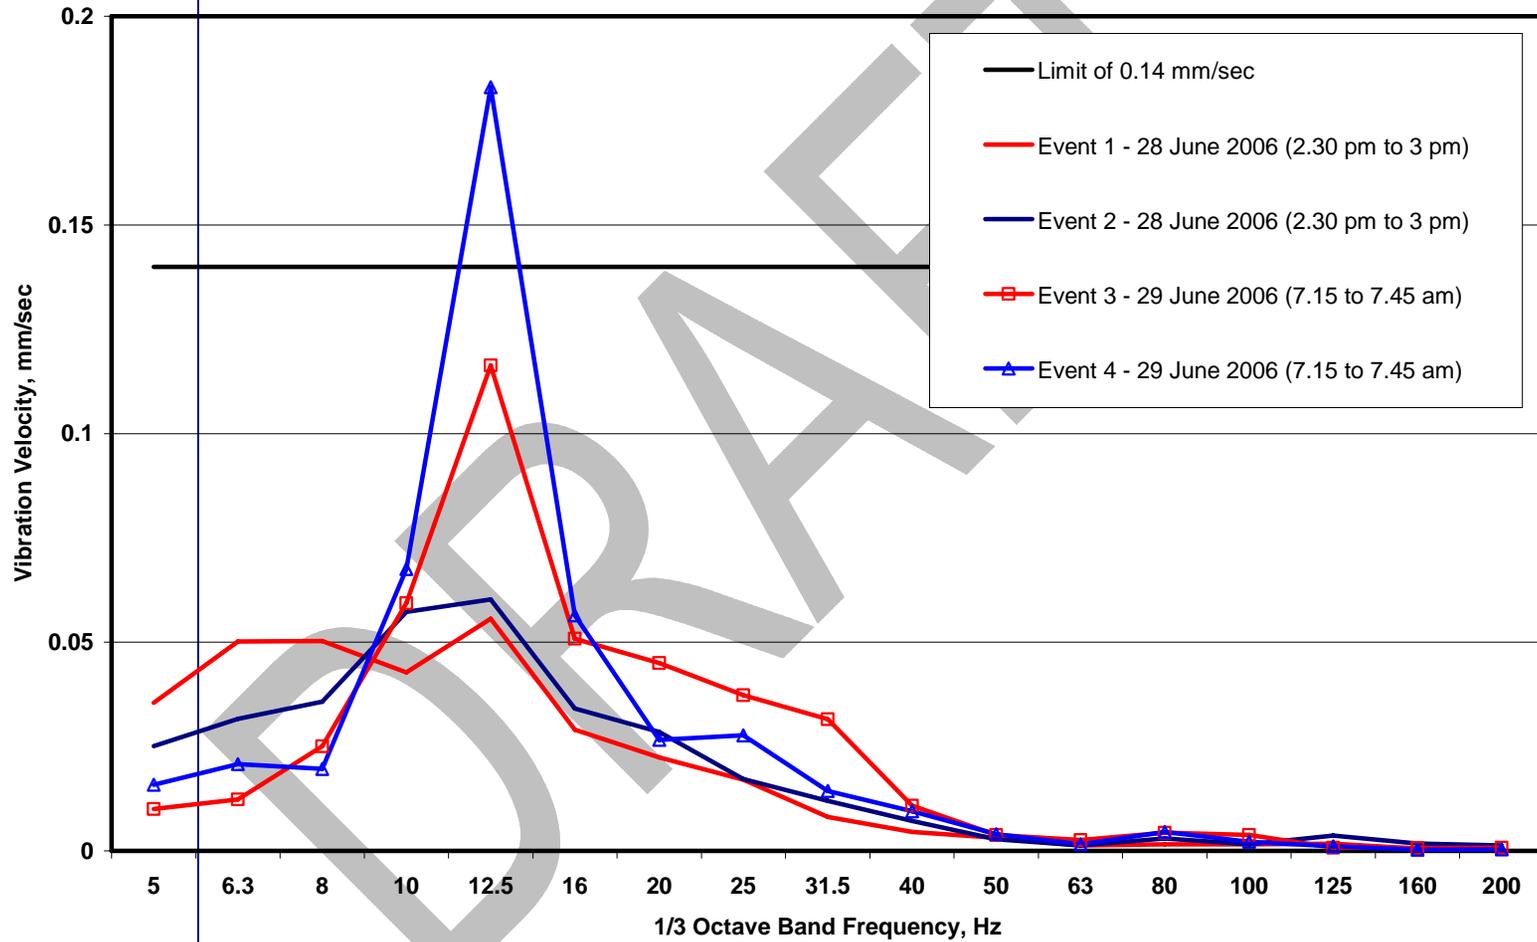
Figure 8. Vibration Levels from Road Traffic Pass-Bys
East side of Huron Church - Opposite to 3495 - Turning Loop

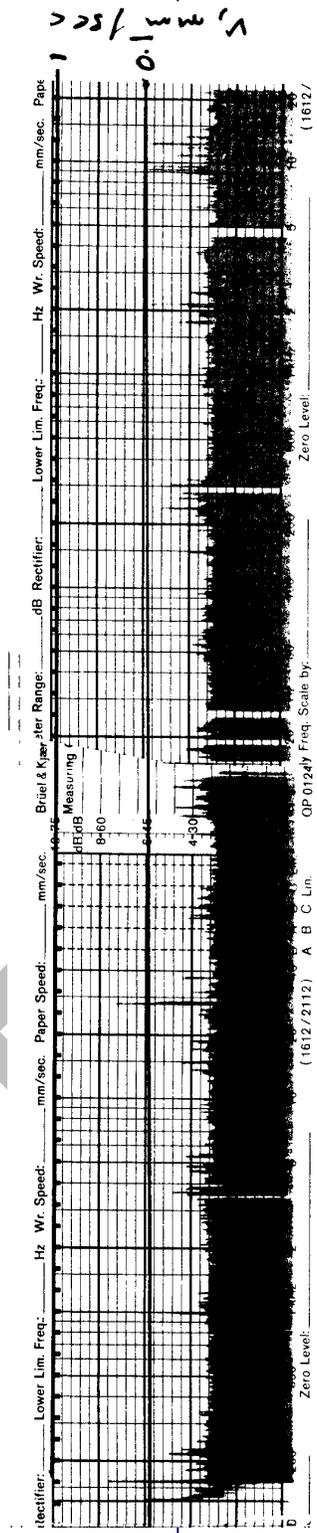
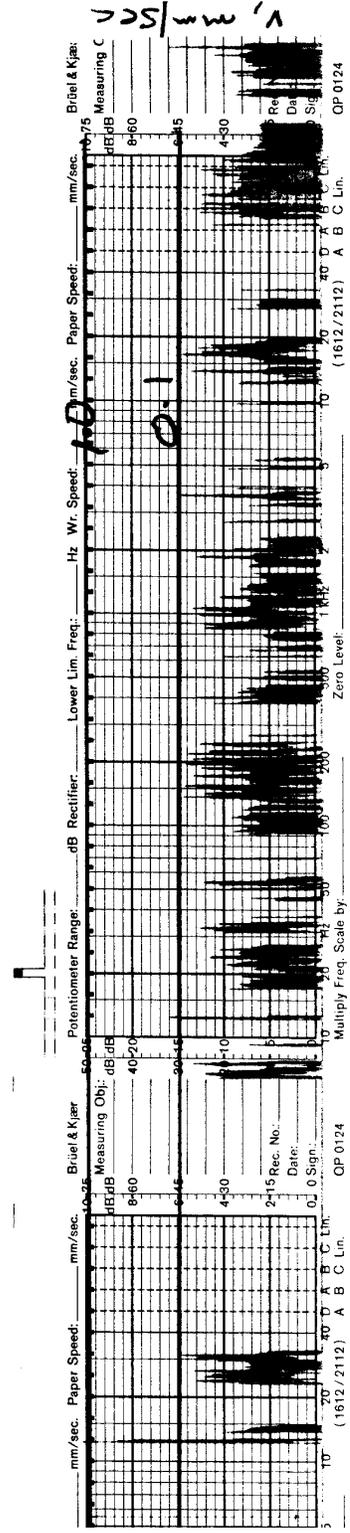
FIGURE 9. VIBRATION TIME HISTORY FOR LOCATION 1

(a) 28 June 2006 – 8.10 am to 8.29 am

(b) 29 June 2006 – 11.32 am to 11.49 am

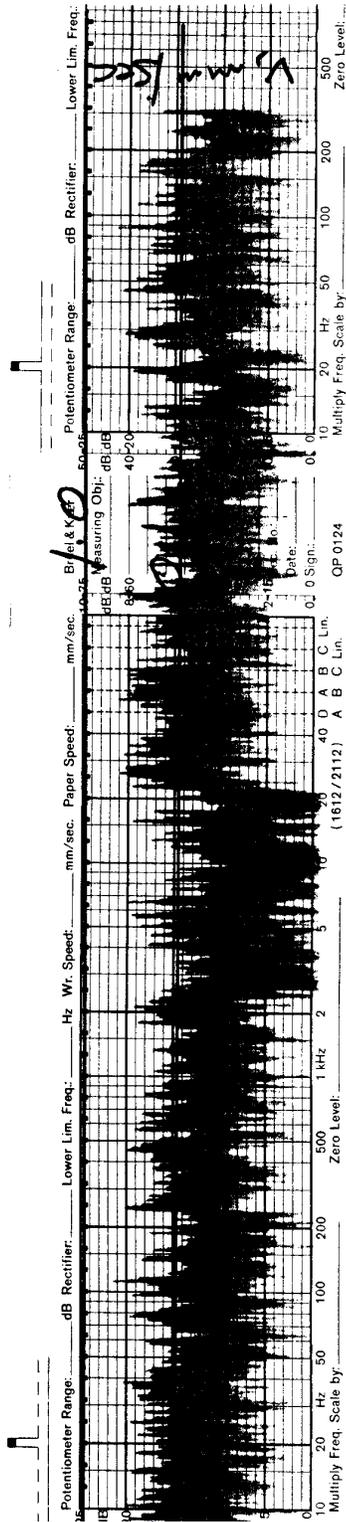
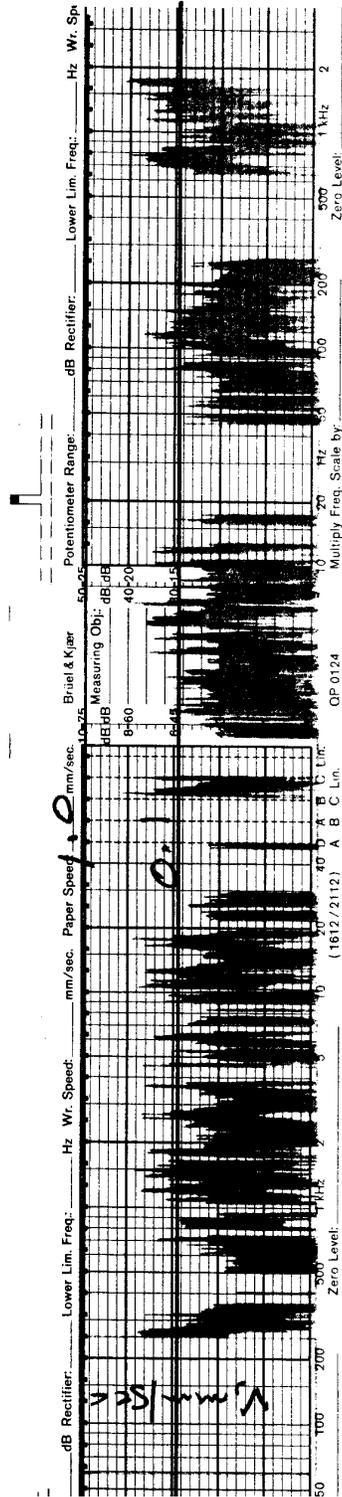
FIGURE 10. VIBRATION TIME HISTORY FOR LOCATION 2

(a) 28 June 2006 - 9.27 am to 9.47 am

(b) 29 June 2006 - 1.56 pm to 2.10 pm

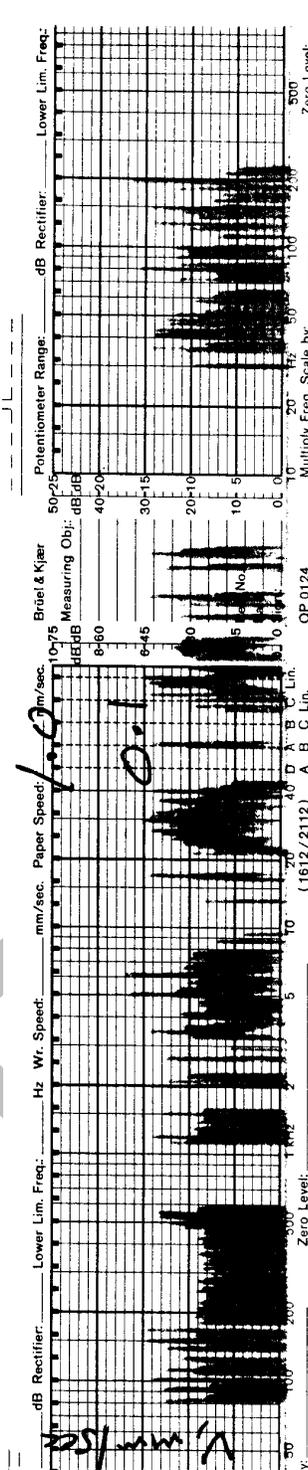
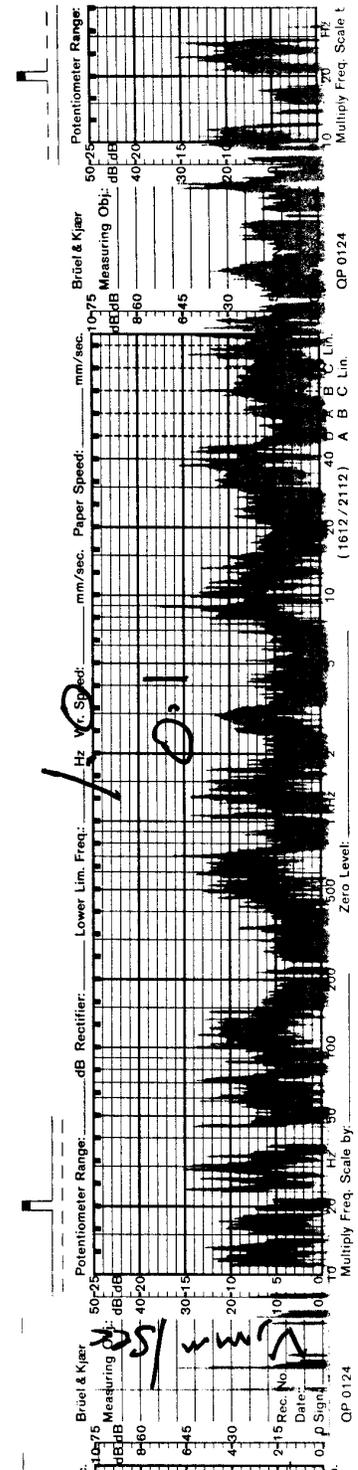
FIGURE 12. VIBRATION TIME HISTORY FOR LOCATION 4

(a) 28 June 2006 – 11.13 am to 11.31 am

(b) 29 June 2006 – 10.50 am to 11.05 am

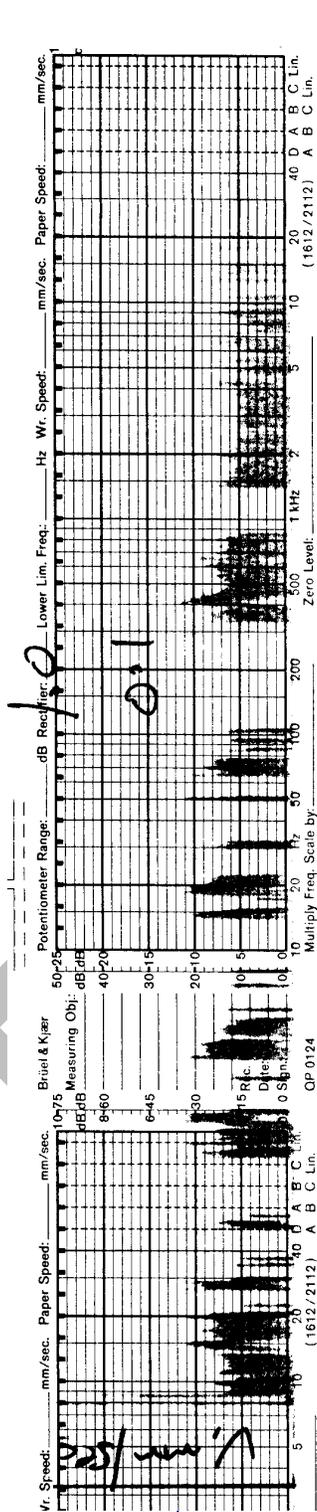
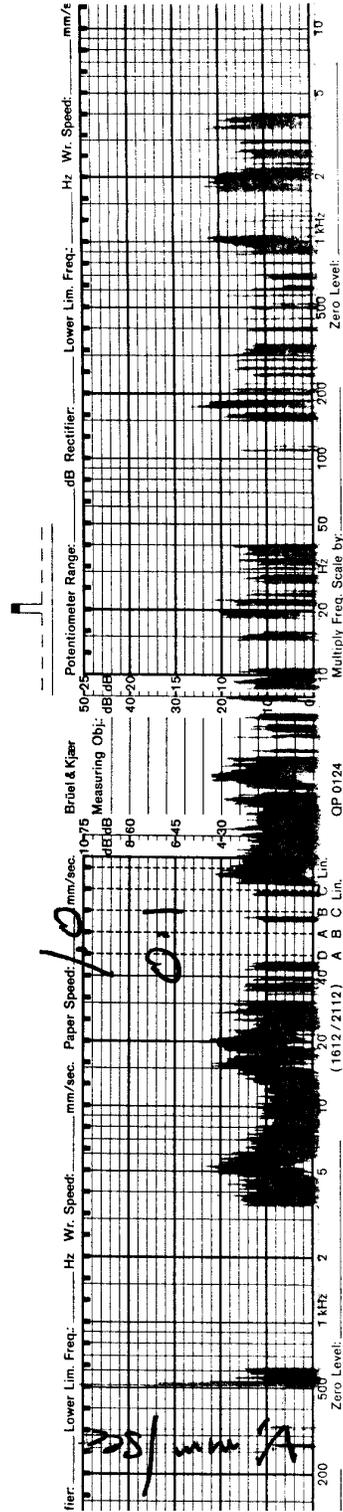
FIGURE 13. VIBRATION TIME HISTORY FOR LOCATION 5

(a) 28 June 2006 – 12.09 pm to 12.27 pm

(b) 29 June 2006 – 11.32 am to 11.49 am

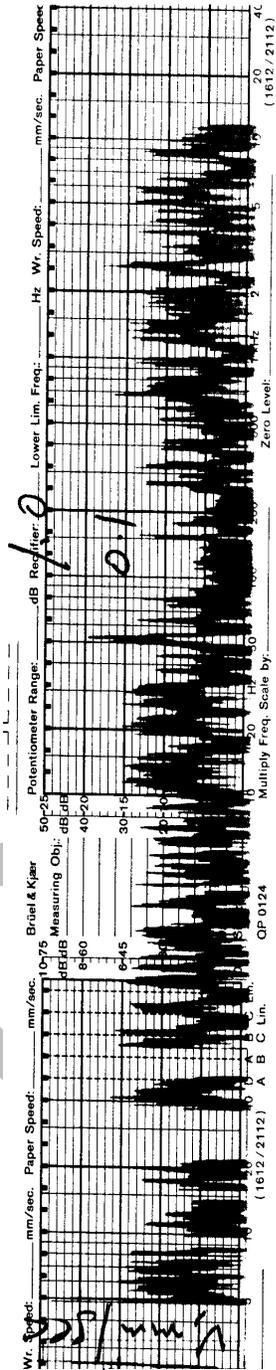
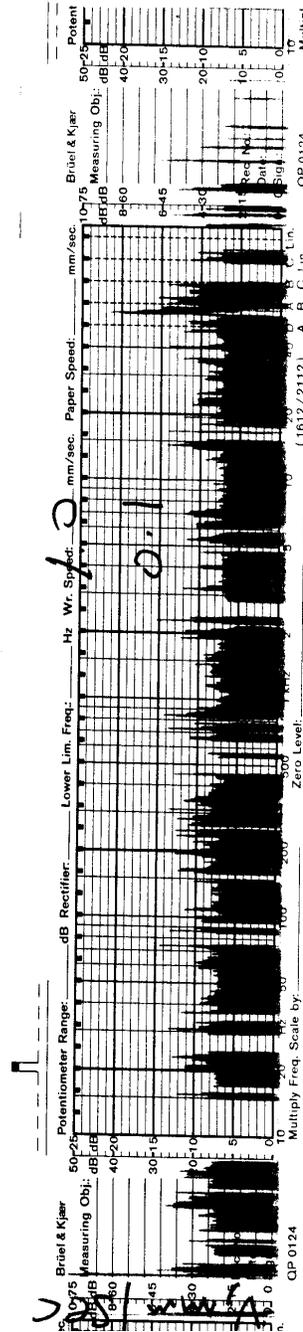
FIGURE 15. VIBRATION TIME HISTORY FOR LOCATION 7

(a) 28 June 2006 – 2.06 pm to 2.21 pm

(b) 29 June 2006 – 8.04 am to 8.20 am

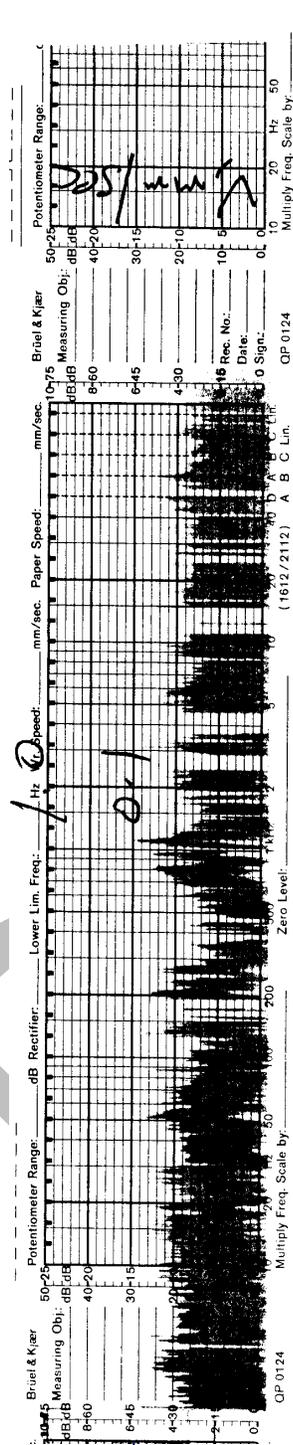
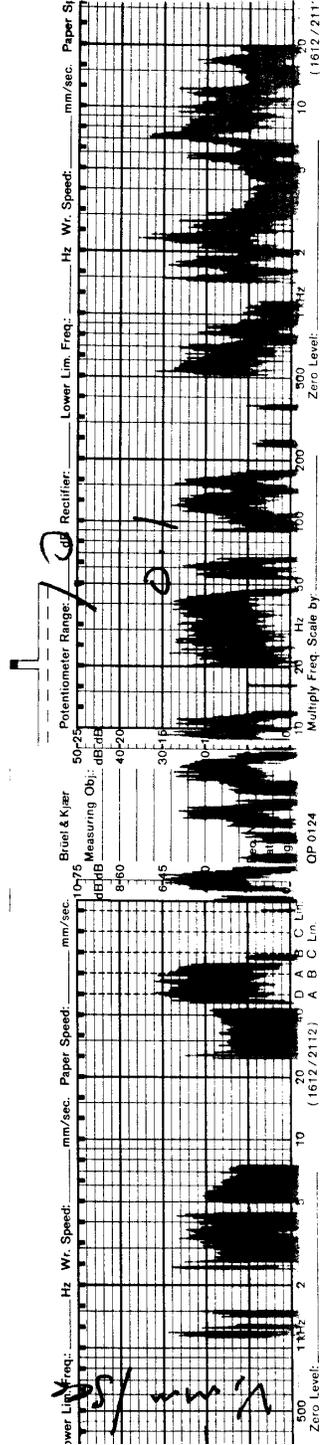
FIGURE 16. VIBRATION TIME HISTORY FOR LOCATION 8

(a) 28 June 2006 – 2.49 pm to 3.04 pm

(b) 29 June 2006 – 7.22 am to 7.39 am
